# SERVICE BULLETIN

| <b>SERVICE BULLETIN</b> | | No.: ESB-98E34-001 | |
| <b>Subject:</b> CHANGE IN REAR SUSPENSION LOWER ARM MOUNTING NUT | | <b>&lt;M/Y&gt;</b><br>96-10 | |
| <b>Group:</b> REAR SUSPENSION | | | |

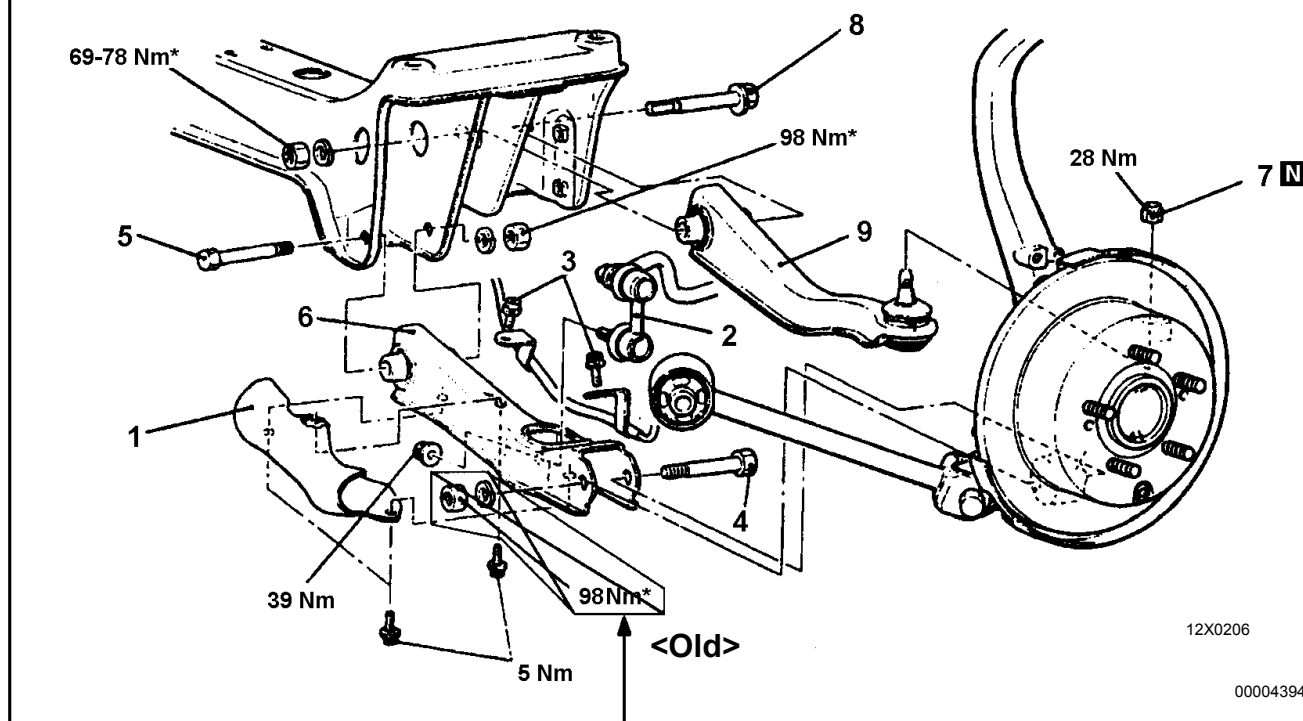
| <b>1. Description:</b><br>With change of the nut for mounting the rear suspension lower arm to a self-locking nut, a mark indicating that the nut is not reusable has, been added and the tightening torque changed. | | | |

1. Lower arm cover
2. Stabilizer link ball joint and lower arm connection
3. ABS wheel-speed sensor clamp bolts
4. Lower arm assembly and knuckle connection bolt
5. Lower arm assembly mounting bolt
6. Lower arm assembly

\*: Indicates parts which should be temporarily tightened, and then fully tightened with the vehicles on the ground in the unladen condition.
