# SERVICE BULLETIN

| <b>SERVICE BULLETIN</b> | | No.: ESB-98E52-501 | |
| <b>Subject:</b> CORRECTION TO SRS TROUBLESHOOTING | | <b>&lt;M/Y&gt;</b><br>96-10 | |

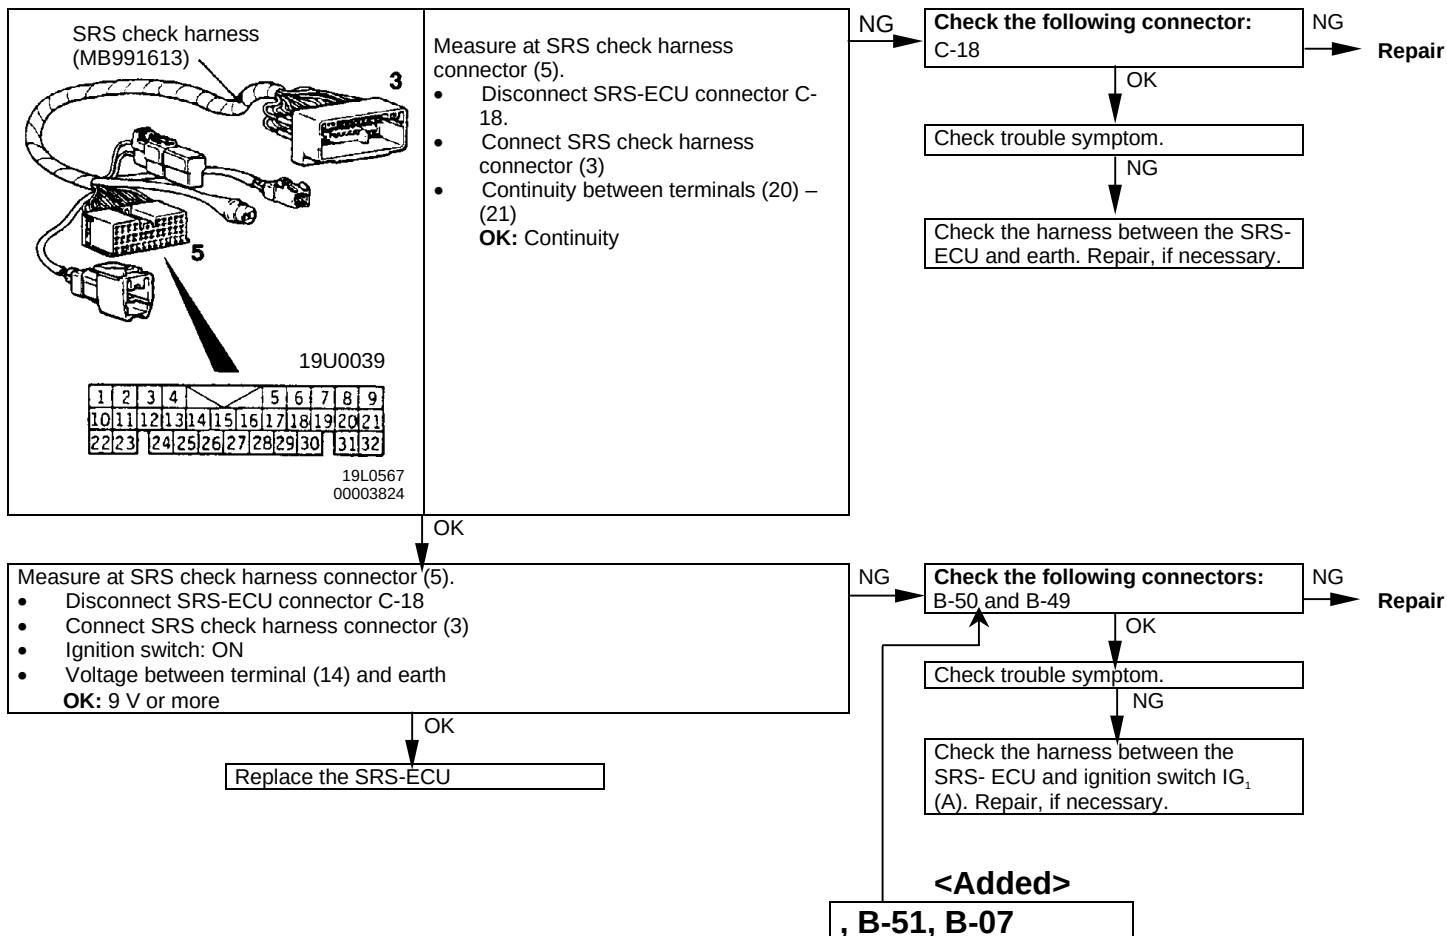
| <b>1. Description:</b><br>In the power circuit system inspection under SRS – Troubleshooting, omission of connector numbers has been rectified. | | | |

| Code No. 41 IG <sub>1</sub> (A) power circuit system | Probable cause |
| This diagnosis code is output if the voltage between the IG <sub>1</sub> (A) terminal and the earth is lower than the specified value for a continuous period of 5 seconds or more. However, if the vehicle condition returns to normal, diagnosis code No. 41 will be automatically erased, and the SRS warning lamp will switch off. | <ul style="list-style-type: none"> <li>Malfunction of harnesses or connectors</li> <li>Malfunction of SRS-ECU</li> </ul> |
