# SERVICE BULLETIN

| <b>SERVICE BULLETIN</b> | | No.: ESB-98E52-501 | |
| <b>Subject:</b> CORRECTION TO SRS TROUBLESHOOTING | | | |

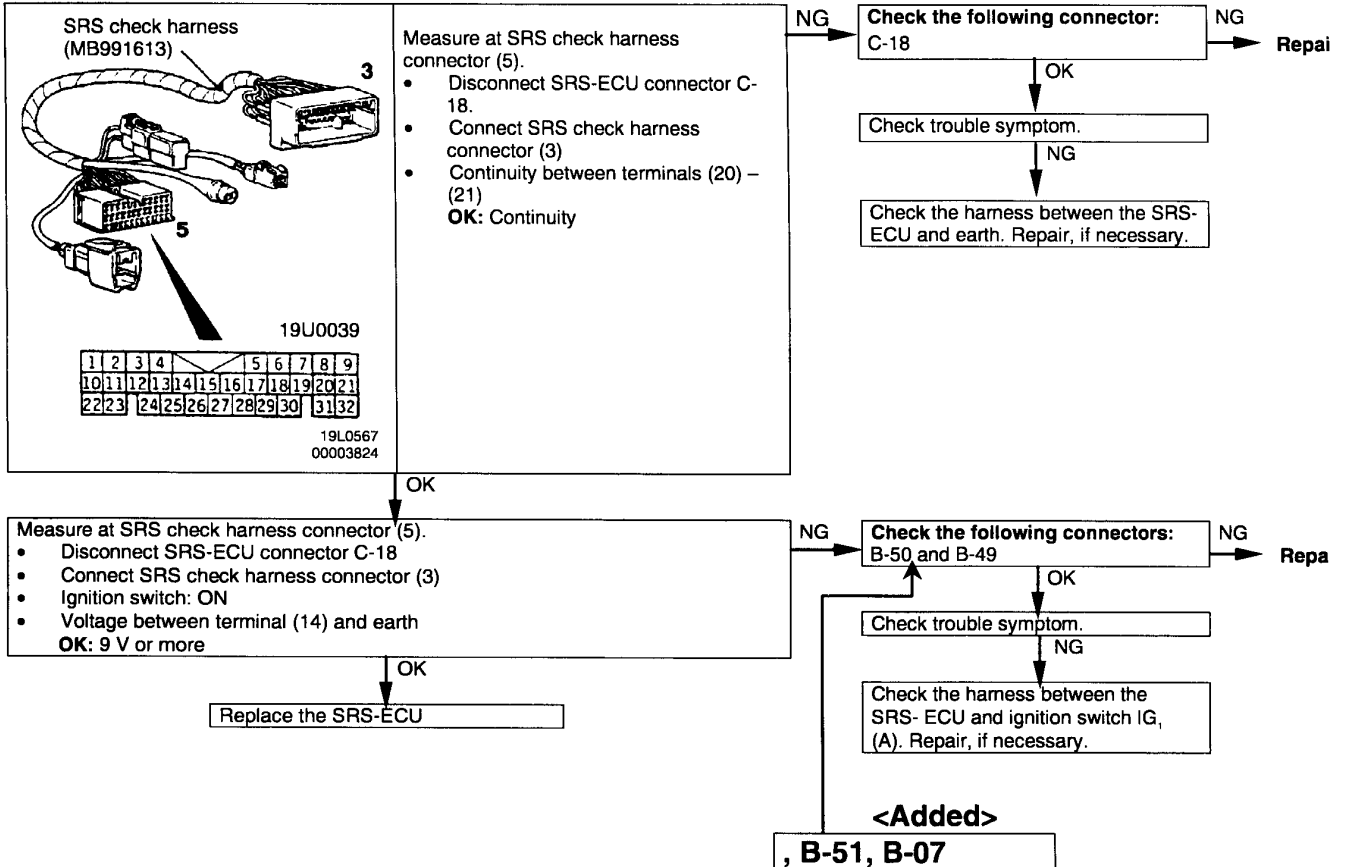
| <b>1. Description:</b><br>In the power circuit system inspection under SRS – Troubleshooting, omission of connector numbers has been rectified. | | | |

| Code No. 41 IG, (A) power circuit system | Probable cause |
|---|---|
| This diagnosis code is output if the voltage between the IG, (A) terminal and the earth is lower than the specified value for a continuous period of 5 seconds or more. However, if the vehicle condition returns to normal, diagnosis code No. 41 will be automatically erased, and the SRS warning lamp will switch off. | <ul style="list-style-type: none"> <li>Malfunction of harnesses or connectors</li> <li>Malfunction of SRS-ECU</li> </ul> |
