| SERVICE BULLETIN | | |
| <b>To:</b> | <b>All Dealers</b> | <b>Reference</b><br><b>SB-17-0298</b><br><br><b>Issued:</b><br><b>26 February 2009</b> |
| <b>Subject:</b> | <b>Headlamp Drying Out Procedure</b> | |

| SERVICE BULLETIN | | |
|---|---|---|
| <b>Subject:</b> | <b>Rear Lamp Assembly Condensation Removal and Repair Procedure</b> | |

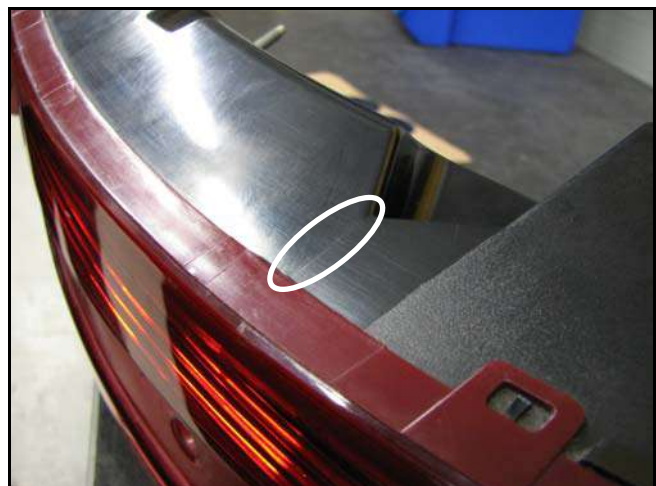
Figure 3

8. Turn the lamp unit to let the water drain out of the hole.
8. Find the location of the water leak (see the example in Figure 3). Refer to 'Water Leak Locations' after this Workshop Procedure for the usual crack or split locations.

**Note:** *The location of the water leak can be difficult to find.*

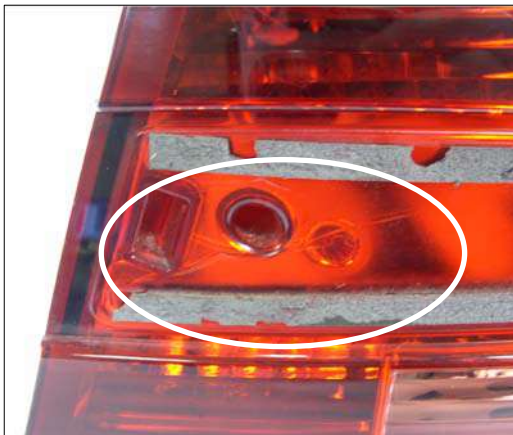
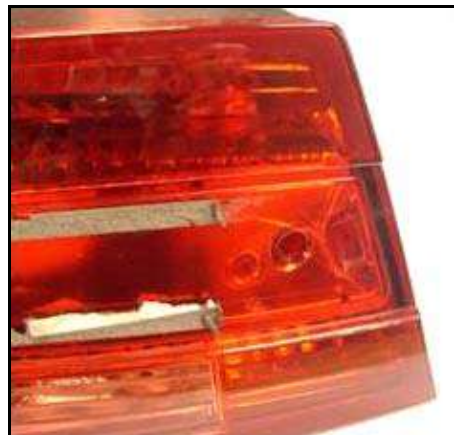
- A crack in the lens under the infill panel (Figure 7 and Figure 8).
- Cracks in the housing around the mounting points (Item A, Figure 9), rub-through on the edge of the lens (Item B, Figure 9) and lens/housing separation because of load between the lens and the panel (Figure 10).

13. Dry the damaged area with an airline.
14. Degrease the damaged area.
15. Use cyanoacrylate adhesive to seal all small cracks found and make sure that you fully seal the crack. For larger holes use an applicable 2-part epoxy adhesive.
16. Clean the area around the drilled hole with applicable alcohol cleaner and cloth.
