## Squeaks and Rattles

### Diagnostic Information and Procedures

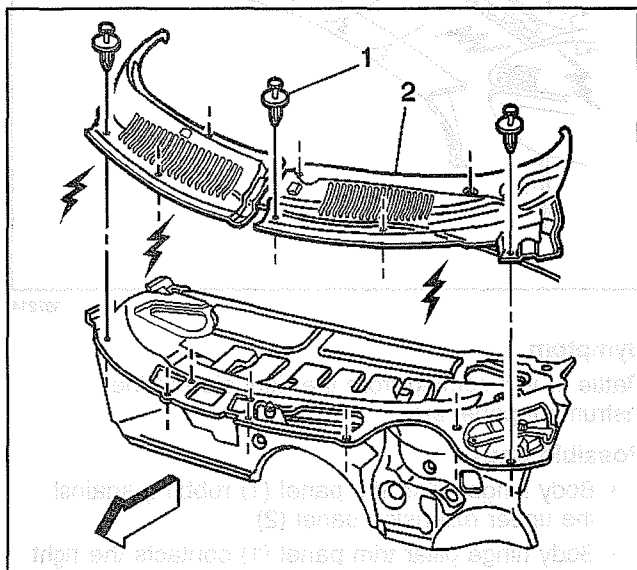
397255

Itching sound from the bottom of the windshield.

The air inlet screen (2) is rubbing against the bottom edge of the windshield.

Remove the air inlet screen (2). Look for witness marks from the windshield on the air inlet screen (2).

1. Apply isolation (vinyl nitril foam or equivalent) to the inlet screen and windshield interface.
2. Add foam tape to the right and/or left side of the air inlet screen(s) (2).

3. Foam strips are to be installed 1.0 mm to 3.0 mm (.04 in to .08 in) inboard from the glass interface edge of the inlet screen

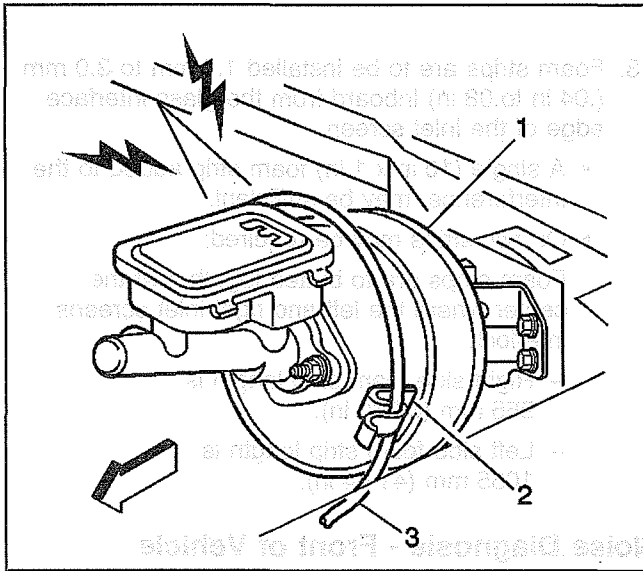
397232

Tapping sound is heard coming from the instrument panel.

The cruise control servo cable (3) is tapping against the cowl.

- Visually inspect for the following:
- Witness marks on the cable (3) and/or cowl
- Cruise control servo cable (3) resting against the cowl

Reposition the cable (3) on the brake booster (1). The cable clip (2) should be in the three o'clock position.

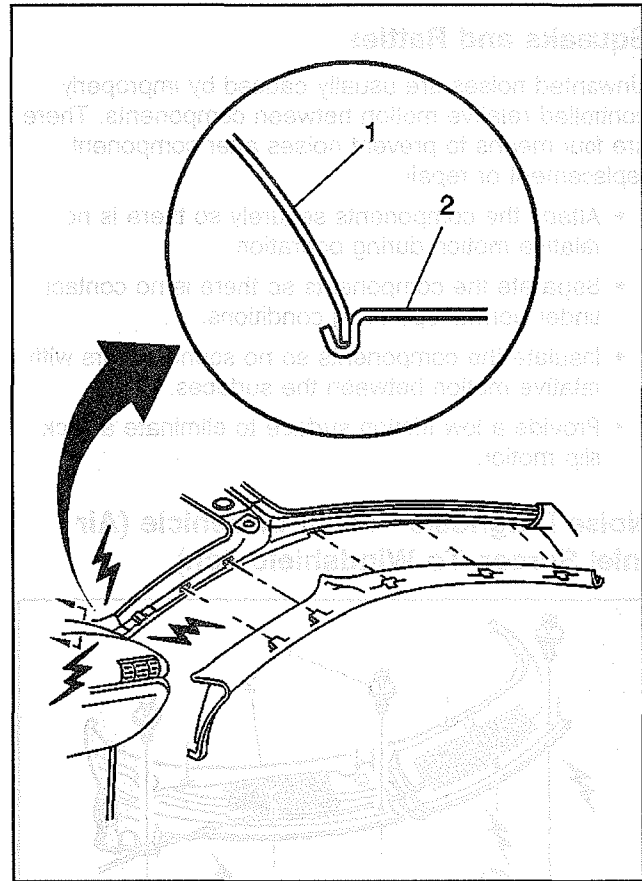
397214

Rattle or itch coming from the right side of the instrument panel area.

- Body hinge pillar trim panel (1) rubbing against the upper extension panel (2).
- Body hinge pillar trim panel (1) contacts the right side wall of the instrument panel.

- Look for witness marks on the following:
- Hinge pillar trim panel (1)
- Upper extension panel (2)
- Side wall of the instrument panel
- Push down on the corner of the upper extension panel (2) to see if it is able to spring back and touch the hinge pillar trim panel (1).
- Push against the instrument panel wall to see if it is able to spring back and touch the hinge pillar trim panel (1).

- Apply felt tape to the upper extension panel (2) at the point of contact.
- Apply felt tape to the instrument panel wall at the point of contact.

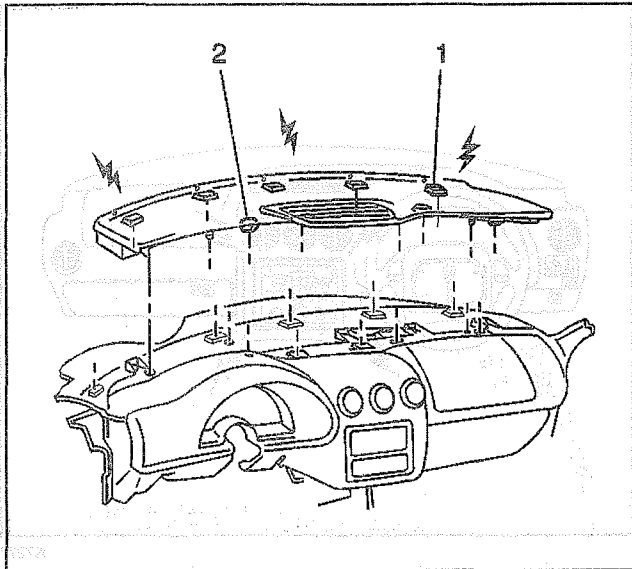
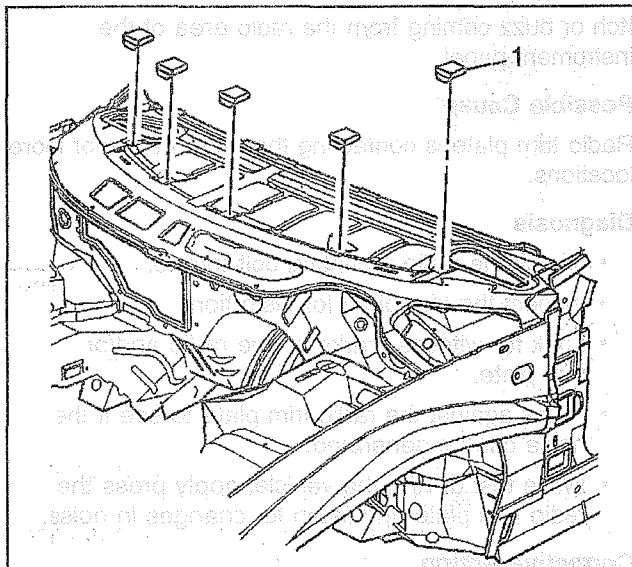
Rattle from the top of the instrument panel.

- Check the retaining clips (2) and dual lock fasteners (1) for the following:
  - Missing
  - Damaged
  - Not fully engaged
- The adhesive attaching the dual lock fasteners (1) fails.

While test driving the vehicle, apply pressure to the upper trim panel and listen for changes in noise.

- If the adhesive has failed, replace the dual lock fastener.
- Fully engage all clips and dual locks
- Replace any damaged or missing clips (2) or dual lock fasteners (1).

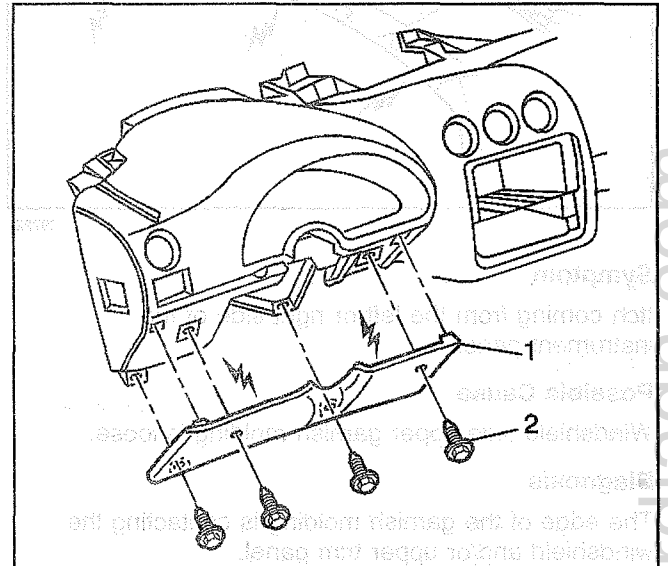
397220

Itching sound from below the steering column.

Knee bolster rubbing against the cluster bezel.

While test driving apply hard upward pressure and listen for the itch to change.

- Loosen knee bolster bolts.
- Reposition knee bolster downward and forward to create clearance to the bezel.

- Retighten the bolts to 1.9 N·m (17 lb in). Refer to *Radio Replacement (Chevrolet)* and *Radio Replacement (Pontiac)* in Entertainment.

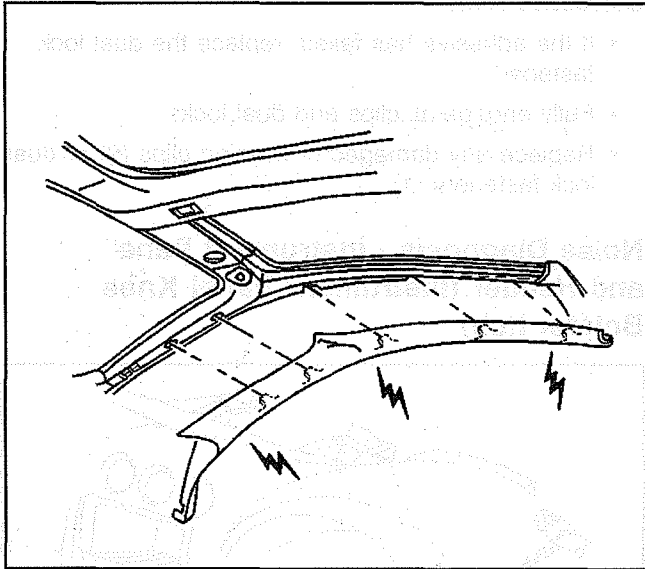
397222

Itch coming from the left or right side of the instrument panel.

Windshield side upper garnish molding is loose.

The edge of the garnish molding is contacting the windshield and/or upper trim panel.

- Replace the damaged clips on the garnish molding.
- Replace the garnish molding if the clip area is broken.

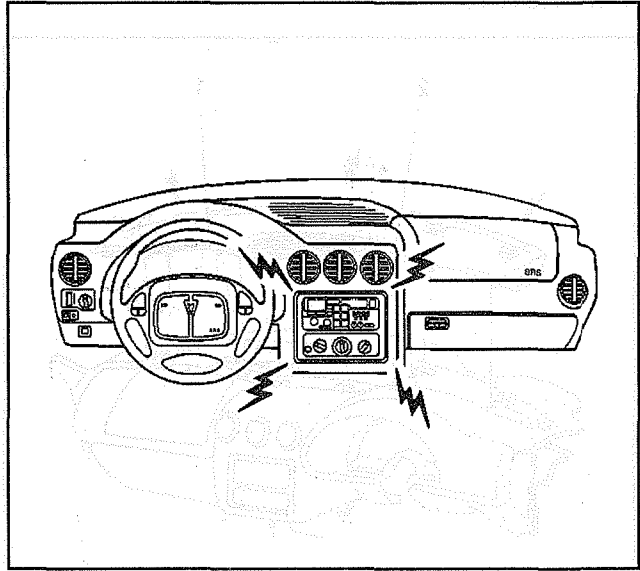
397277

Itch or buzz coming from the radio area of the instrument panel.

Radio trim plate is contacting the radio at one or more locations.

- Check the radio mounting bolt torque.
- Inspect the trim plate for distortion.
- Look for witness marks on the radio and/or trim plate.
- Press against the radio trim plate to see if the noise can be generated.
- While test driving the vehicle, apply pressure to the radio trim plate and listen for changes in noise.

- Tighten the radio mounting bolts to 8 N·m (7 lb in). Refer to *Radio Replacement (Chevrolet)* and *Radio Replacement (Pontiac)* in Entertainment.
- Replace the radio trim plate.
- Apply felt tape to the radio and/or edge of the radio trim plate at the point(s) of contact.

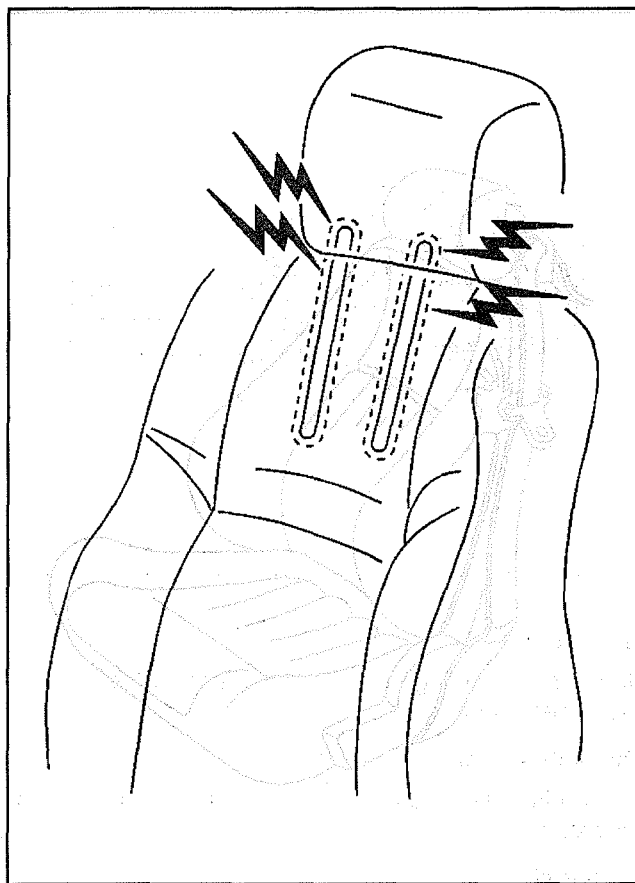
397223

Rattle coming from the head restraint area.

Head restraint posts rattling in the receiver holes.

Test drive the vehicle, and apply pressure to the head restraint.

- Remove the head restraint.
- Bend the posts approximately 25.4 mm (1.0 in) outward. This pre-loads the posts in the receiver holes.

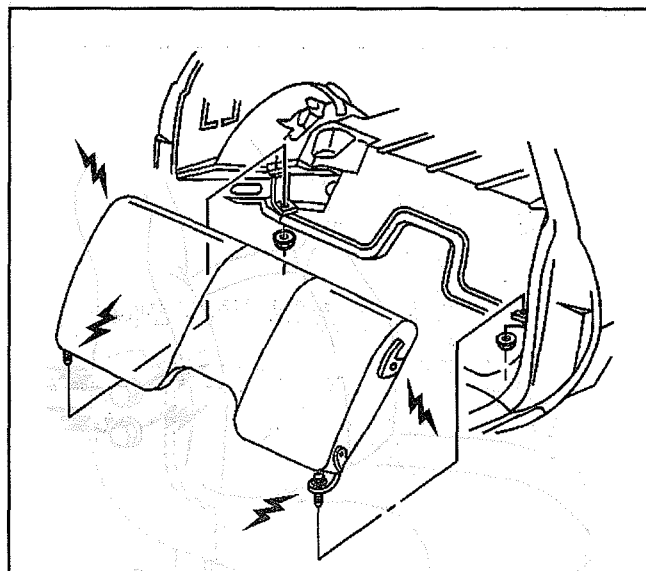
397226

Rattle from the rear seatback rest area.

- Check for the seat belt buckle hitting the seat trim.
- Rear seatback is not in tension against to the striker bolt. This allows the latch to rattle on the striker bolt.

Test drive the vehicle, apply pressure to the rear seatback, listen for the rattle.

- Insure that the rear seat is in the proper location (rearward as far as possible).
- Loosen the lower hinge bolt.
- Push the bottom of the seat rearward and apply pressure rearward.

Tighten the pivot support nut to 24 N·m (18 lb ft).

- Reevaluate. If condition persists, loosen striker and reposition rearward as far as possible. Bend striker with mallet to create and interference fit.

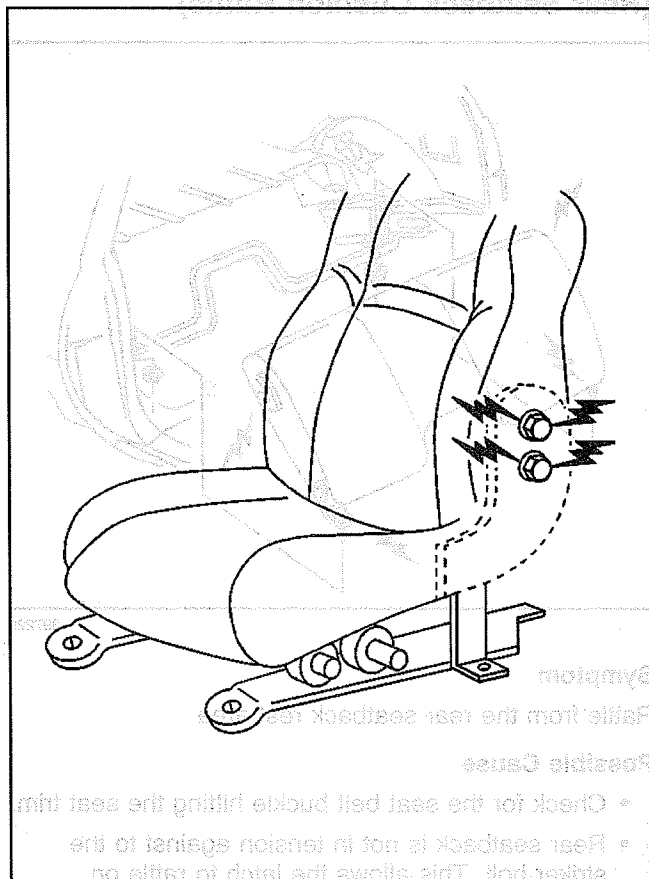
397227

Creak heard in seat back when occupants weight shifts.

Seatback hinge recliner bolts not tightened to specifications.

Check and tighten the bolts.

Tighten the seatback hinge recliner bolts to 24 N-m (18 lb ft).

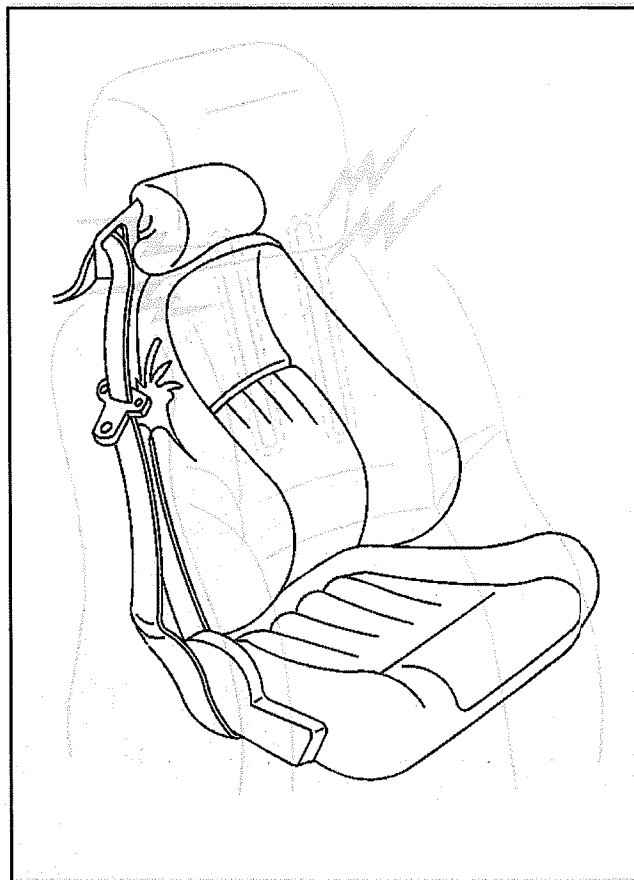
397228

Rattle from the side of the front seat.

The seat belt latch rattles against the plastic trim of the seat.

Visually inspect the seat belt latch and seat for contact.

Add felt tape to the plastic part of the seat belt latch.

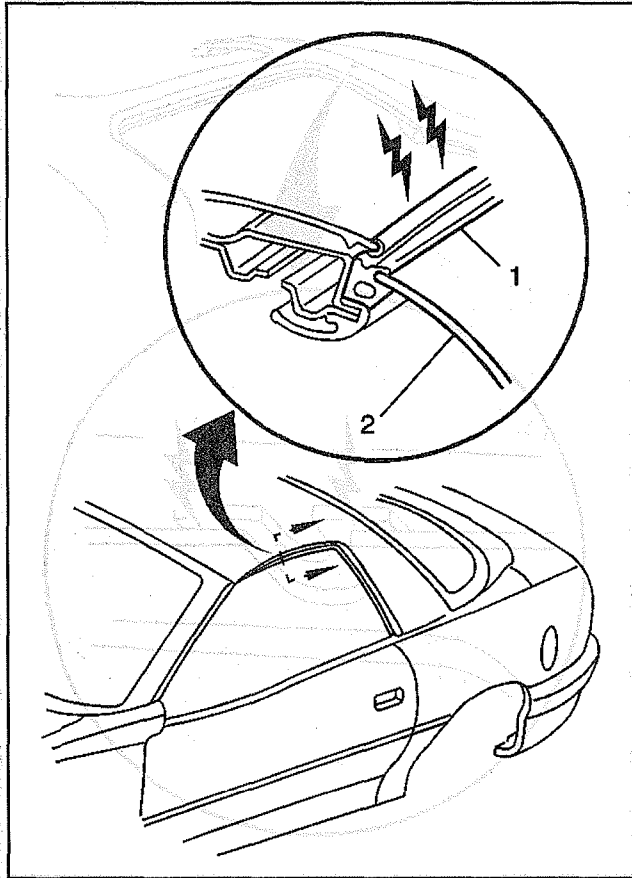
397252

Itching noise heard at the door window (1) to weatherstrip (1) interface.

Door glass (2) rubbing against the weatherstrip (1).

Test drive the vehicle, roll the window (2) down so it is just off the weather-strip (1).

Apply Krytox weatherstrip lubricant (GM P/N 9985767) to weatherstrip/glass interface. Use Krytox oil only, after application, let stand 30 minutes. Wipe off excess.

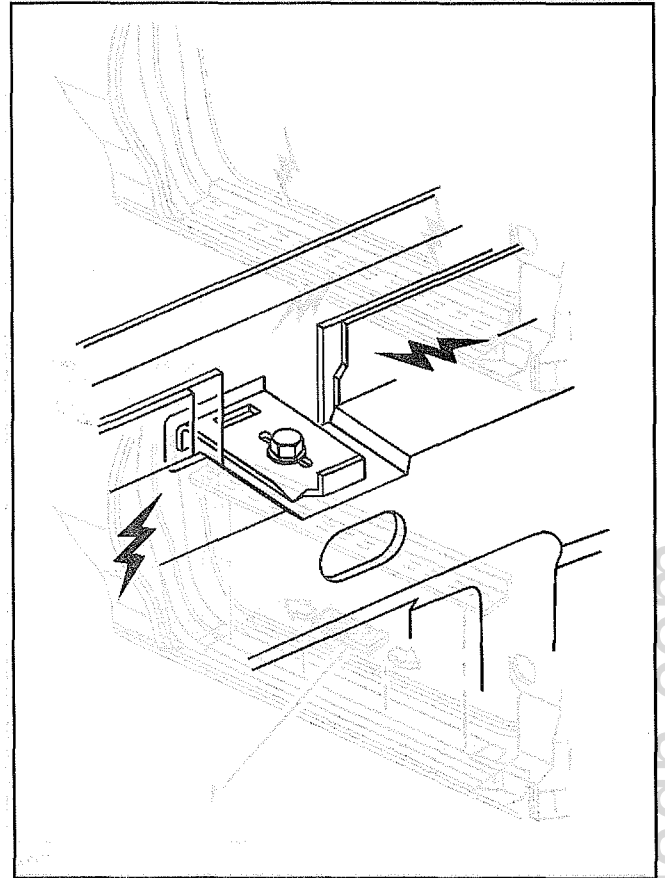
397256

Rattle coming from the bottom of the door to door glass area when the window is completely up.

The window guide stabilizer is not adjusted properly.

Close door completely. Push on the bottom of the door glass to check for movement.

- Adjust the window guide stabilizer.
- The stabilizers should be adjusted to 18.5 mm (0.73 in) from the inner edge of the door to the back of the stabilizer.
- If symptom continues, replace the window guide stabilizer.

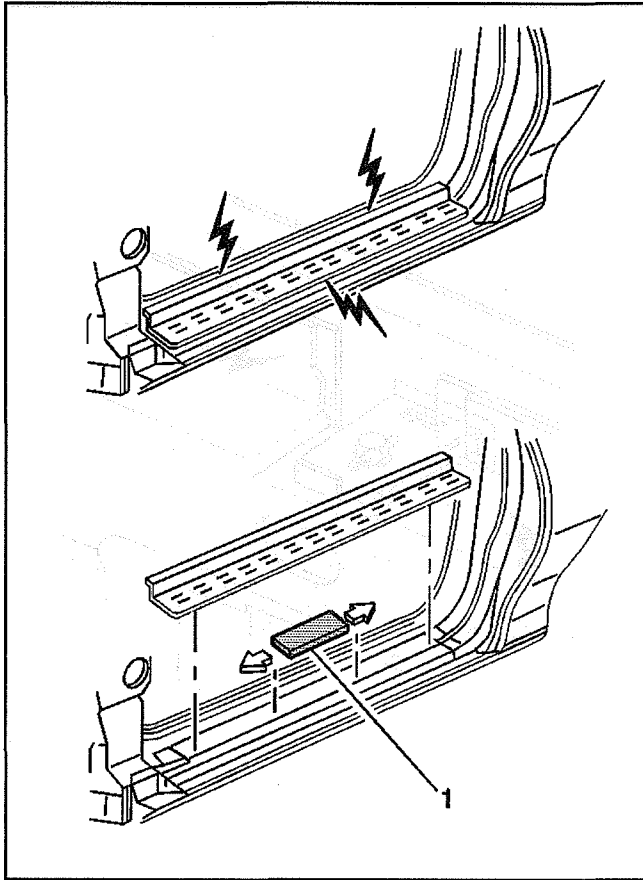
397258

Buzzing sound coming from the lower door area.

- The side door sill plate is loose and emits a buzzing sound.
- The clips on the sill plate are broken.

Open door, push sill plate back and forth to check for movement.

- Place foam tape underneath the plate in sensitive areas.
- Replace the sill plate.

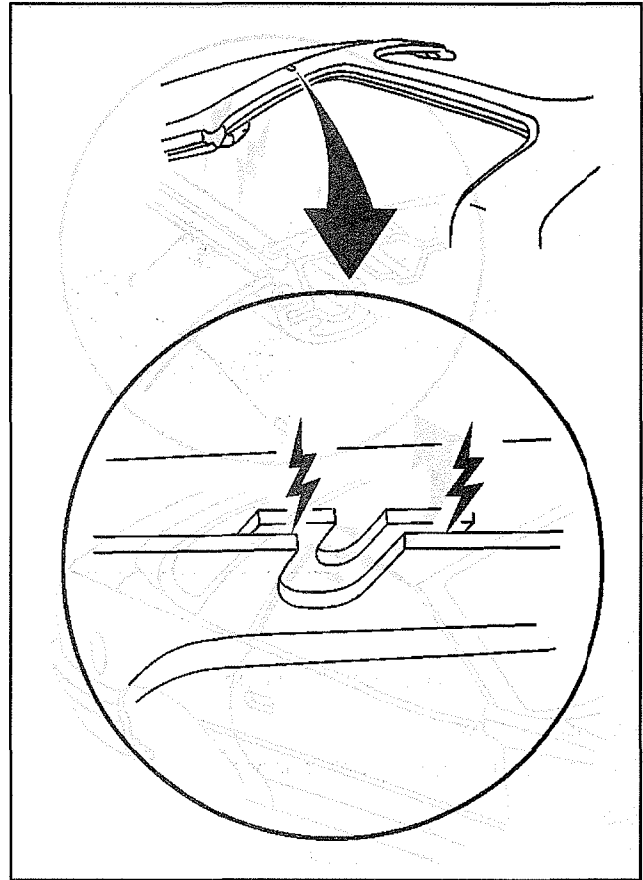
397234

A tapping sound is heard along the windshield header.

Sheet metal is tapping.

Test drive the vehicle and pry on location shown.

Pry apart the two layers of metal.

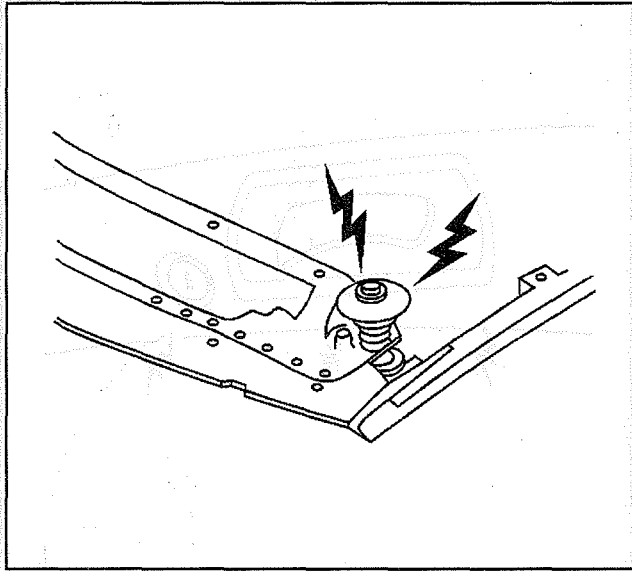
397236

Creak sound coming from the #1 bow.

The #1 bow to side rail bolt is loose.

Check torque on the side rail bolt.

- Apply blue LOCTITE® to the side rail bolt.

Tighten the side rail bolt to 17 N·m (13 lb ft).

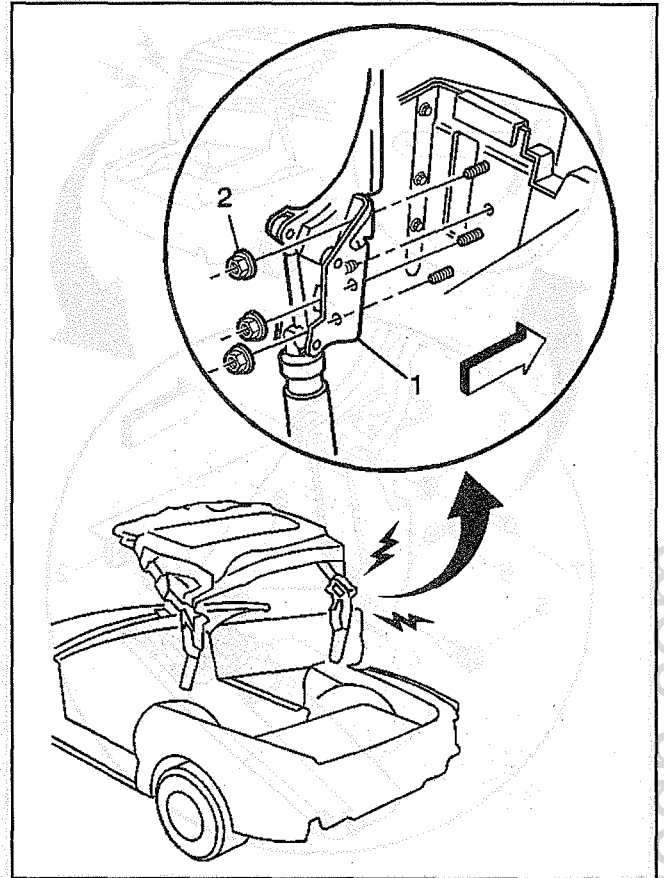
397239

- Rattle in the B-pillar area.
- Creak in the B-pillar area.

Folding top pivot bracket bolts (2) may be loose.

Check pivot bracket bolt for looseness.

Tighten the pivot bracket bolt.

Tighten the pivot bracket bolt to 27 N·m (20 lb ft).

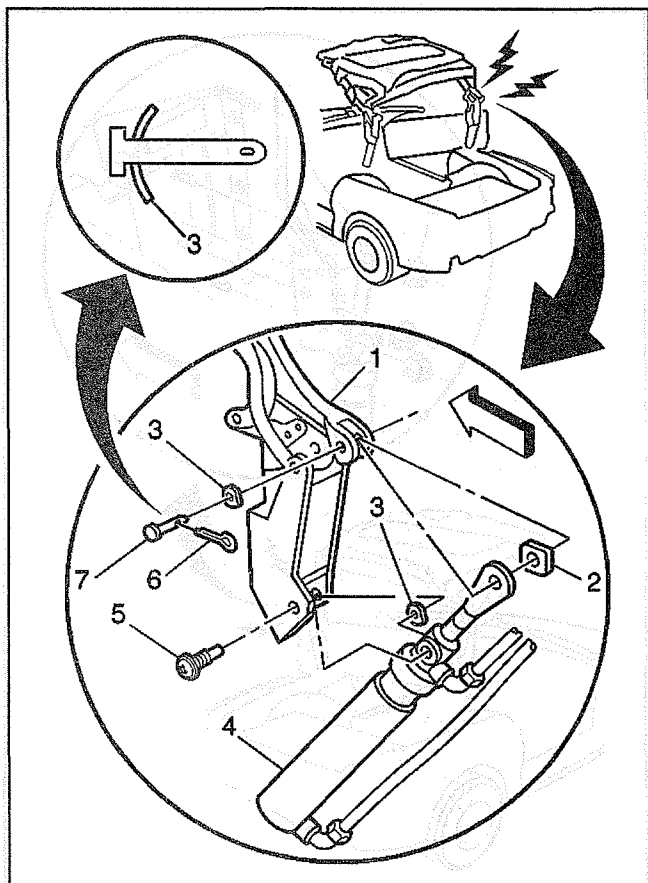
397246

- Rattle in the B-pillar area.
- Creak in the B-pillar area.

- Folding top cylinder pivot pin (7) is dry.
- Spring washer (3) may not be installed properly.
- Folding top cylinder bolt (5) is loose.

- Check cylinder bolt (5) for looseness.
- Check spring washer (3) for correct orientation.

- Lubricate the cylinder pivot pin (7).

- Tighten the cylinder bolt (5) to specification.

Tighten the cylinder bolt (5) to 50 N-m (37 lb ft).

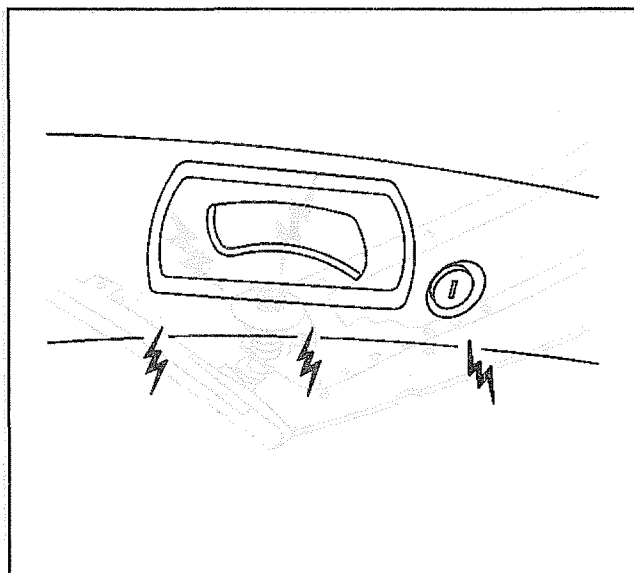
397274

Over moderate to rough road surfaces, a tapping sound or rattle is heard in the T-top handle location.

- Looseness in riveted joints between the crank plate and rods (front and rear).
- Flat spring and/or lock bracket is contacting the lock rod(s).

- Inspect for looseness in the riveted joints (front and rear).
- Look for witness marks and lock rod contact to the flat spring and/or lock bracket.

- Vehicles that have looseness in the riveted joints, order and install new T-tops.
- Flock interfaces between the flat spring and lock bracket and rod(s) so rod(s) do not contact.

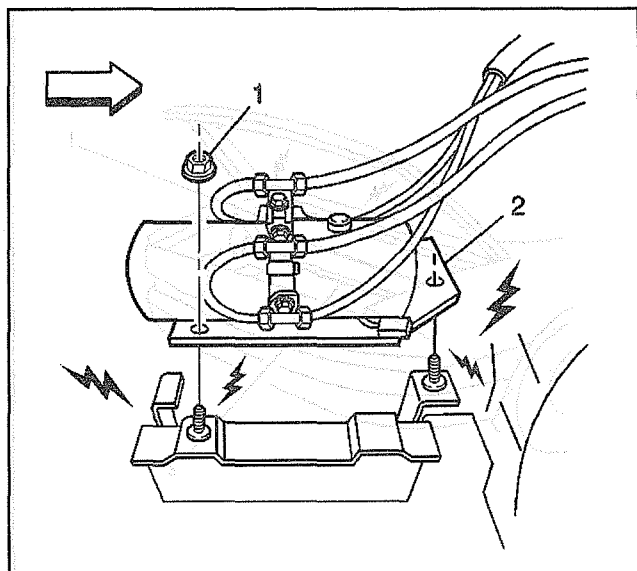
397250

Rattle coming from the rear of the vehicle.

- Folding top pump mounting nuts (1) loose or missing.
- Mounting stud(s) missing or broken.

Visually inspect for mounting studs and nuts (1).

- Replace missing or broken studs with bolts.

Tighten the pump mounting nuts (1) to 6 N·m (53 lb in).

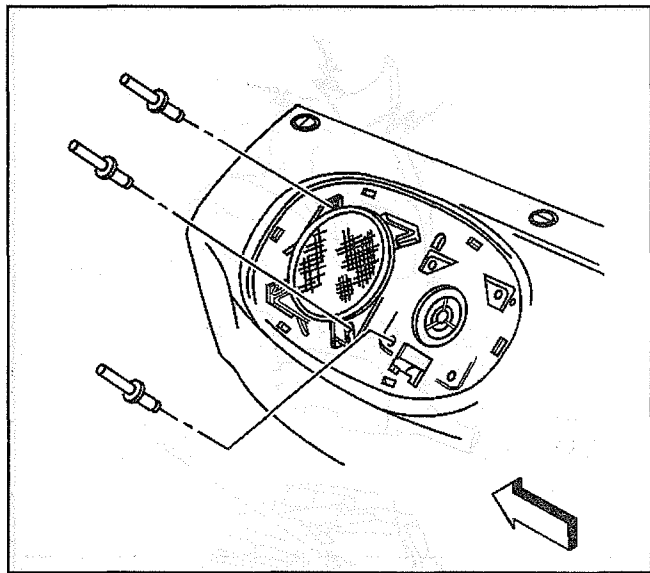
362247

Rattle from the rear speaker located on the rear quarter trim panel.

The rivets do not hold well due to improper installation.

- Remove the rear quarter trim.
- Check speaker attachment to the trim for looseness.

Install new rivets or isolation material as necessary.

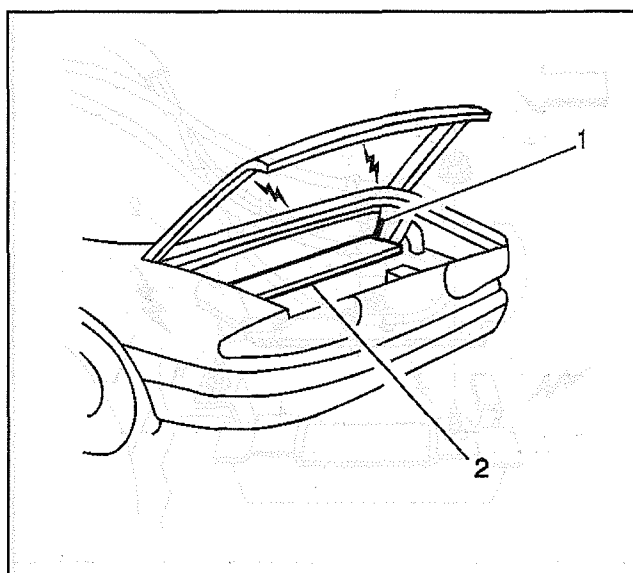
397264

Rattle from the rear of the vehicle.

Rear compartment closeout panel (2) rattles against the side trim.

Remove the closeout panel (2) and test drive the vehicle.

Apply a 2 in x 5

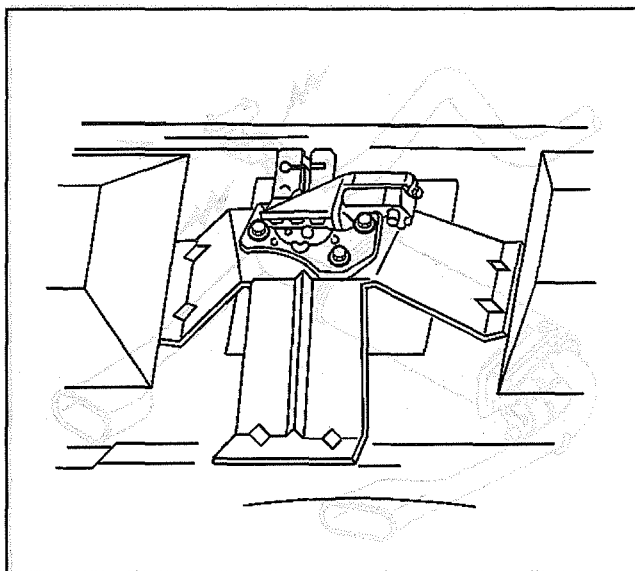
397266

A rattle coming from the rear hatch area.

- The hatch latch is not in the correct position, both cross-car and up/down.
- Overslam bumpers are not properly set.

Test drive the vehicle and, with the aid of a helper, push up on the rear compartment lift window panel to stop the noise.

- Loosen the latch.
- Center with the striker and retighten. Be sure to provide equal clearance to the latch sides.
- Lower the lift window pane and run bumpers out to a point that a single piece of paper can barely be pulled out when the rear panel is fully closed.

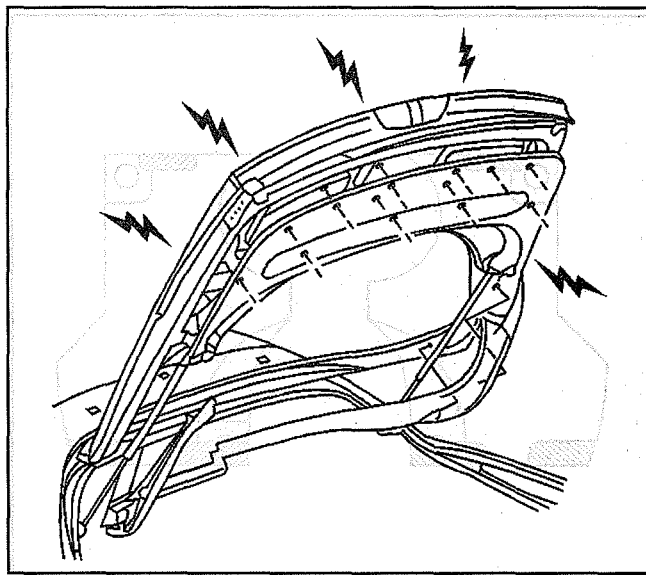
397267

Rattle from the rear compartment trim area.

Trim is loose due to misinstalled or missing fasteners.

Carefully pull the rear compartment trim down to view behind, look for misinstalled or missing fasteners.

Install new fastener.

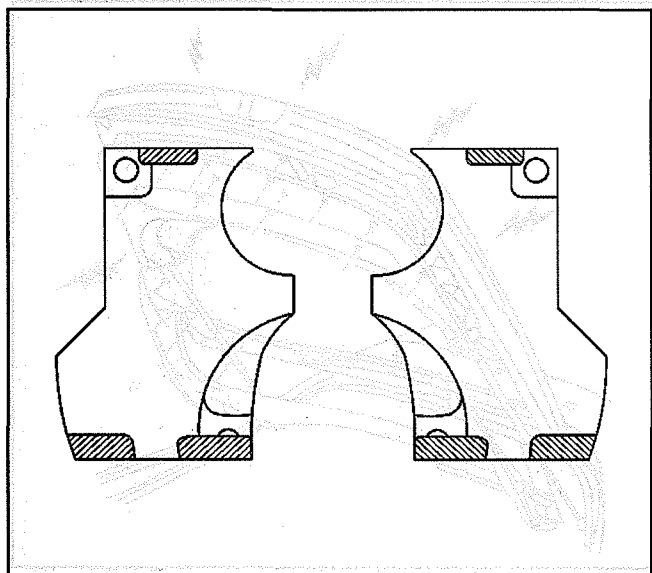
397275

High pitched itch coming from the rear (right, left or both) of the vehicle over moderate to rough roads. Sounds similar to sheet metal joint creaks.

The styrofoam inserts located behind the quarter trim panel are contacting and rubbing against the quarter inner sheet metal surfaces.

Look for witness marks on the styrofoam insert of the quarter panel inner sheet metal surface.

Apply 3 pieces of 30 x 80 mm GM 6068M closed cell foam (P/N 22638774) or similar isolation material at specified location. Wrap foam around edges approximately 1/4 inch.

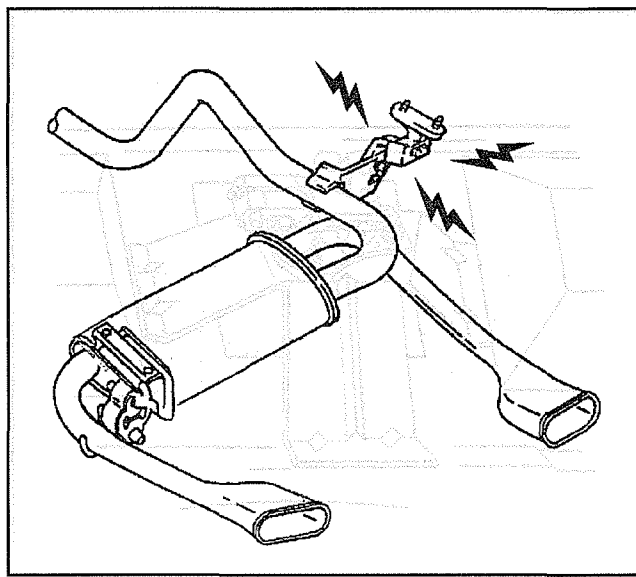
397269

Rattle from the underside of the vehicle.

The slots on the exhaust hangers increase in size over time.

Visual inspection for excessive gap in exhaust hanger where exhaust system blade is inserted.

Replace hanger(s).

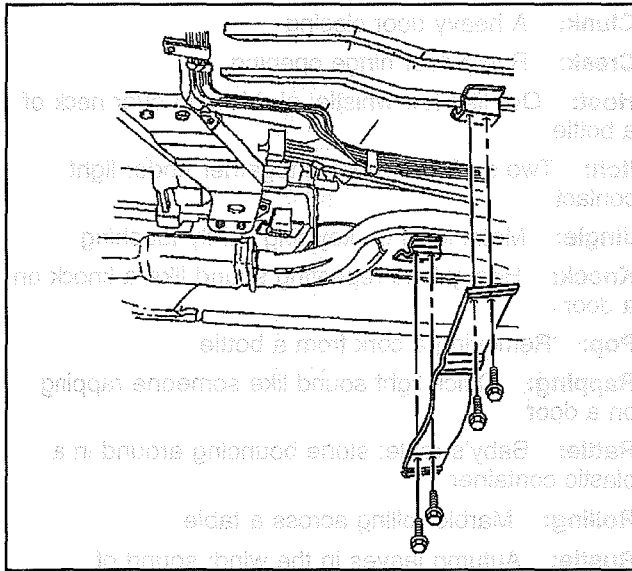
368319

Underbody rattle.

The exhaust system intermediate pipe is hitting the cross brace.

Look for witness marks on the pipe and cross brace. Minimum clearance between the pipe and the brace should be:

- For the 3800 V6 the specification is 19.0 mm (0.748 in)
- For the 5.7L V8 the specification is 14.0 mm (0.551 in)

- Reposition exhaust system to provide minimum clearance using the above specifications.
- Loosen the slip joint, converter bracket hanger and take down pipe to manifold.
- Raise exhaust system with a single post jack.
- Retighten the system starting with the converter bracket, then tighten the take downs at the manifolds, lastly tighten the pipe clamp.

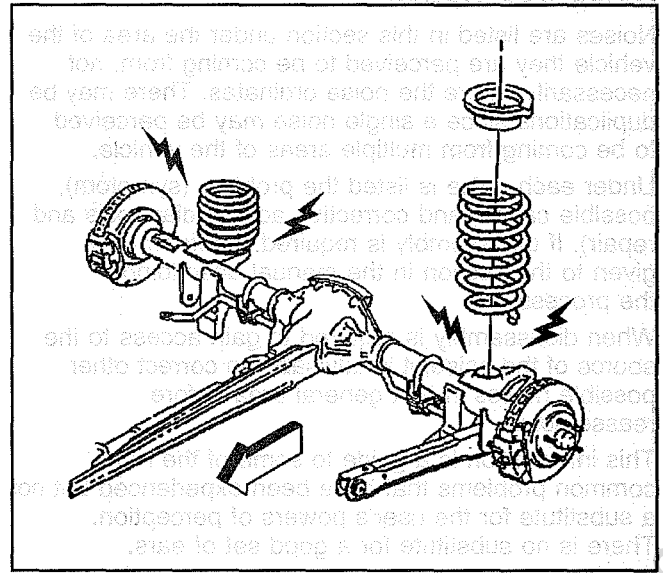
397273

A clunk is heard in the rear of the vehicle.

- Spring isolator is mispositioned.
- A rear suspension component is not tightened to specification.

- Visually inspect the isolator position on top of the spring. The spring tail end should be pointed forward.
- Check all rear suspension attachments for proper torque.
