## GROUP 26

### FRONT AXLE

##### OUTLINE OF CHANGE

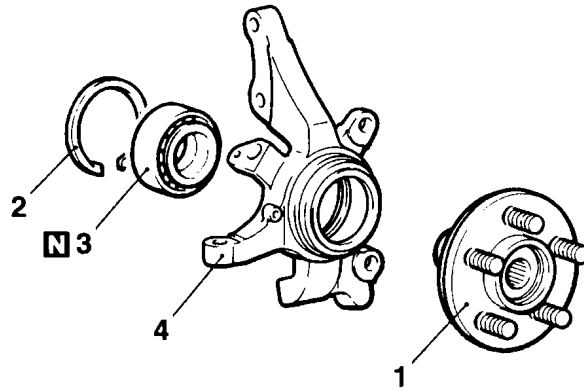
BW0238AL

- ▶D◀ • Hub rotation starting torque check  
 ▶C◀ • Wheel bearing axial play check  
 ◀A▶ 1. Hub  
 ▶B◀ 2. Snap ring

- ◀B▶ ▶A◀ 3. Wheel bearing  
 4. Knuckle

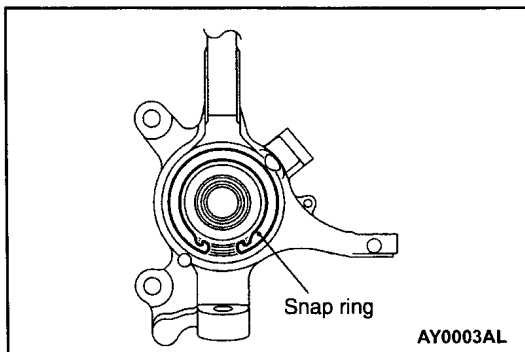
#### ▶B◀ SNAP RING INSTALLATION

The notch in the snap ring should face down.

The sealing performance between the snap ring and the bearing seal can be ensured by making the snap ring face down. If the snap ring notches face toward the different direction, the sealing performance may be impaired.
