## GROUP 54

# CHASSIS ELECTRICAL

#### OUTLINE OF CHANGE

The following service procedures have been revised due to the change in the immobilizer-ECU.

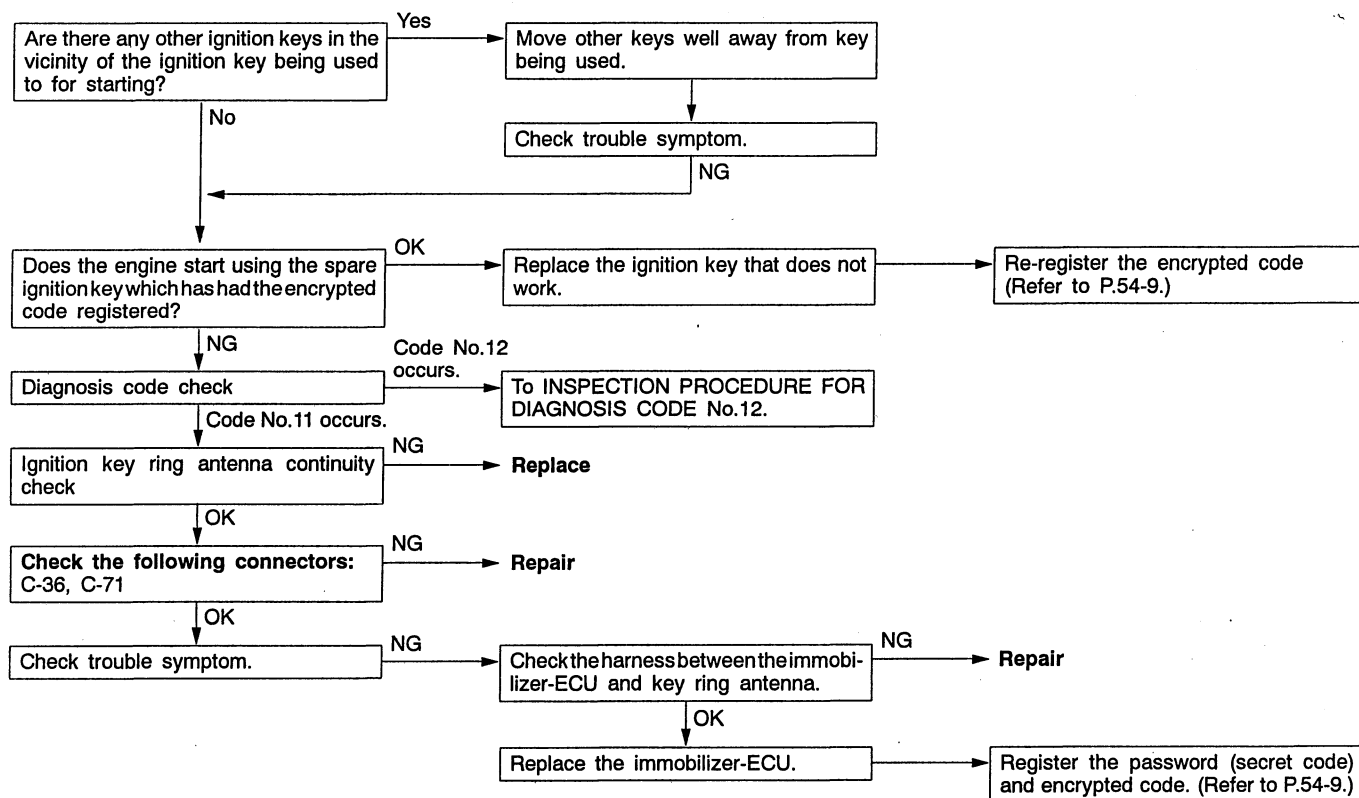
| Code No.11 Transponder communication system or radio interference of encrypted code | Probable cause |
|---|---|
| <ul style="list-style-type: none"> <li>The encrypted code of the transponder is not sent to the immobilizer-ECU immediately after the ignition switch is turned to ON position.</li> <li>If the engine is started while several ignition keys are in the vicinity, then interference between the different keys may occur, which will cause this code to be generated.</li> </ul> | <ul style="list-style-type: none"> <li>Radio interference of encrypted code</li> <li>Malfunction of transponder</li> <li>Malfunction of ignition key ring antenna</li> <li>Malfunction of harness or connector</li> <li>Malfunction of immobilizer-ECU</li> </ul> |

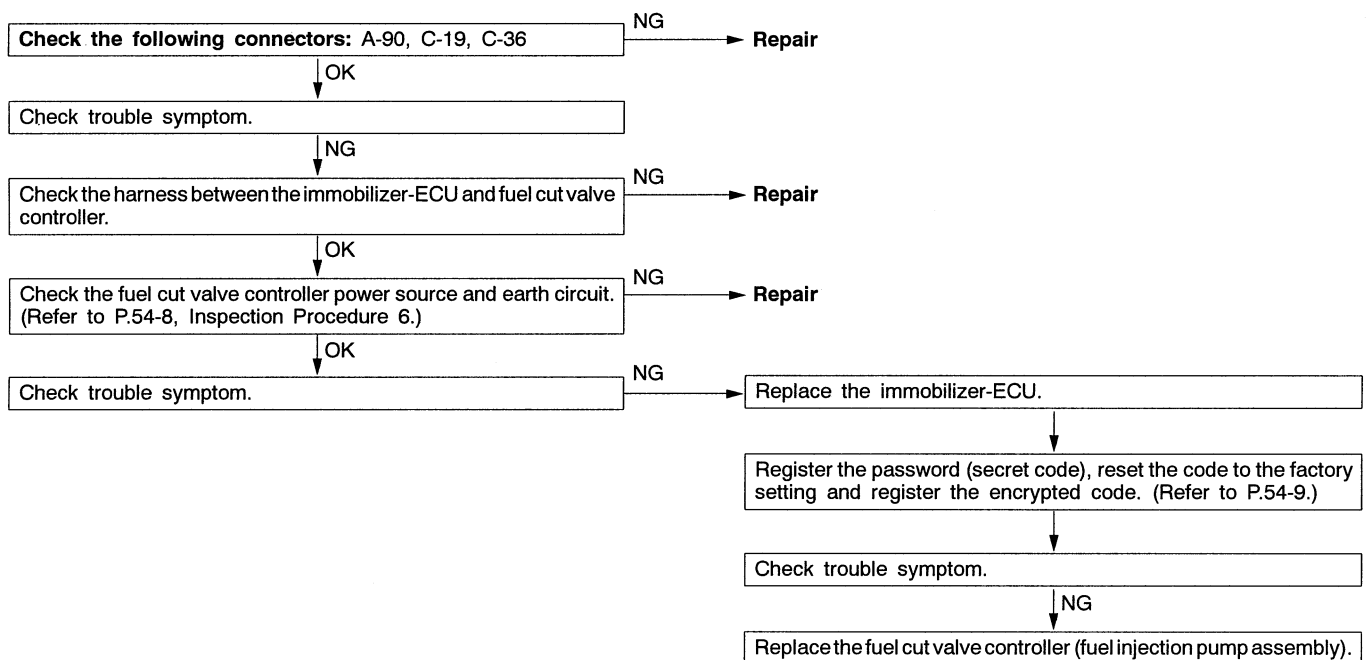
| Code No.21 Communication system between fuel cut valve controller and immobilizer-ECU | Probable cause |
|---|---|
| The confirmation code is not sent from the fuel cut valve controller within the specified time after the ignition key is turned to ON or, an incorrect code is sent. | <ul style="list-style-type: none"> <li>• Malfunction of harness or connector</li> <li>• Malfunction of fuel cut valve controller</li> <li>• Malfunction of immobilizer-ECU</li> </ul> |

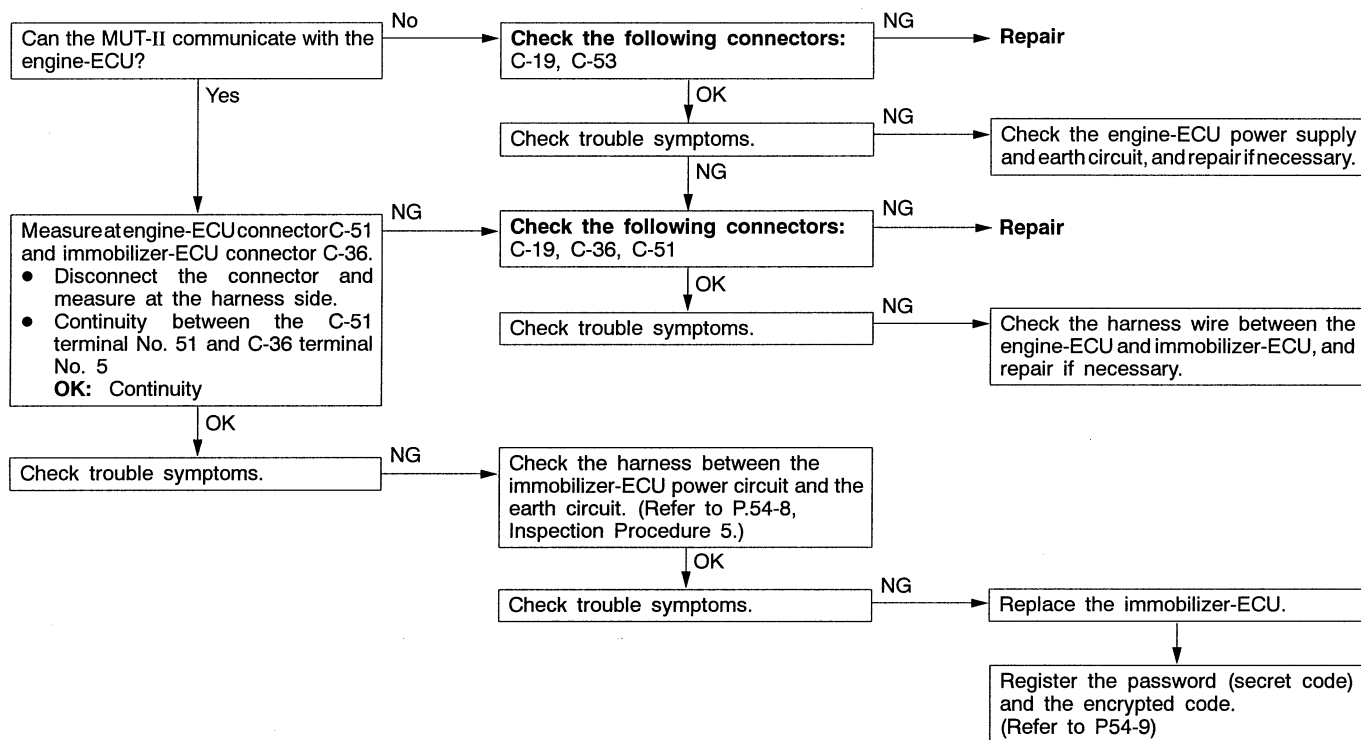
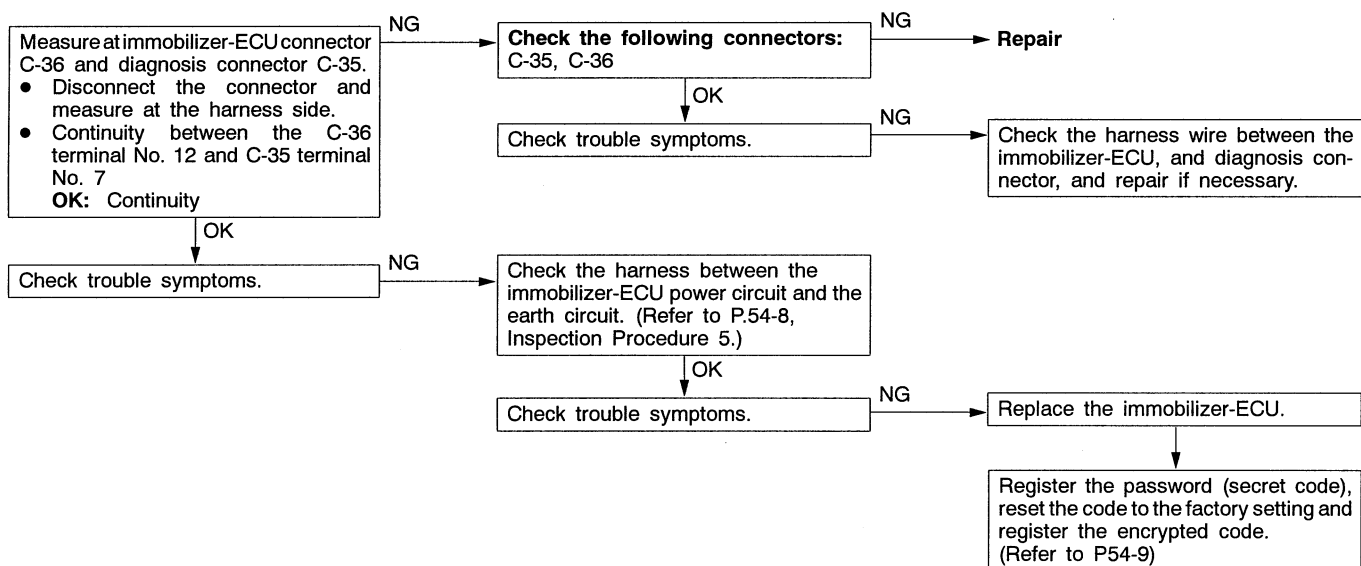
## Inspection Procedure 1

| Communication with MUT-II is impossible | Probable cause |
| The cause is probably that a malfunction of the diagnosis line or the immobilizer-ECU is not functioning. | <ul style="list-style-type: none"> <li>• Malfunction of diagnosis line</li> <li>• Malfunction of harness or connector</li> <li>• Malfunction of immobilizer-ECU</li> </ul> |

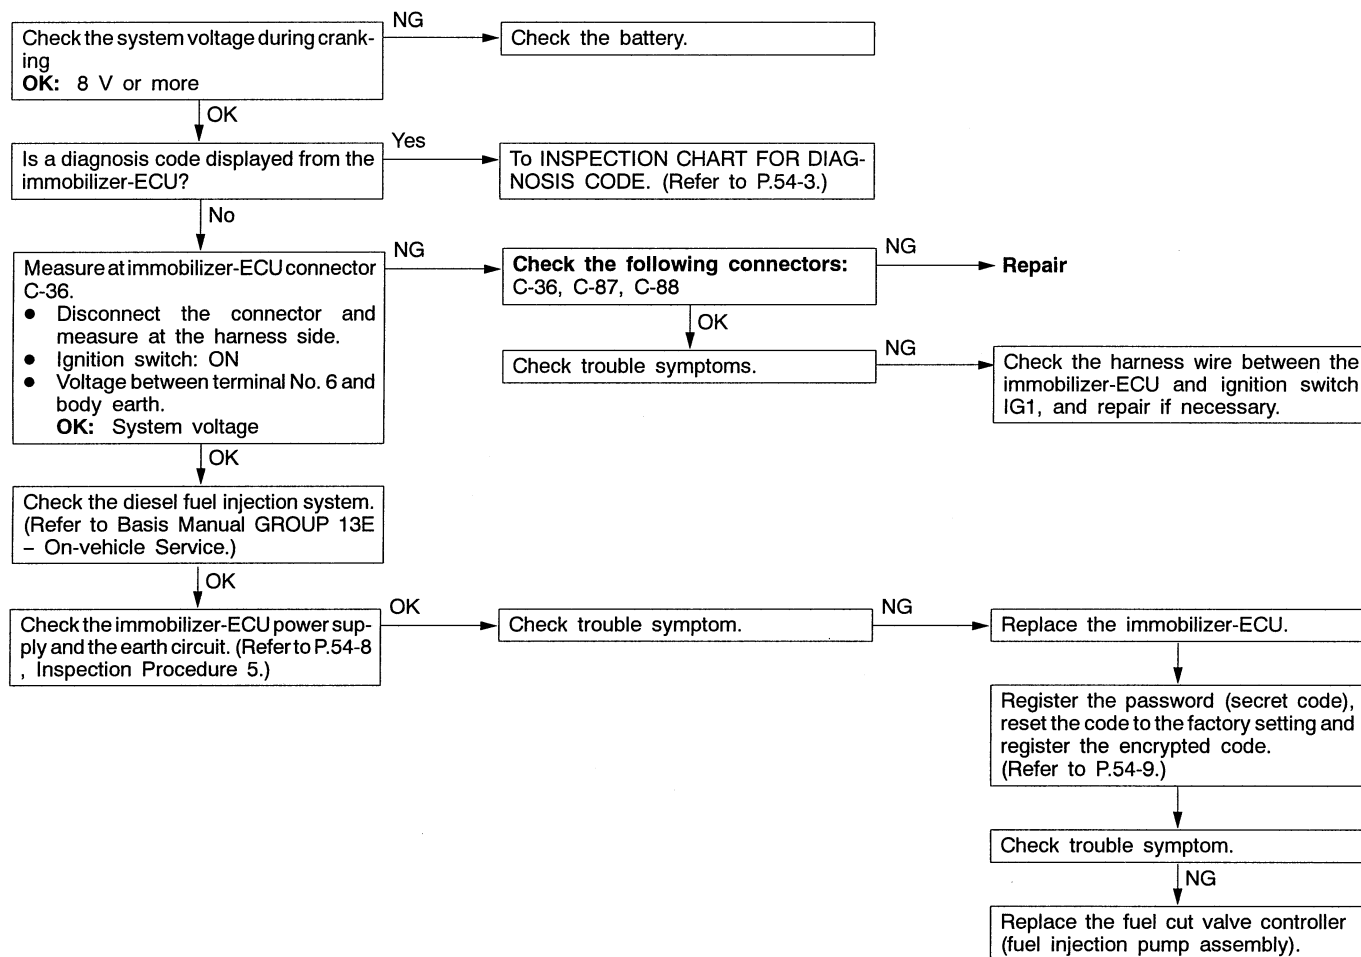
## Inspection Procedure 4

| Engine does not start (Cranking but no initial combustion). <4D5> | Probable cause |
| If no fuel injection, there might be a problem with the fuel injection system in addition to a malfunction of the immobilizer system.<br>It is normal for this to occur if an attempt is made to start the engine using a key that has not been properly registered. | <ul style="list-style-type: none"> <li>• Malfunction of diesel fuel injection system</li> <li>• Malfunction of immobilizer-ECU</li> </ul> |

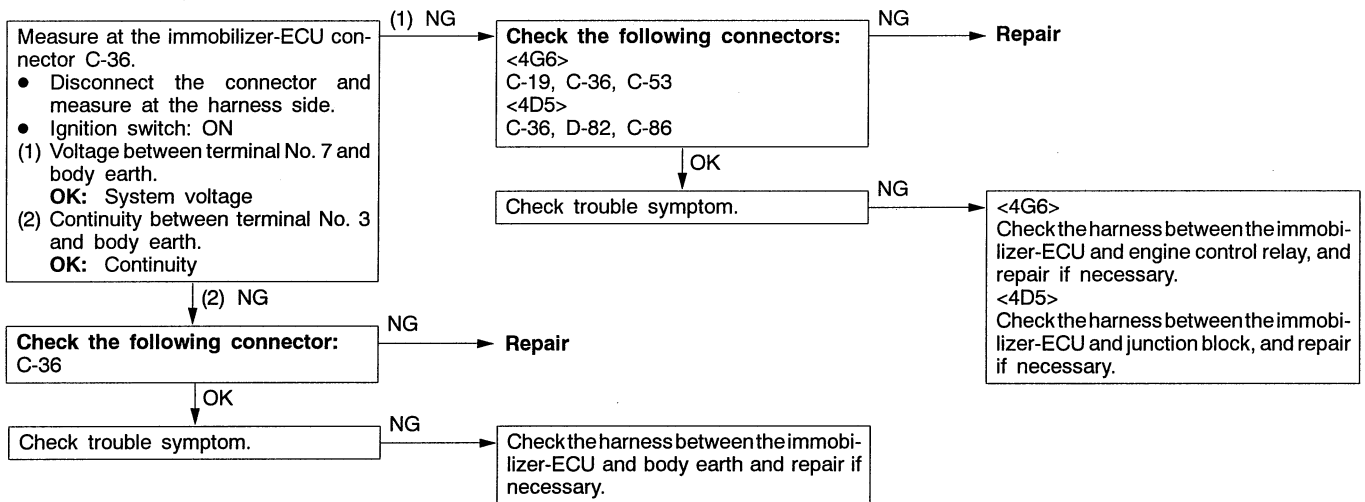
## Inspection Procedure 5

## Malfunction of the immobilizer-ECU power source and earth circuit

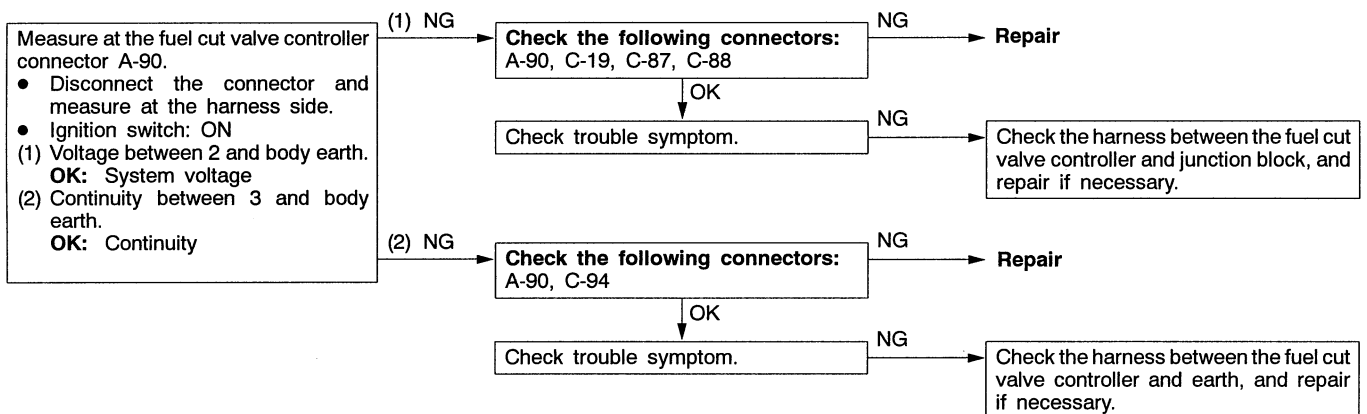
## Inspection Procedure 6

Malfunction of the fuel cut valve controller power source and earth circuit  
<4D5>
