## GROUP 13A

# MULTIPOINT FUEL INJECTION (MPI)

#### OUTLINE OF CHANGES

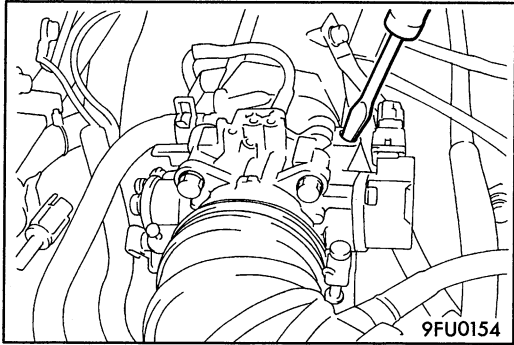
5. Check the idle speed.

**Standard value: 850 ± 50 r/min**

- (1) The engine speed may be 20 to 100 r/min lower than indicated above for a new vehicle [driven approximately 500 km or less], but no adjustment is necessary.
- (2) If the engine stalls or the engine speed is low even though the vehicle has been driven approximately 500 km or more, it is probable that deposits are adhered to the throttle valve, so clean it.

6. If not within the standard value range, turn the speed adjusting screw (SAS) to make the necessary adjustment.

If the idling speed is higher than the standard value range even when the SAS is fully closed, check whether or not there is any indication that the fixed SAS has been moved. If there is an indication that it has been moved, adjust the fixed SAS.
