Machine Translated by Google  
Car Sonata V 2007 mileage 62000 km. Of these, 54,000 on gas. G4GC engine From  
the literature, clearances when checking **intake valves are 0.12-0.28**

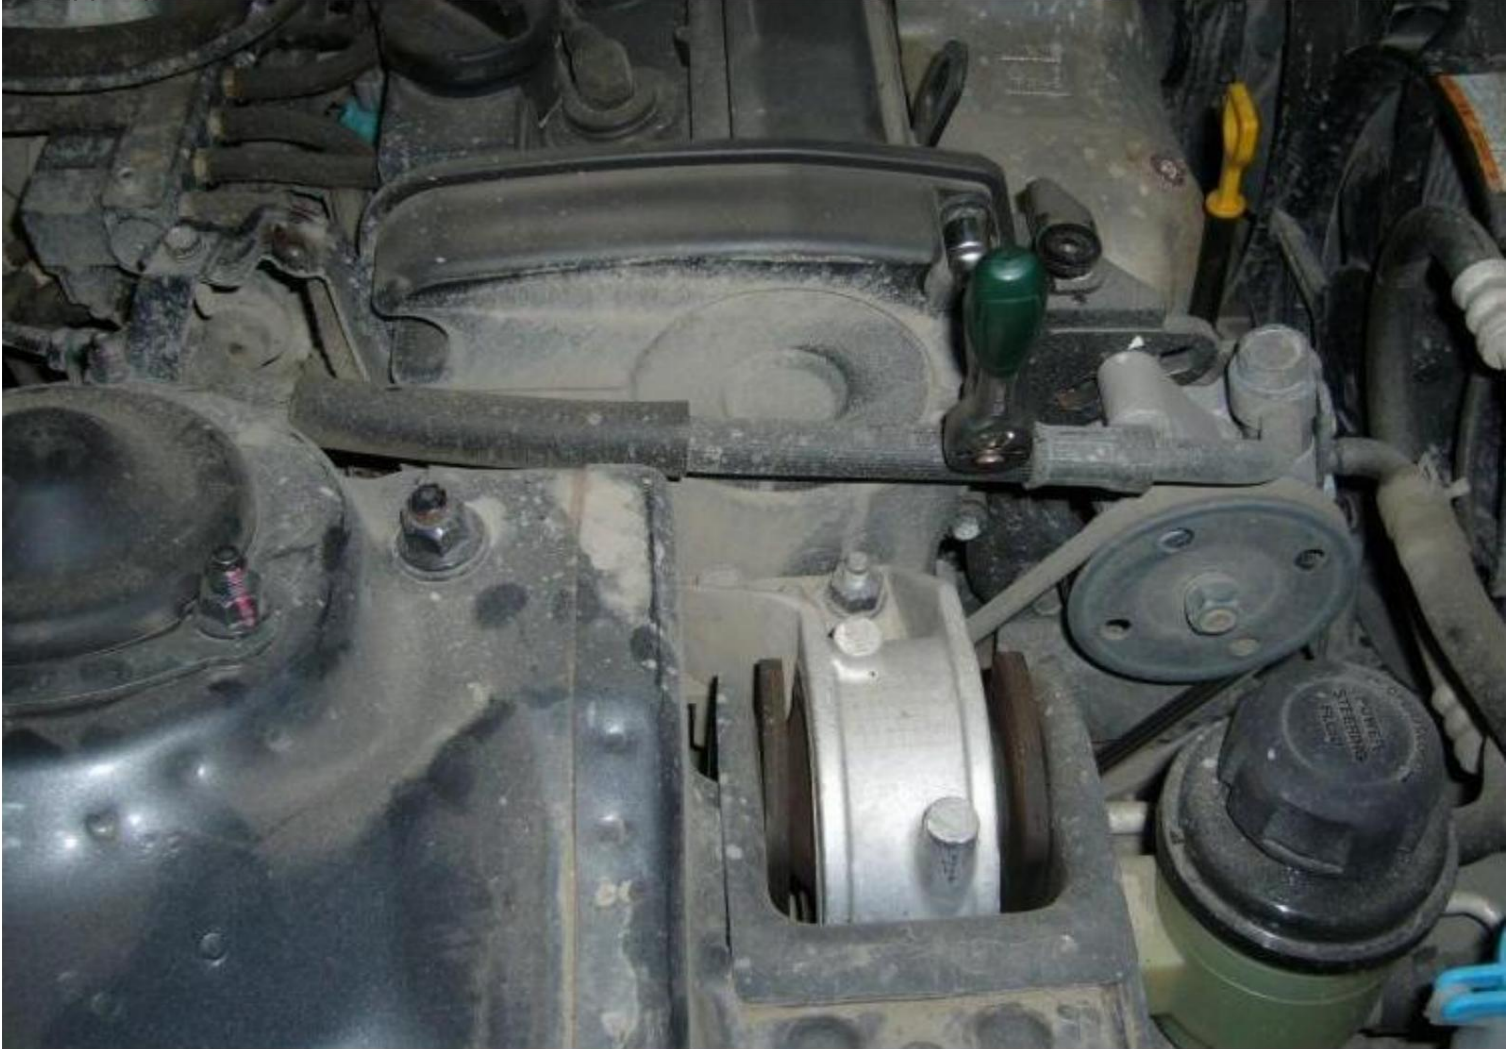
If the engine is cold for about an hour. 1. Remove  
the protective cover of the engine head for 10 -4 bolts 2. Remove  
the upper protection of the timing belt head for 10 -4 bolts

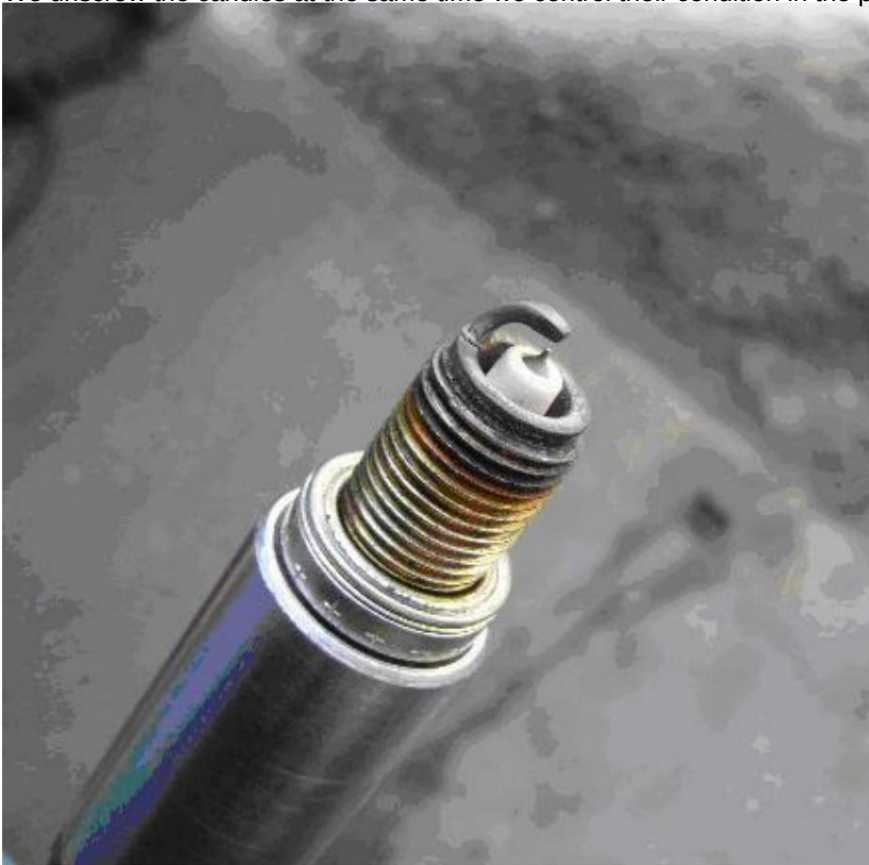
We unscrew the candles at the same time we control their condition in the photo: my candle after 15000

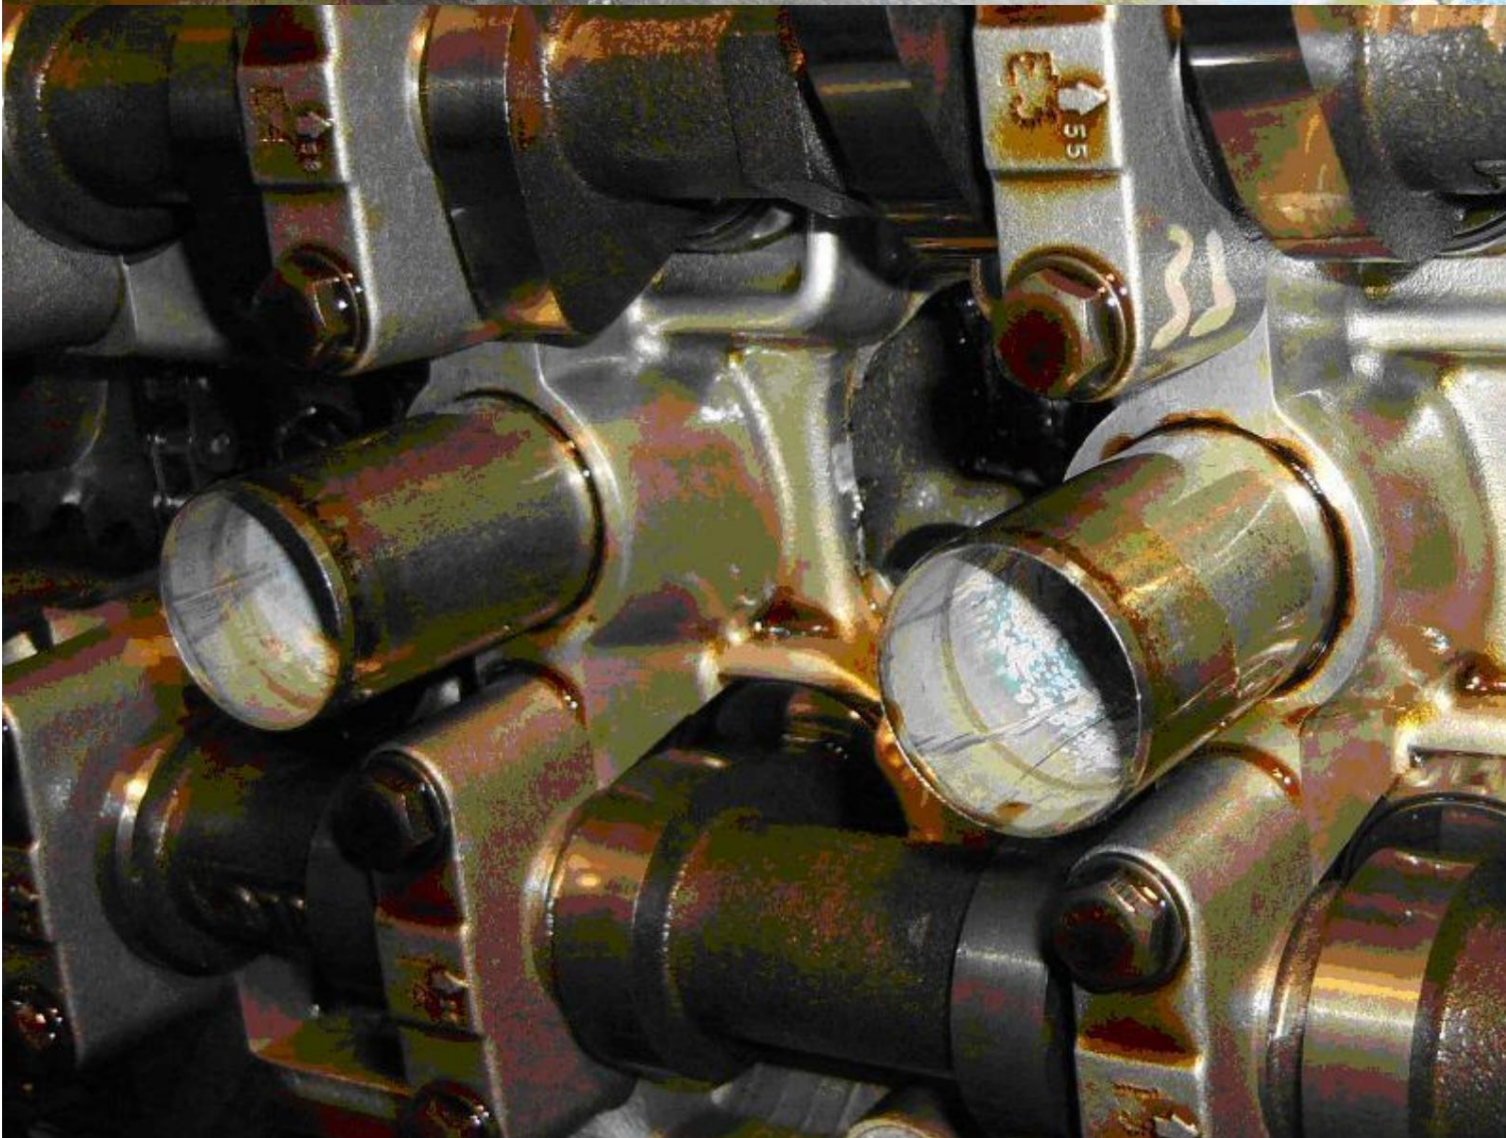
6. Along the perimeter of the camshaft cover, unscrew 13 bolts with the same key and prying with a screwdriver we take it off.

This is the state of the engine after 62,000 varnish and other deposits, there is no clean conclusion, I remain on this oil.

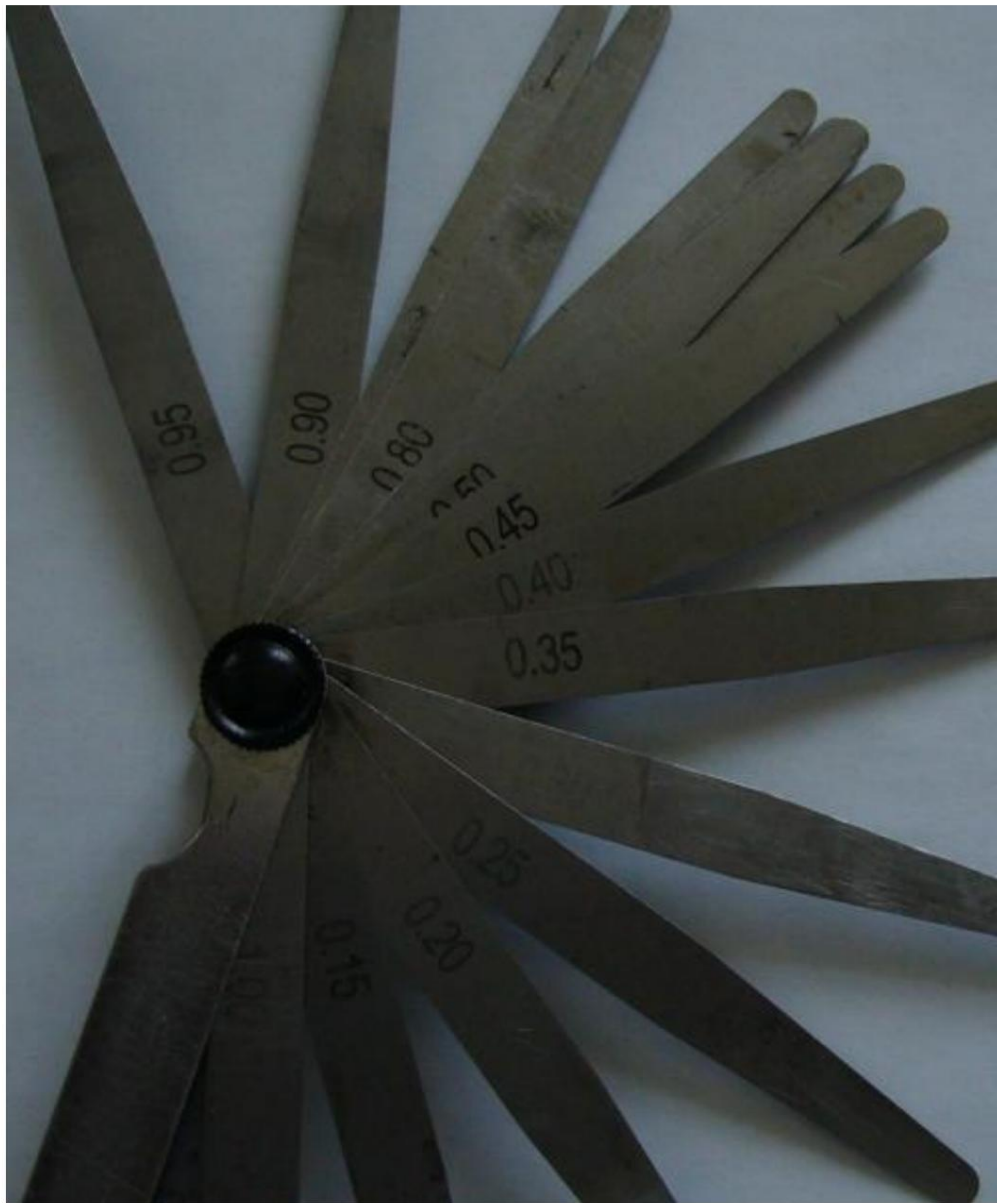
7 Jacked up the right front wheel incl. 5th gear and remembering that, experience and alcoholism will always take up over youth and enthusiasm, without bothering with the marks, stupidly turning the wheel to close the valves on the cylinders that I will measure, while measuring the gaps with probes and recording the dimensions. A set of probes.

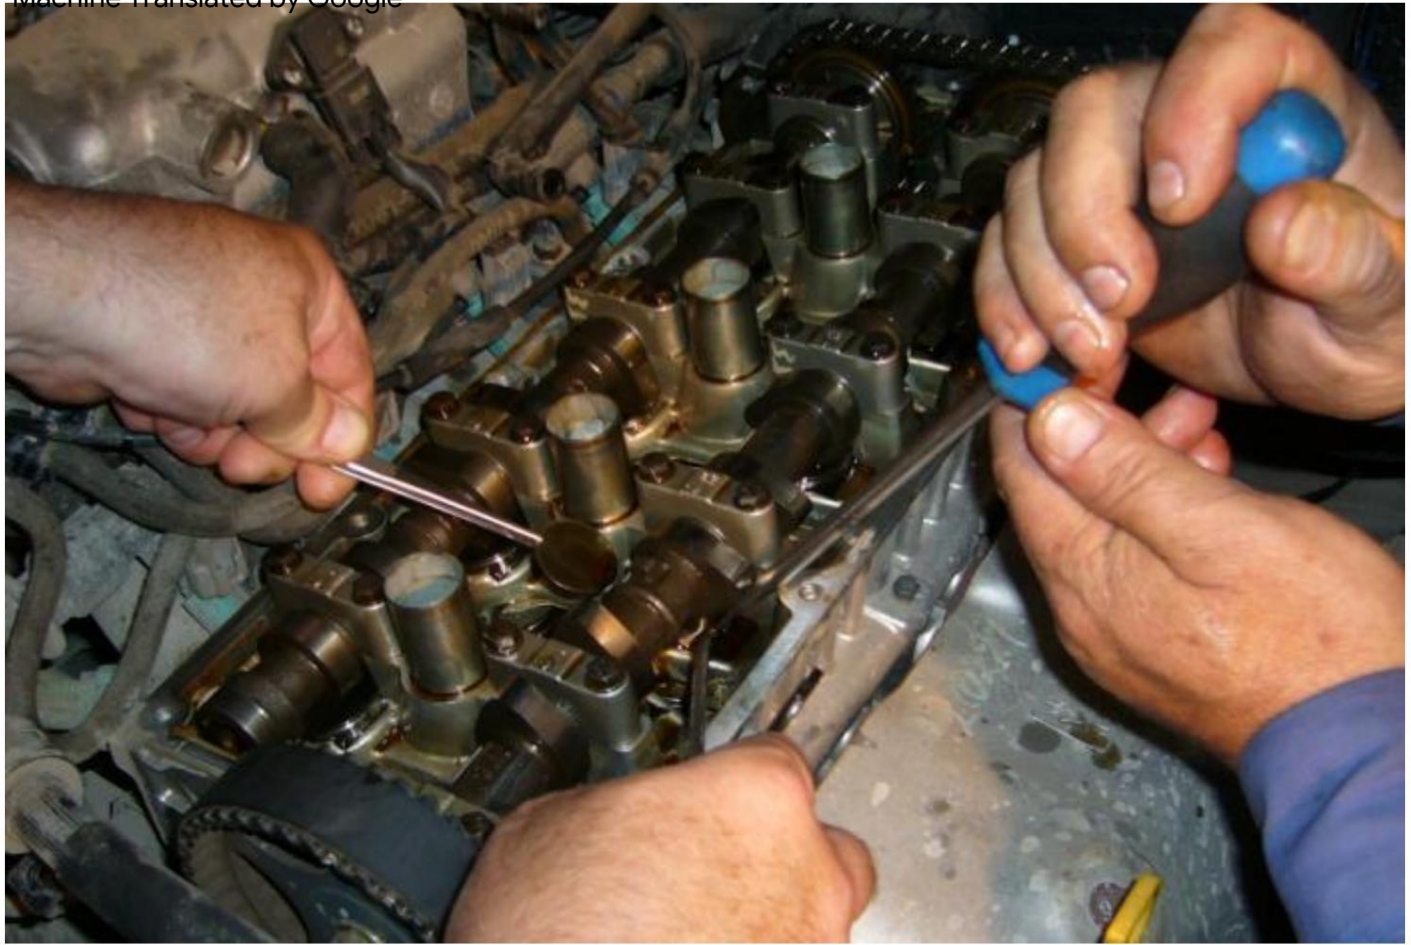
Having measured the inlet valves, the probe 0.2 passed easily, but the probe 0.25 did not climb (i.e., the gap is approximately 0.22-0.23) I was glad that everything was normal, but my first five outlets were at the limit, i.e. probe 0.2 came in with great, great difficulty. 6,7,8 - probe 0.25 easily 0.3 did not climb almost the norm. Where to stick the probe will not describe. Despite the lack of fixtures and the lack of time for its manufacture, it was decided to remove the shims in the old-fashioned way and grind them. Using a large screwdriver, resting against the camshaft, we press the so-called thrust washer, we put a stopper between the thrust washer and the cam piece of metal (I put the parallelepiped 9-9-30 at hand) so that the stopper does not touch the adjusting washer Remove the screwdriver and an awl through the groove in the thrust we pry the washer with the adjusting washer, it stuck with oil, so everything is easy to write, but it's gimmicky. We suffered with the first puck for half an hour, there was even an idea to tie up the timing belt and throw off the camshaft - a moot point which is faster.

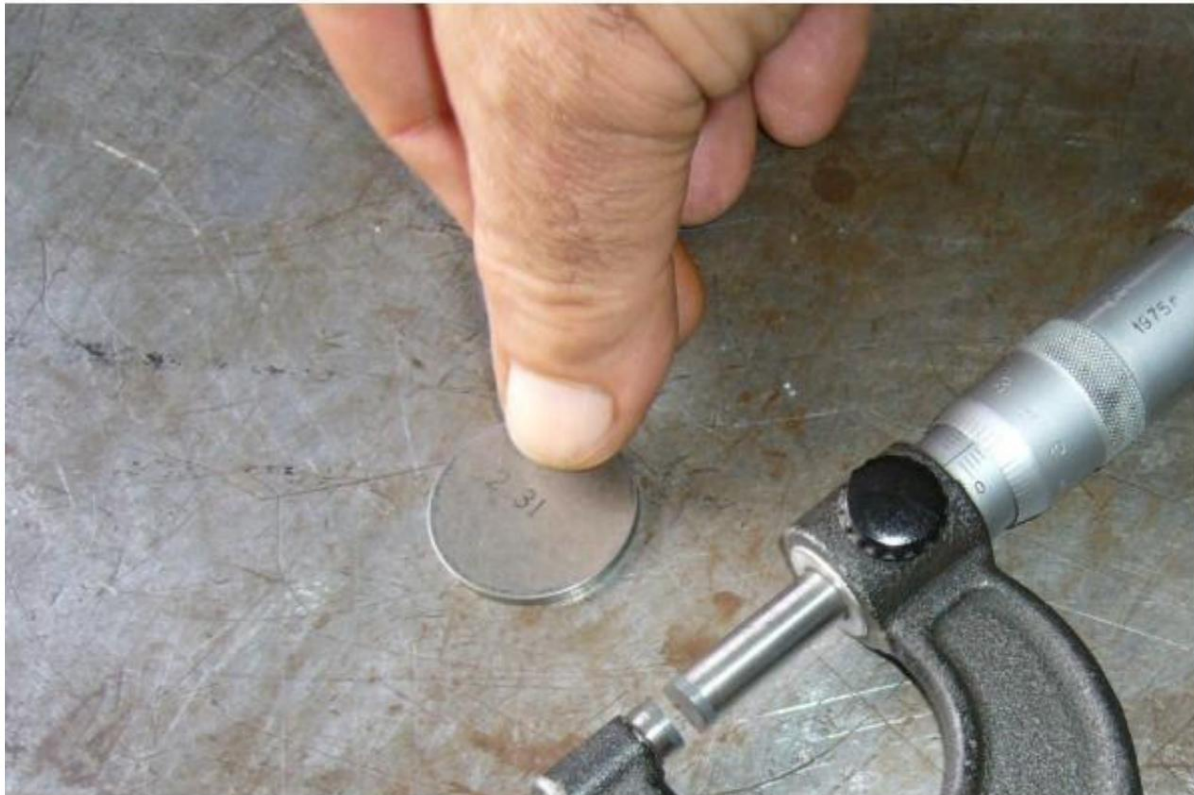
There is a size on the washers on the reverse side, by the way, having checked it with a micrometer, all the markings are very accurate

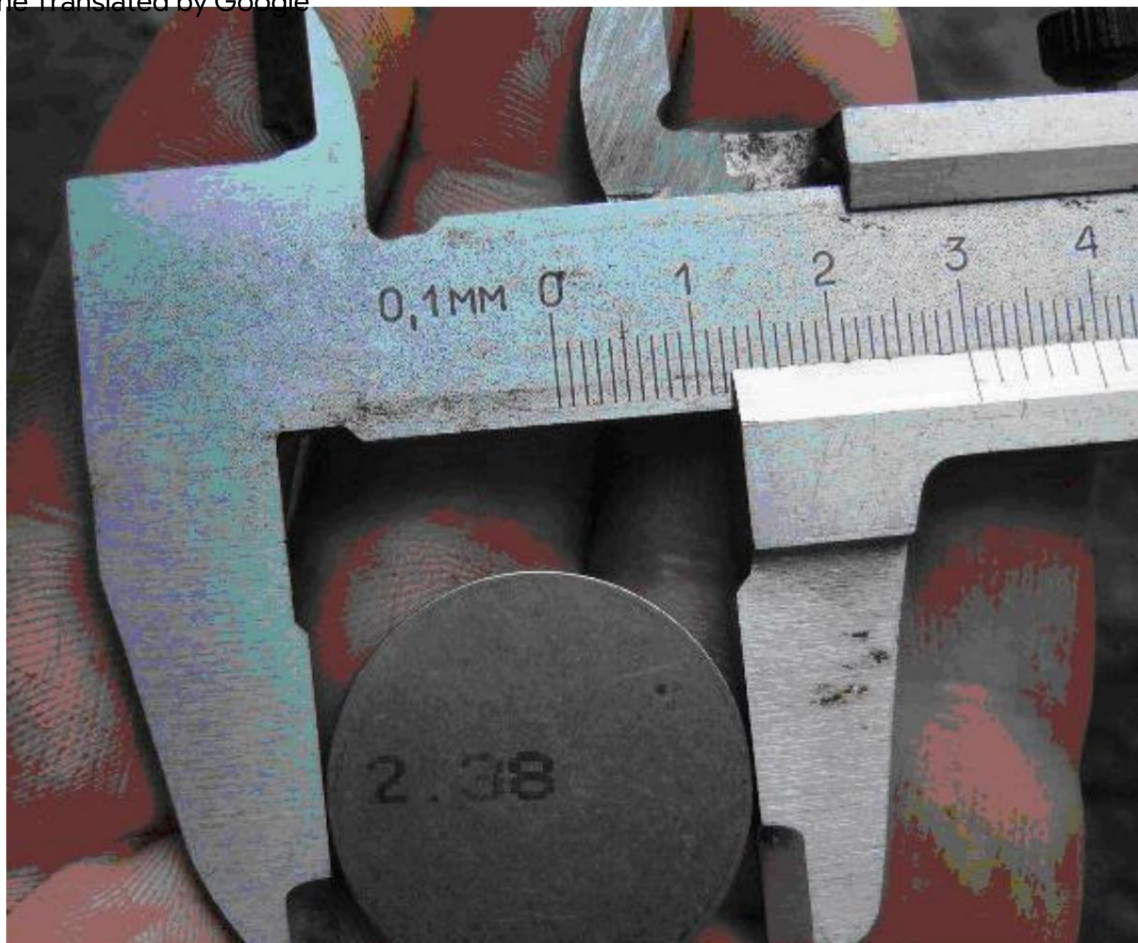
For those who want to find similar washers, their diameter is 30mm

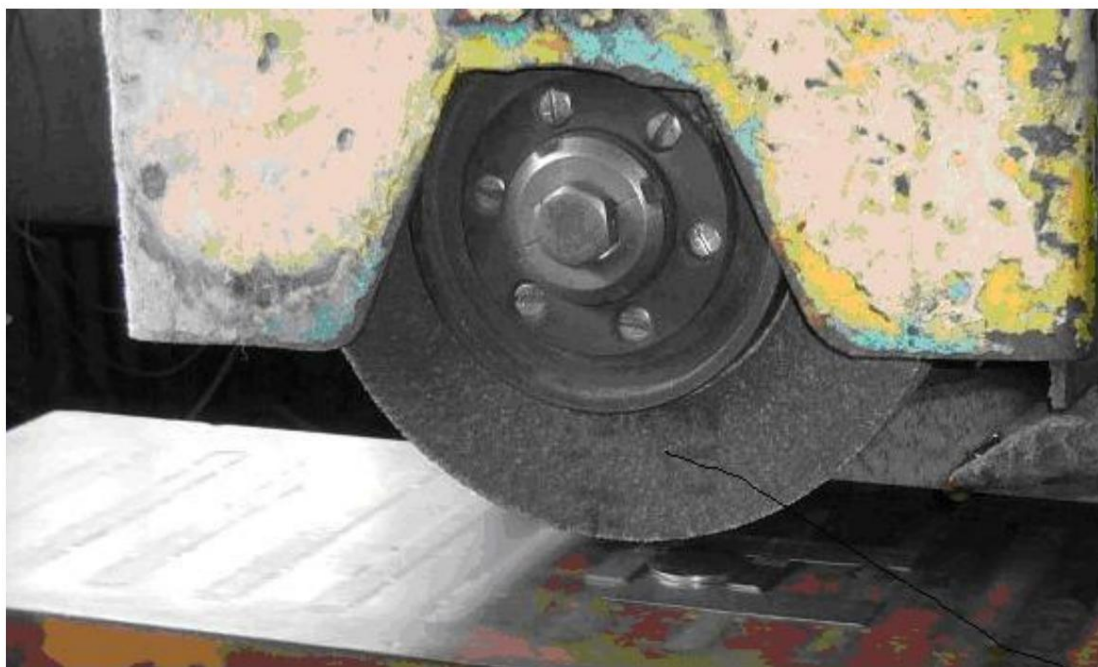
Then everything is simple if the gap determined by the probe is 0.2 mm and the adjusting washer as in the photo is 2.38, then it is necessary to remove 0.1 from the washer, that is, the washer should become 2.28, while the thermal valve clearance will be 0.3 or order a washer with a thickness 2.28. I've been grinding

Installing the washers is not much easier than removing everything, too, one pressed down the thrust washer with a screwdriver, the other put the adjusting washer in place while not using the stopper. Then, after turning the wheel a couple of turns, we double-check the gaps, write down and assemble in the reverse order. I didn't want to do an extremely increased gap yet, I want to go through 10 thousand with a variator and then double-check the gaps and draw a conclusion. Maybe I did something wrong, described it as I did it, I think our GURUS will correct it. But for myself, thanks to the forum, I concluded. Checking the gaps procedure is not long, not difficult and does not require special qualifications, and to devote an hour of time for your favorite work will not be especially recommended to HBO owners, and I think it will not be superfluous for the rest.
