## Audi A4 1995 ➤

| Automatic Gearbox 01V Self-diagnosis | | | | | | | | | |

**Automatic Gearbox 01V Self-diagnosis**

01 - Self-diagnosis, Electrical check

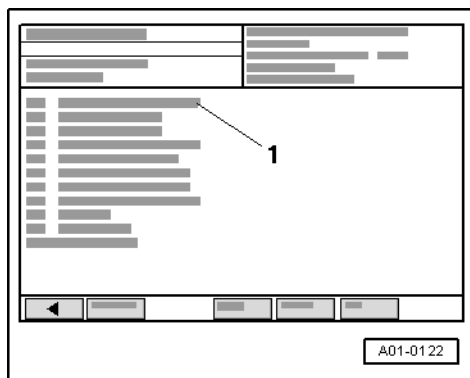
- -> Selection can now be made from the following list of diagnosis functions -1-:

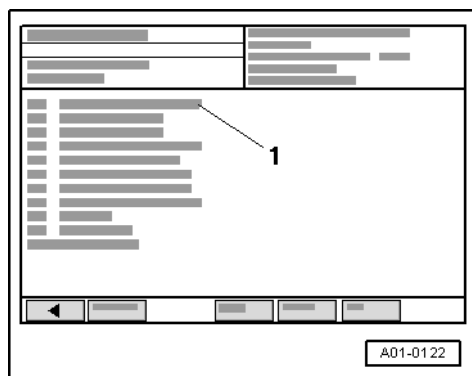
- Connect up vehicle diagnostic, testing and information system VAS 5051 => Page 22 and select vehicle system "02 - Gearbox electronics". Ignition must be on.

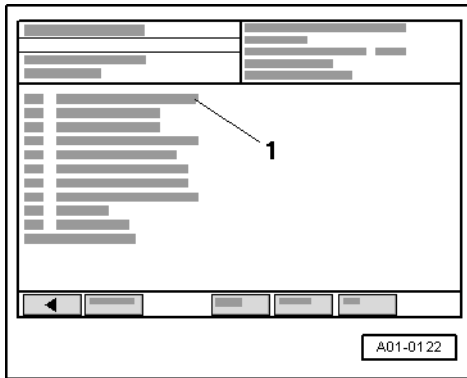
-> Display on VAS 5051:

- Following display and print-out of last fault, eliminate faults as per fault table => Page **27** onwards.
- Select diagnosis function "02 - Interrogating fault memory" again in list -1- and erase fault memory => Page **78**.
- From list -1- select diagnosis function "06 - End of output" => Page **80**.

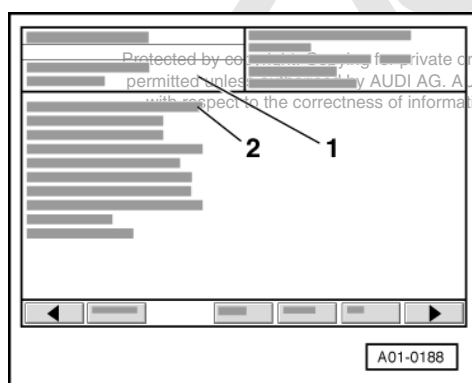
-> Display on VAS 5051:

- 1 - Display: 8th control element being tested
- 2 - Lower display zone: Pressure control valve 4 -N218

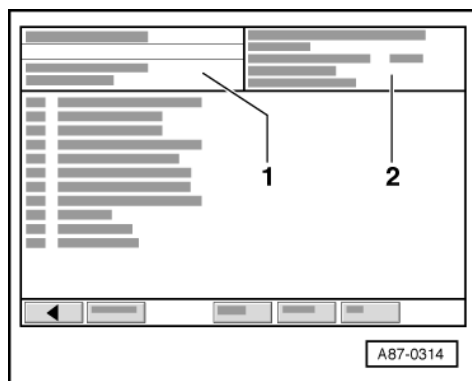
- Connect up vehicle diagnostic, testing and information system VAS 5051 => Page **22** and select vehicle system "02 - Gearbox electronics". Ignition must be on.

Encoding can only be performed with ignition on and selector lever set to "P" or "N". Accelerator pedal must remain in idle position. Vehicle must be stationary and engine must not be started.

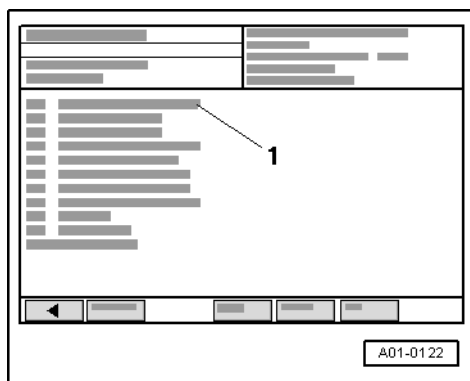
-> Display on VAS 5051:

- From list -1- select diagnosis function "07 - Encoding control unit".

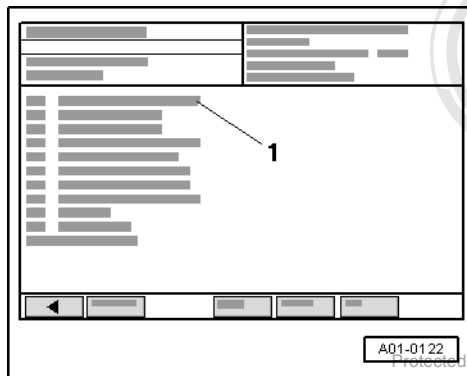
- Connect up vehicle diagnostic, testing and information system VAS 5051 => Page **22** and select vehicle system "02 - Gearbox electronics". Ignition must be on.
