## GROUP 54A

# CHASSIS ELECTRICAL

- Due to the introduction of 5-door models, the rear speaker service procedure has been changed.

- Due to the introduction of 5-door models, the troubleshooting for the rear power windows have been added.

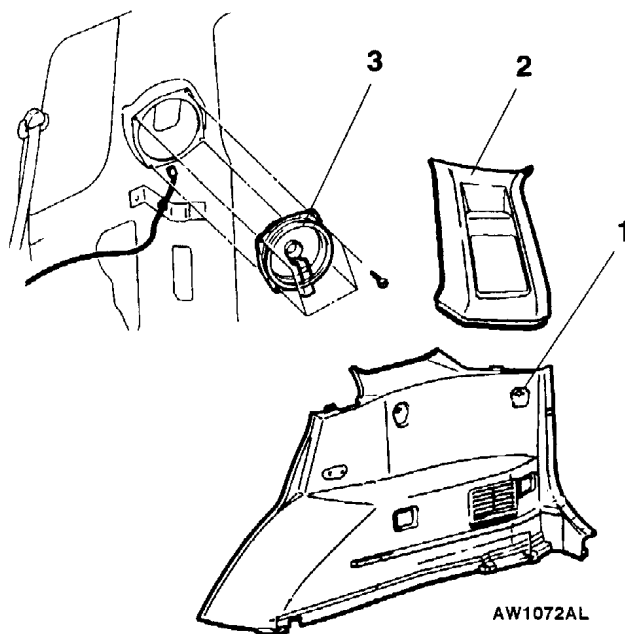
5-door models

#### Rear speaker removal steps

1. Quarter trim, lower (Refer to GROUP 52A.)
2. Rear pillar trim (Refer to GROUP 52A.)
3. Speaker

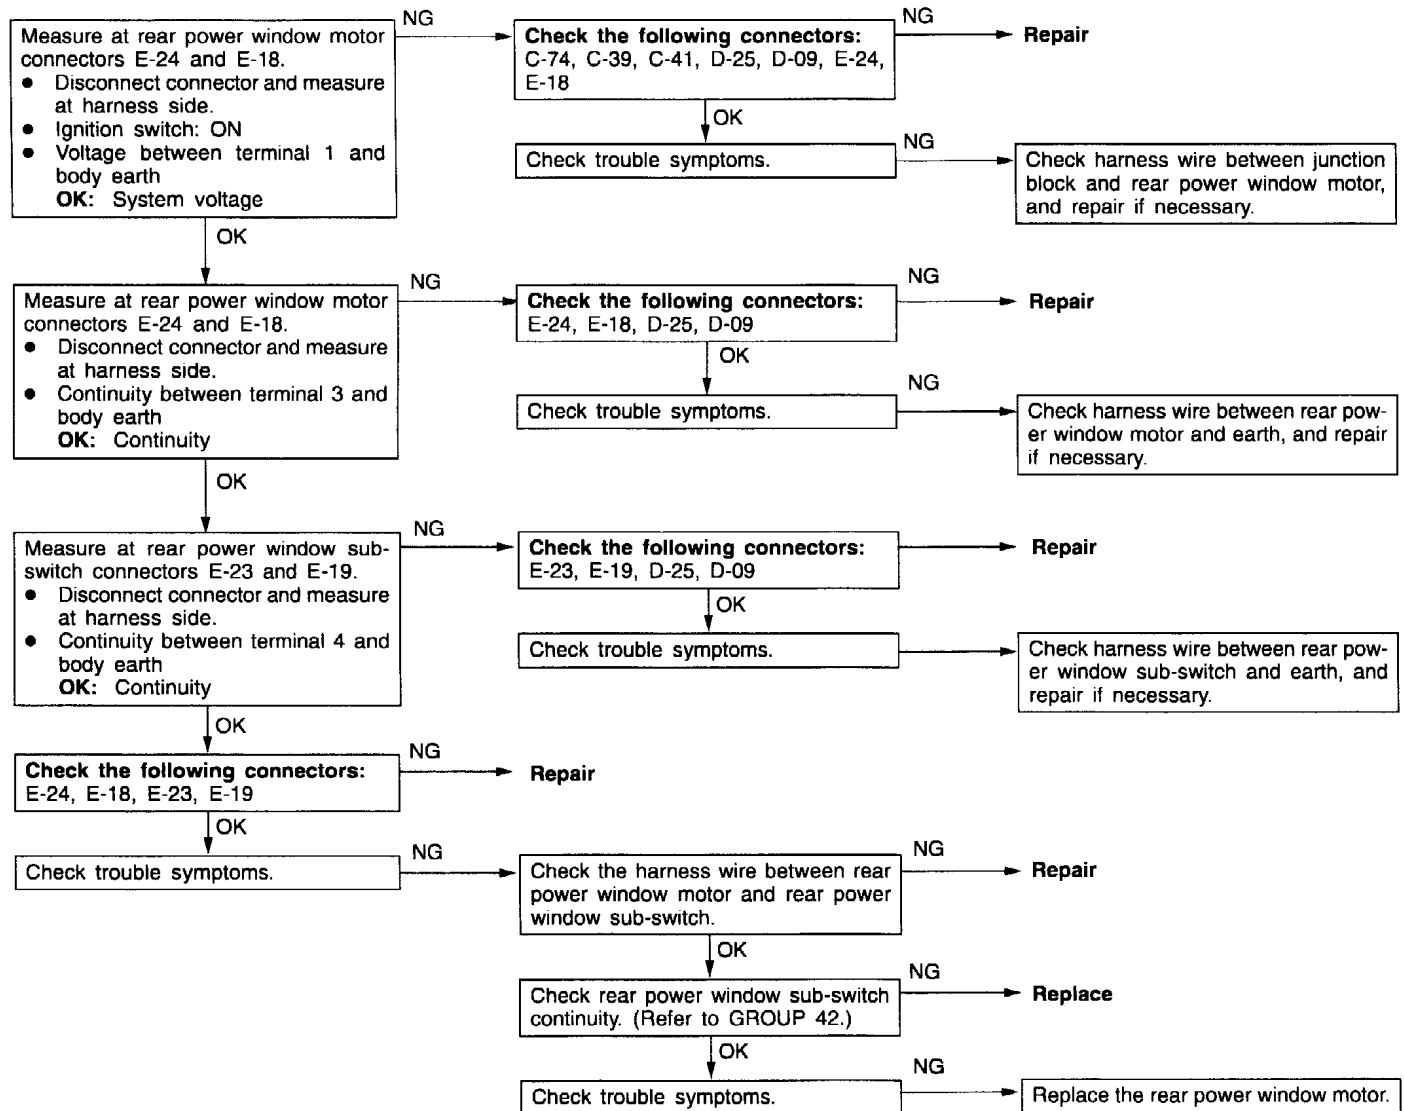
## Inspection Procedure D-9

| Power windows: Rear power window sub-switches can not operate rear door windows. (However, power window main switch can operate rear door windows.) | Probable cause |
| Power supply circuit or earth circuit of the rear power window motor, rear power window motor or rear power window sub-switches may be defective. | <ul style="list-style-type: none"> <li>• Malfunction of rear power window sub-switches</li> <li>• Malfunction of rear power window motors</li> <li>• Malfunction of wiring harness or connector</li> </ul> |
