# SERVICE BULLETIN

| <b>SERVICE BULLETIN</b> | | No.: ESB-98E34-001 | |
| <b>Subject:</b> CHANGE IN REAR SUSPENSION LOWER ARM MOUNTING NUT | | <b>&lt;M/Y&gt;</b><br>96-10 | |
| <b>Group:</b> REAR SUSPENSION | | | |

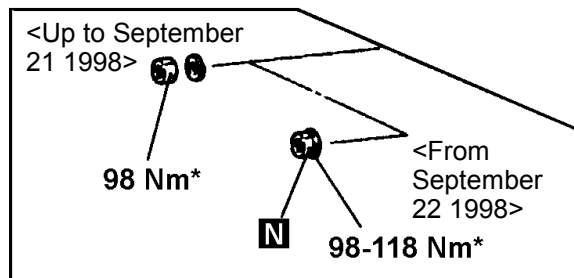
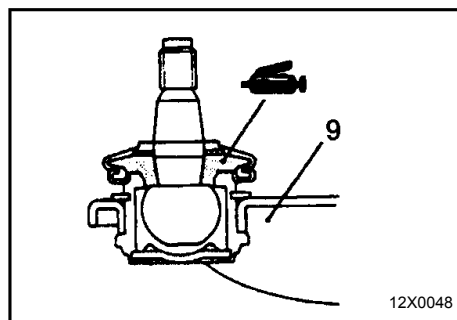
<New>

| <b>1. Description:</b><br>With change of the nut for mounting the rear suspension lower arm to a self-locking nut, a mark indicating that the nut is not reusable has, been added and the tightening torque changed. | | | |
