## Service Action

**Code: 48I5**

**Subject: 2006-2010 Passat/Passat Wagon and 2009-2010 CC/Passat CC**  
**Electronic Steering Column Lock**

### Corrective Action

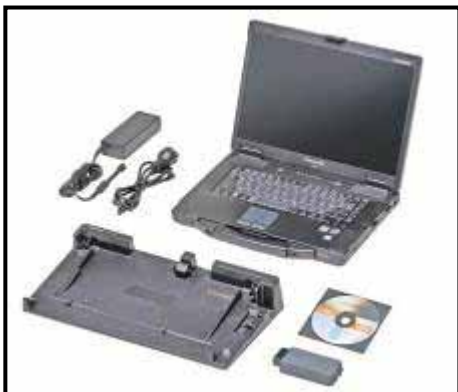
⇐ VAS 6150 Laptop Diagnostic Unit, VAS 5051B

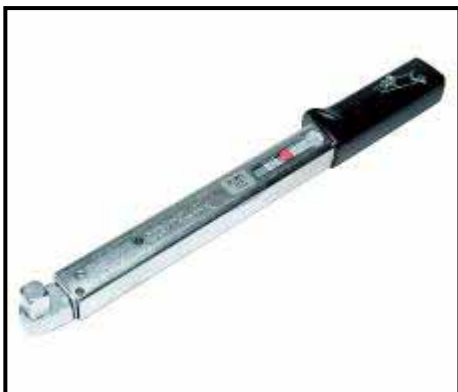
⇐ VAG 1331 – Torque Wrench 5 – 50 Nm (or equivalent)

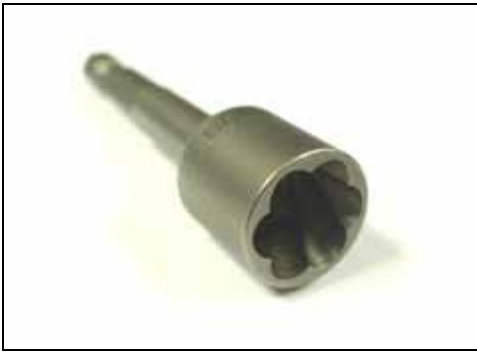
⇐ T10424US Special Socket (or equivalent)

**Note:** DO NOT USE other extractor tools with different designs as they may create excessive chips and damage the steering column.

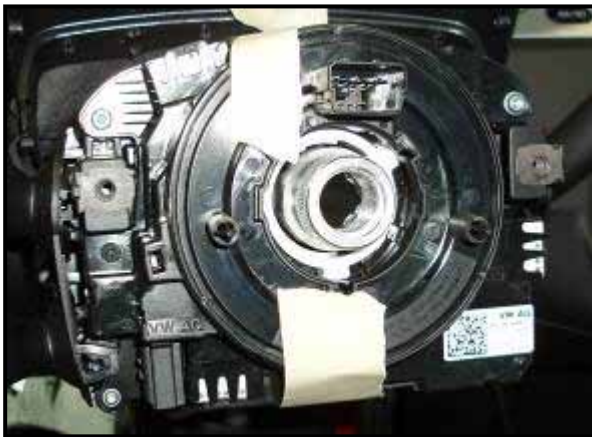
- ⇐ Apply tape to spiral spring <as shown in picture> to lock spring into position and prevent damage

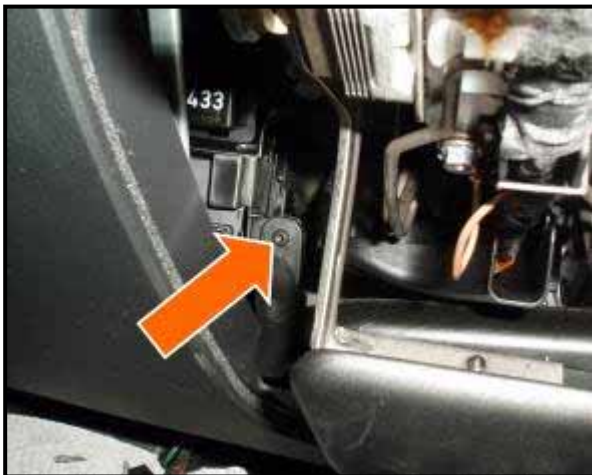
⇐ Remove T-20 screw <arrow> and remove footwell vent

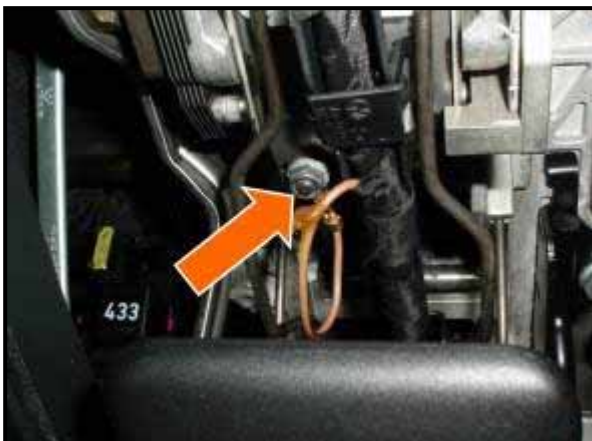
⇐ Remove steering column harness ground nut <arrow>

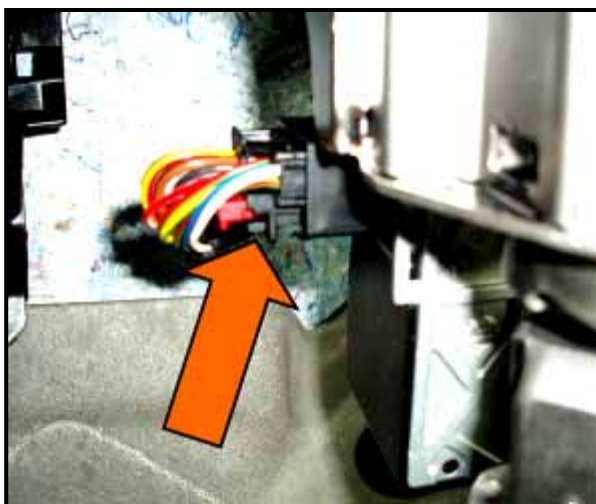
- ⇐ Disconnect lower steering column harness connector <arrow> by first disengaging its red connector lock

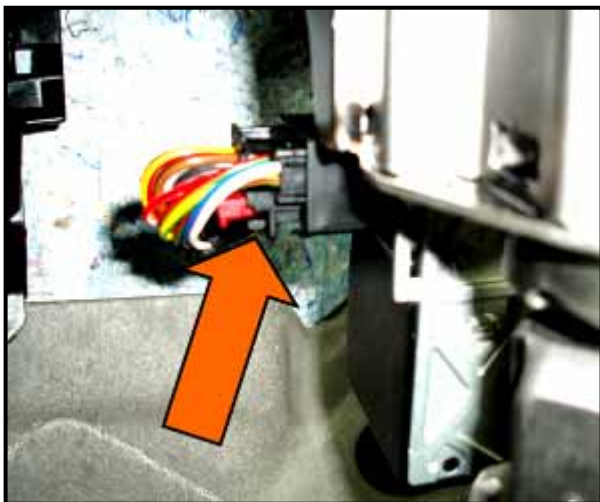
- ⇐ Reconnect lower steering column harness connector <arrow> and reengage its red connector lock until you hear an audible “click”

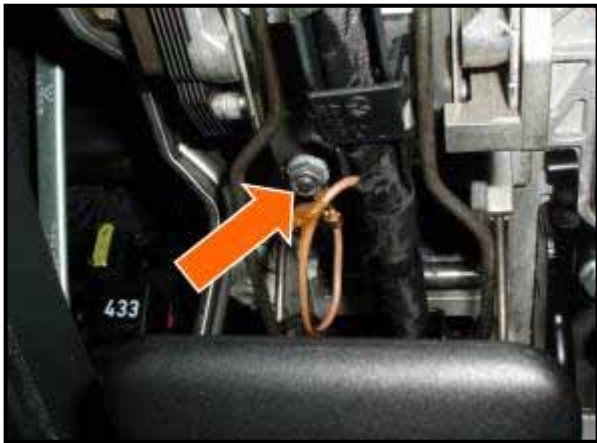
- ⇐ Reinstall steering column harness ground nut <arrow> and torque to 10Nm

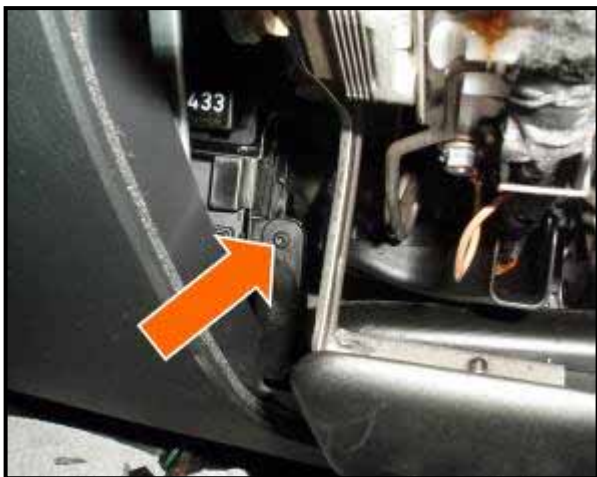
- ⇐ Reinstall footwell vent properly into position and reinstall T-20 screw <arrow> to secure vent
