## GROUP 54

# CHASSIS ELECTRICAL

### IGNITION SWITCH AND IMMOBILIZER SYSTEM

#### Immobilizer System

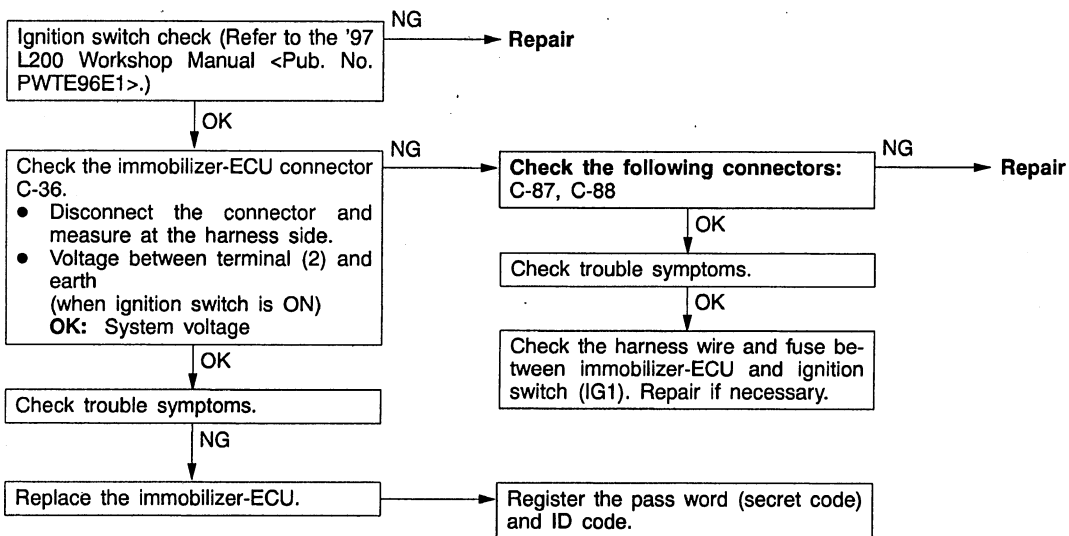
| Code No.32 IG signal circuit system | Probable cause |
| The ignition switch signal is not being input to the immobilizer-ECU. | <ul style="list-style-type: none"> <li>• Malfunction of wiring harness or connector</li> <li>• Malfunction of the Ignition switch</li> <li>• Malfunction of the immobilizer-ECU</li> </ul> |

| Diagnosis code No. | Inspection items | Reference page |
|---|---|---|
| 32 | IG signal circuit system | 54-2 |

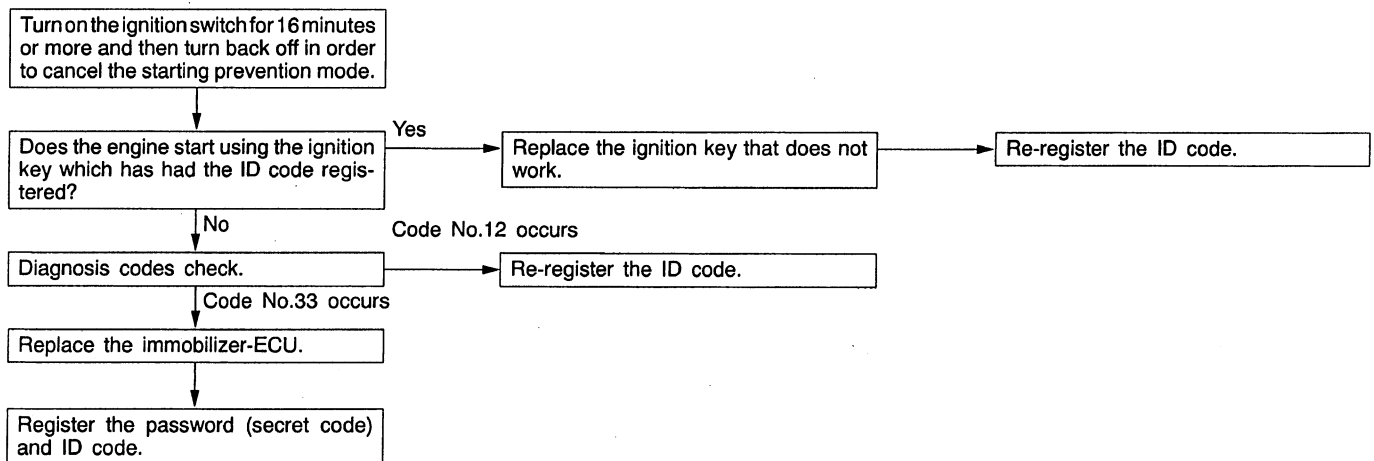
| Code No.33 Starting prevention mode activated due to incorrect operation | Probable cause |
| The ID codes do not match for a total of 5 continuous operations. | <ul style="list-style-type: none"> <li>• The ID code in the ignition key being used has not been properly registered.</li> <li>• Malfunction of the immobilizer-ECU</li> <li>• Malfunction of the transponder</li> </ul> |

| Diagnosis code No. | Inspection items | Reference page |
|---|---|---|
| 33* | Starting prevention mode activated due to incorrect operation | 54-2 |

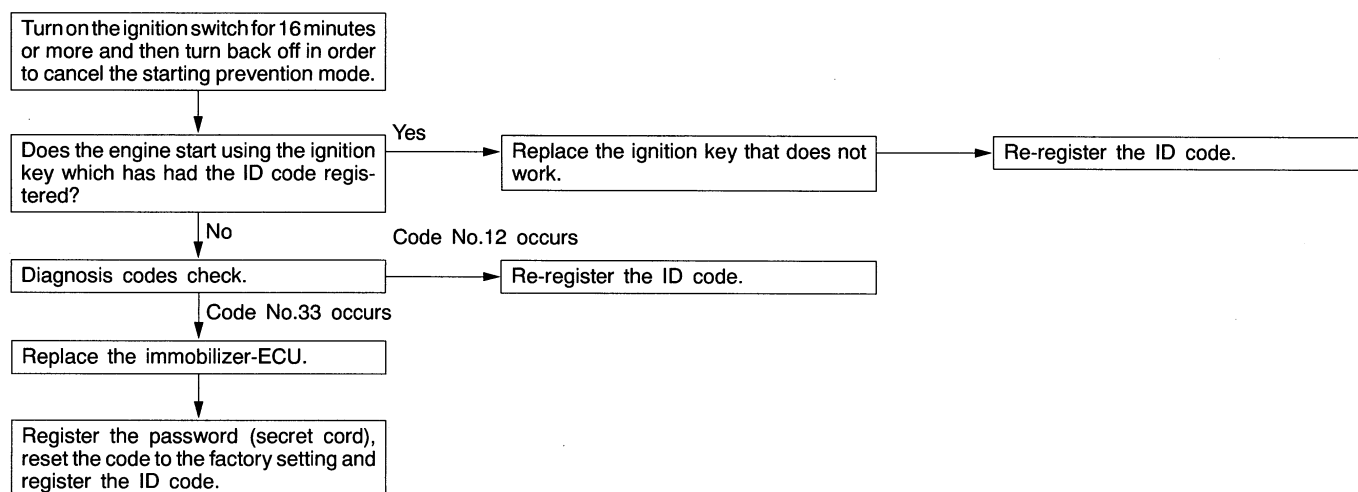
| Code No.33 Starting prevention mode activated due to incorrect operation | Probable cause |
| The ID codes do not match for a total of 5 continuous operations. | <ul style="list-style-type: none"><li>• The ID code in the ignition key being used has not been properly registered.</li><li>• Malfunction of the immobilizer-ECU</li><li>• Malfunction of the transponder</li></ul> |

| Diagnosis code No. | Inspection items | Reference page |
|---|---|---|
| 33* | Starting prevention mode activated due to incorrect operation | 54-3 |

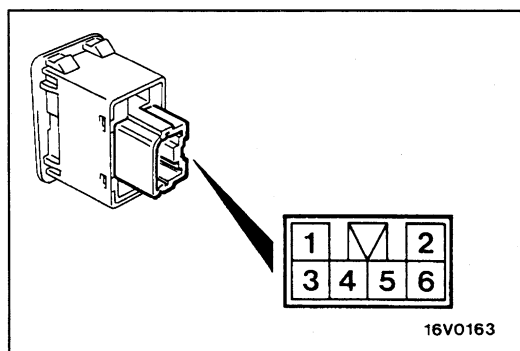
#### REAR FOG LAMP SWITCH CONTINUITY CHECK
