# MULTIPOINT FUEL INJECTION (MPI)

#### OUTLINE OF CHANGE

The service procedures have been revised due to the following change.

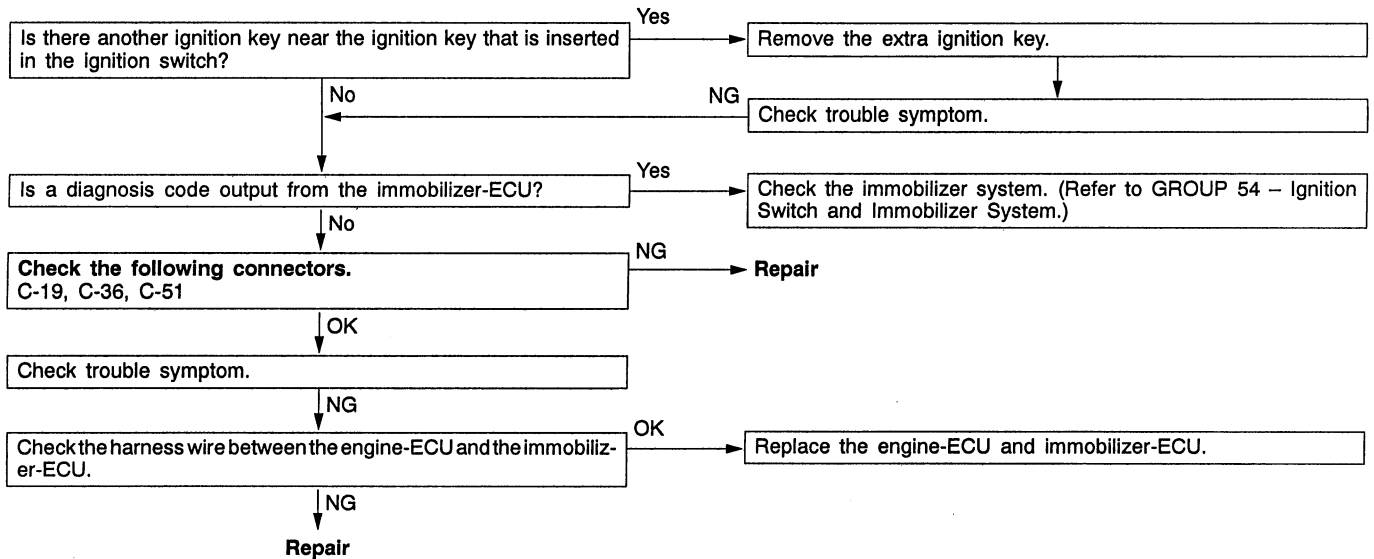
| Code No.54 Immobilizer system | Probable cause |
| Range of Check<br>• Ignition switch: ON<br>Set Conditions<br>• Improper communication between the engine-ECU and immobilizer-ECU | • Radio interference of ID codes<br>• Incorrect ID code<br>• Malfunction of harness or connector<br>• Malfunction of immobilizer-ECU<br>• Malfunction of engine-ECU |

## NOTE

- (1) If the ignition switches are close each other when starting the engine, radio interference may cause this code to be displayed.
- (2) This code may be displayed when registering the key ID code.

For vehicles with immobilizer system, the inspection procedure “Code No.54 – Immobilizer system” has been changed.

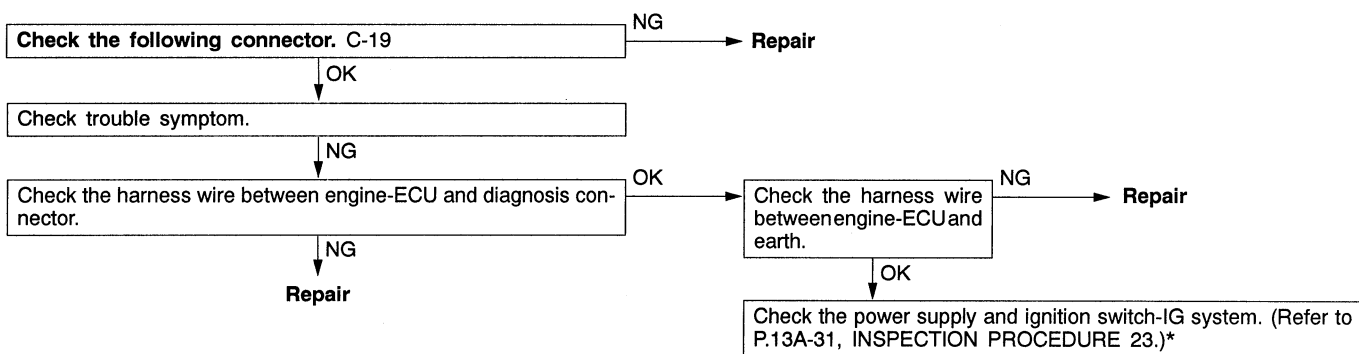
### INSPECTION PROCEDURE 2

| MUT-II communication with engine-ECU is impossible. | Probable cause |
| One of the following causes may be suspected. <ul style="list-style-type: none"> <li>• No power supply to engine-ECU.</li> <li>• Defective earth circuit of engine-ECU.</li> <li>• Defective engine-ECU.</li> <li>• Improper communication line between engine-ECU and MUT-II</li> </ul> | <ul style="list-style-type: none"> <li>• Malfunction of engine-ECU power supply circuit</li> <li>• Malfunction of engine-ECU</li> <li>• Open circuit between engine-ECU and diagnosis connector</li> </ul> |

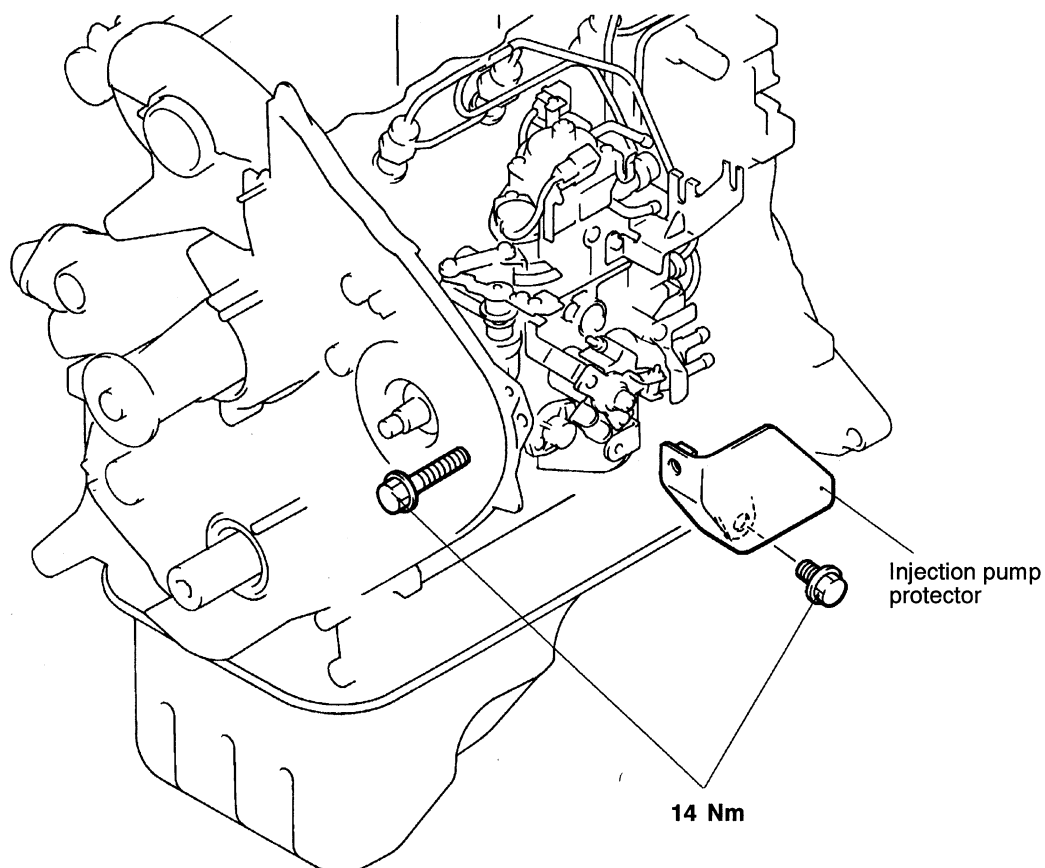
AW0467AA

A protector has been added to protect the injection pump.

#### INJECTION PUMP

#### REMOVAL AND INSTALLATION
