GROUP 54Ah

# COLUMN SWITCH

**GENERAL INFORMATION**

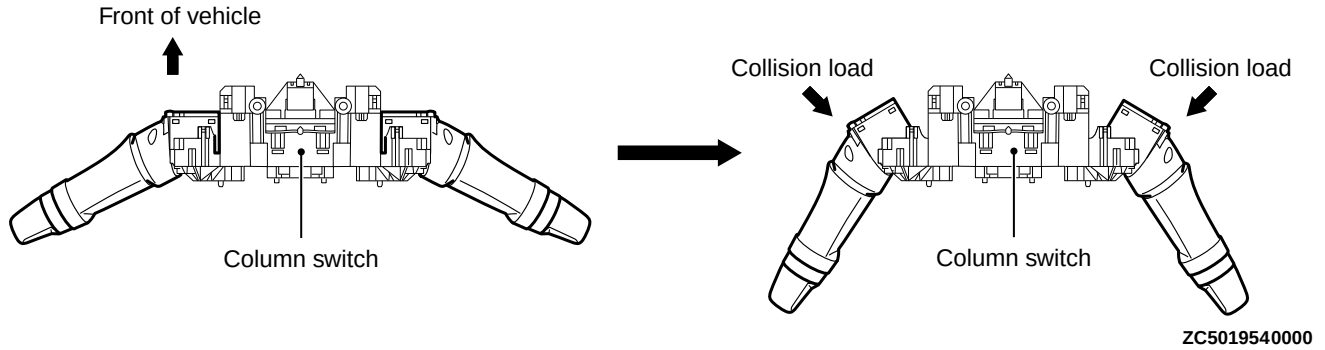
**Function**

If the column switch is moved toward the front of the vehicle and hit on the instrument panel or meter bezel during a frontal collision, the steering wheel is moved to the front of the vehicle because the right and left levers fall down, ensuring the driver's safety. In

addition, the column switch secures the rigidity that the levers do not fall down by the normal operation. The column switch cannot be reused after the deformation.

The column switch has a built in feature to ensure the driver's safety during frontal collision of vehicle.

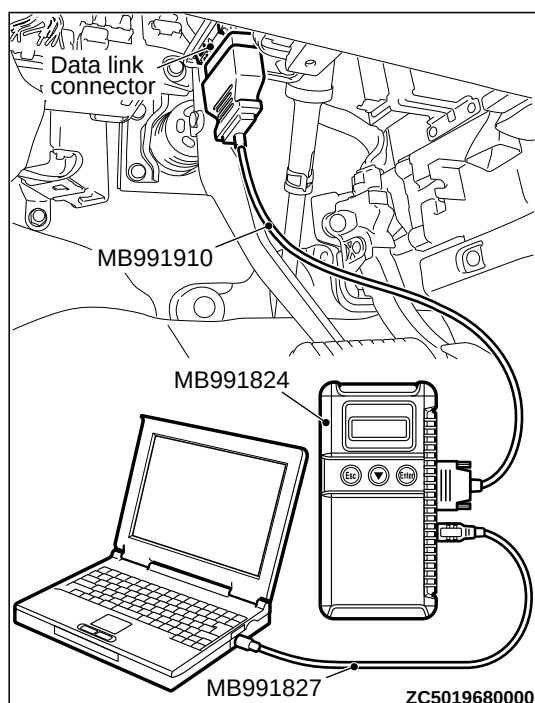
1. Ensure that the ignition switch is at the "LOCK" (OFF) position.
2. Start up the personal computer.
3. Connect special tool MB991827 to special tool MB991824 and the personal computer.
4. Connect special tool MB991910 to special tool MB991824.
5. Connect special tool MB991910 to the data link connector.
6. Turn the power switch of special tool MB991824 to the "ON" position.

*NOTE: When special tool MB991824 is energized, special tool MB991824 indicator light will be illuminated in a green color.*

- MB991958: Scan Tool (M.U.T.-III Sub Assembly)
  - MB991824: Vehicle Communication Interface (V.C.I.)
  - MB991827: M.U.T.-III USB Cable
  - MB991910: M.U.T.-III Main Harness A (Vehicles with CAN communication system)

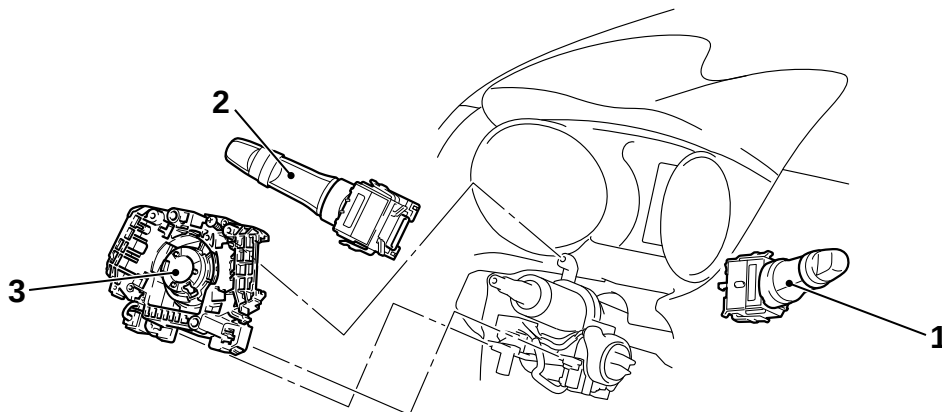
ZC6044620000

### Removal Steps

- To remove the driver airbag module, refer to GROUP 52B - Service Precautions P.52B-28 and Air Bag Module(s) and Clock Spring P.52B-329.
- When the steering wheel sensor is replaced, always carry out calibration to make ASC-ECU

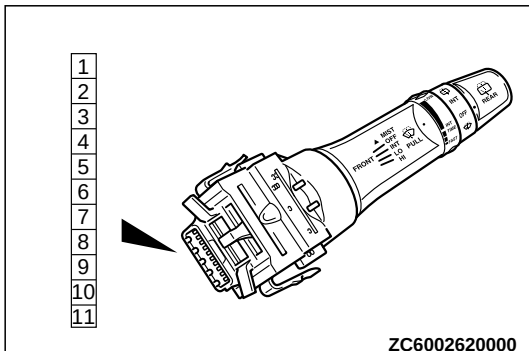
### WIPER/WASHER SWITCH CONTINUITY CHECK

| Switch position | | Tester connection | Specified condition |
| OFF | | - | Open circuit |

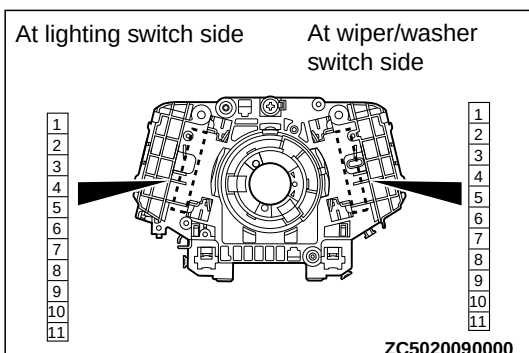
1. Remove the lighting switch and the wiper/washer switch.
2. Check that the continuity is present for the same terminal numbers (No. 2-11) of the column switch body connectors that remain on the steering column.

| Column switch body | Tester connection | Specified condition |
| <ul style="list-style-type: none"> <li>• Lighting switch side connector</li> <li>• Wiper/washer switch side connector</li> </ul> | 2 - 2 | Continuity exists (2 Ω or less) |
