## 2006 TRANSMISSION

## Automatic Transaxle - 4T65-E - Troubleshooting - Impala

## 2006 Chevrolet Impala LS

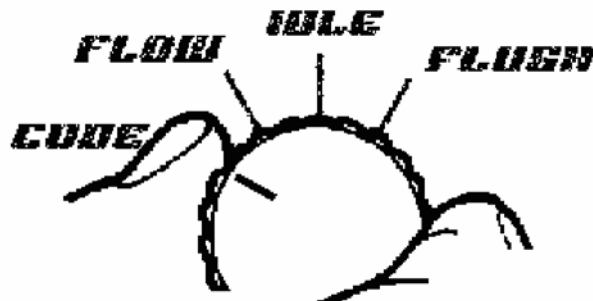
**Fig. 26: Setting Main Function Switch To CODE Position**  
Courtesy of GENERAL MOTORS CORP.

1. Turn the main function switch to the CODE position.
