## 2017 ACCESSORIES AND EQUIPMENT

### Interior Trim and Paneling - Bolt EV

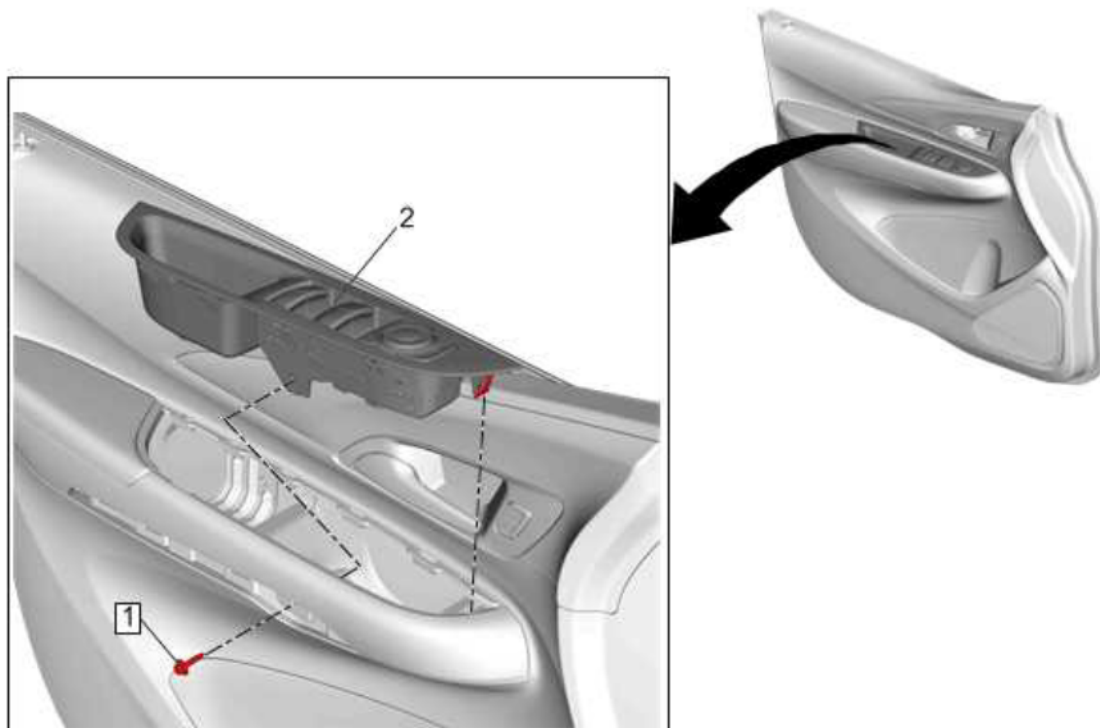
**Fig. 1: Front Side Door Armrest Switch Mount Plate**

| Callout | Component Name |
|---|---|
| 1 | Front Side Door Armrest Switch Mount Plate Fastener<br><br><b>CAUTION:</b><br>Refer to <b><u>Fastener Caution</u></b> .<br><br><b>Tighten</b><br>2.5 N.m (22 lb in) |
| 2 | Front Side Door Armrest Switch Mount Plate<br><br><b>Procedure</b> <ol style="list-style-type: none"> <li>Remove the cloth sound deadening material from the trim.</li> <li>Release the integral retainers from the inside of the door trim. Lift up and outward.</li> <li>Transfer parts as necessary.</li> </ol> |

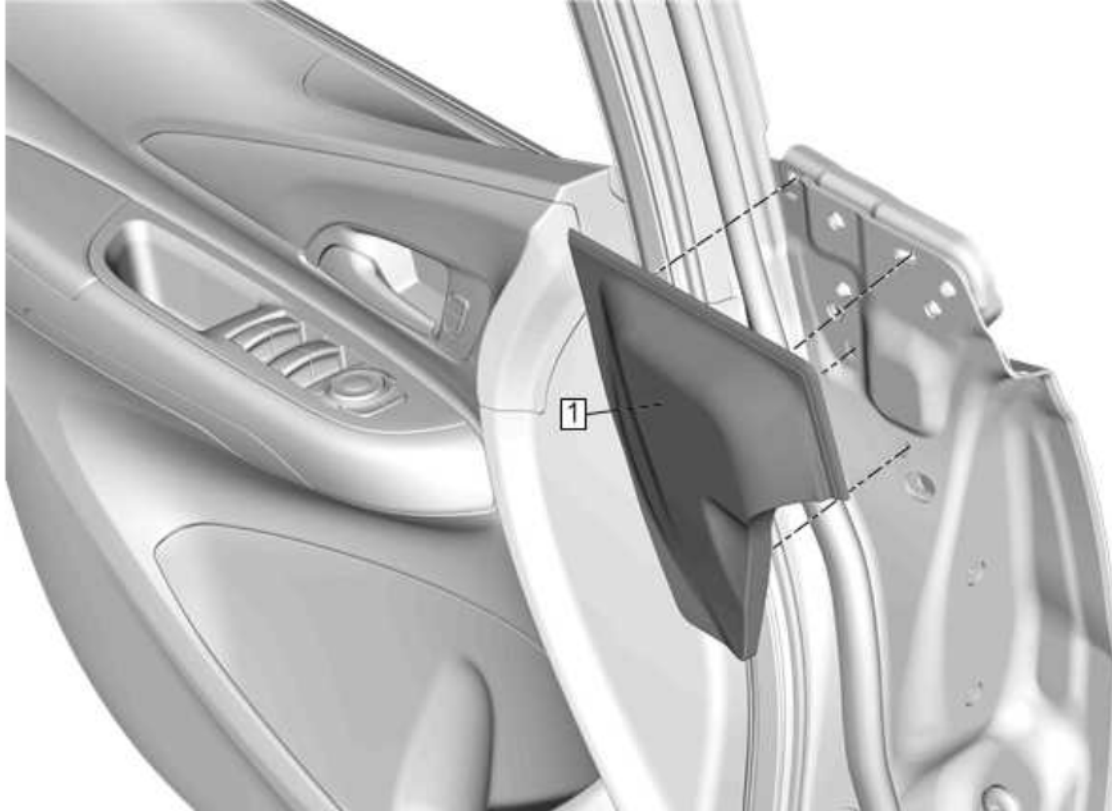
**Fig. 2: Front Side Door Upper Trim Panel**  
 Courtesy of GENERAL MOTORS COMPANY

| Callout | Component Name |
|---|---|
| 1 | Front Side Door Upper Trim Panel<br><b>Procedure</b><br>Pull the door upper trim panel away from the front side door. |

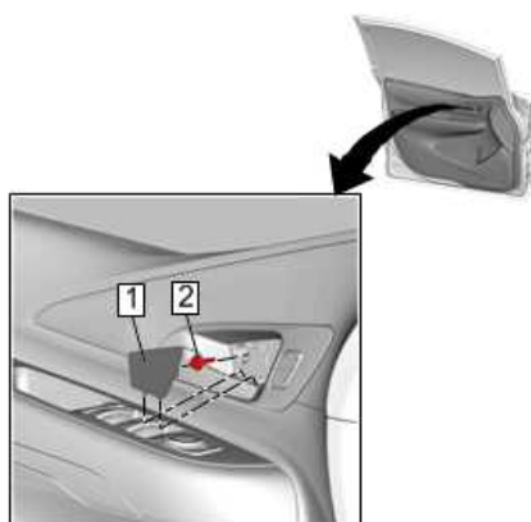
**Fig. 3: Front Side Door Inside Handle Fastener Finish Cap**  
 Courtesy of GENERAL MOTORS COMPANY

1. Remove the front side door inside handle fastener finish cap (1).
2. Remove the front side door inside handle fastener (2).

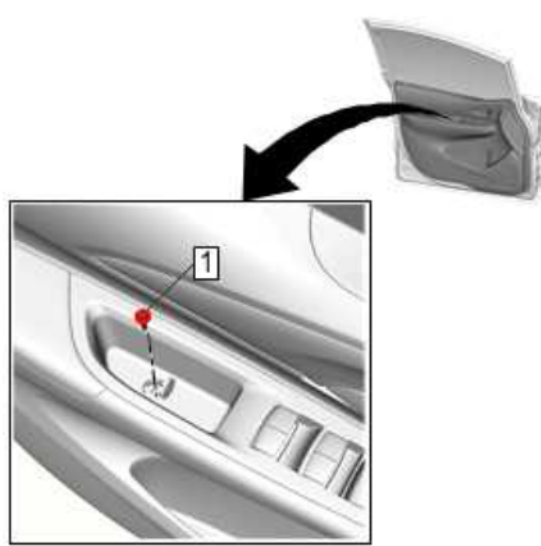
**Fig. 4: Front Side Door Armrest Pull Cup Bolt Cap**  
 Courtesy of GENERAL MOTORS COMPANY

3. Use a flat bladed plastic trim tool to release the front side door armrest pull cup bolt cap.
4. Remove the front side door armrest pull cup fastener (1).

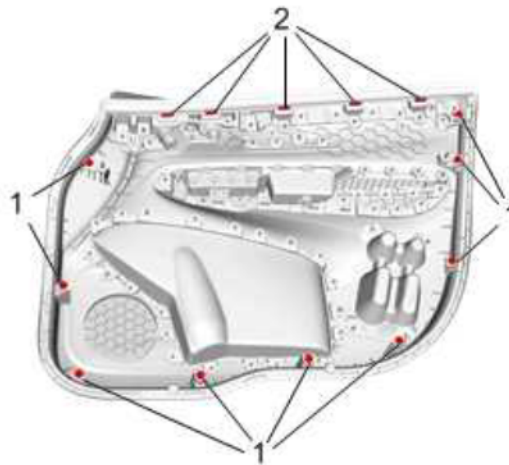
**Fig. 5: Door Trim Panel Retainer**  
 Courtesy of GENERAL MOTORS COMPANY

5. Use a appropriate plastic trim tool loosen the retainer (1) (Qty: 9) along the bottom of the door trim panel.
6. When the panel is sufficiently loosened, grasp with both hands and lift up and release the belt line clip (2) (Qty: 5) with the belt molding.
7. Disconnect the door lock retainer cable from the door trim panel and the inside handle.
8. Disconnect the electrical connector.

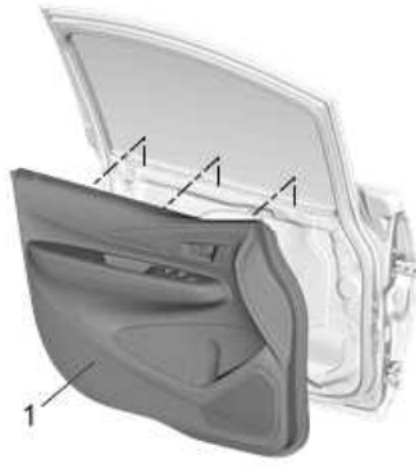
**Fig. 6: Front Side Door Trim**

9. Remove the front side door trim (1).
10. Place the door trim panel on a clean flat surface.
11. Release the belt molding and belt line clips from the door trim panel.

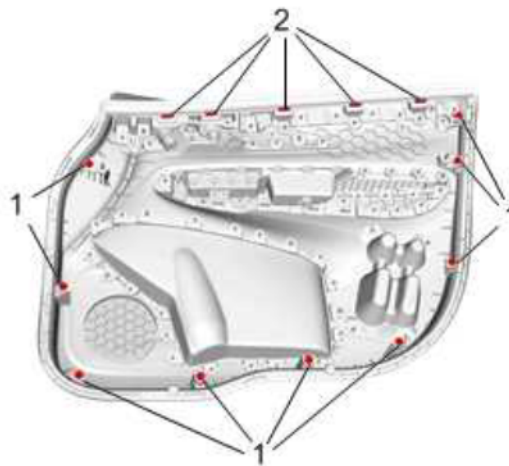
**Fig. 7: Door Trim Panel Retainer**

1. Make sure the belt line clip (2) (Qty: 5) are replaced with new clips before re-attaching the door trim, even if they weren't damaged.
2. Install the belt molding to the front side door trim assembly.
3. The retainer (1) (Qty: 9) that are destroyed during removal must be replaced with new retainers to properly reattach the door trim.

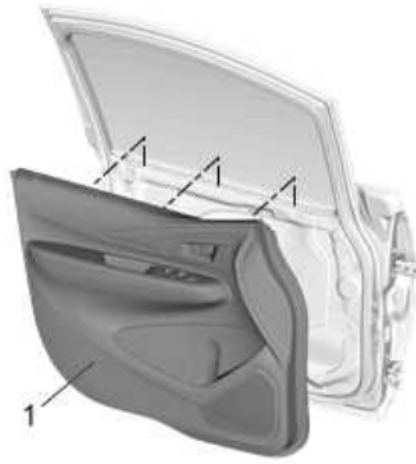
**Fig. 8: Front Side Door Trim**

4. Connect the electrical connector.
5. Connect the door lock retainer cable to the door trim panel and the inside handle.
6. Install the front side door trim (1)

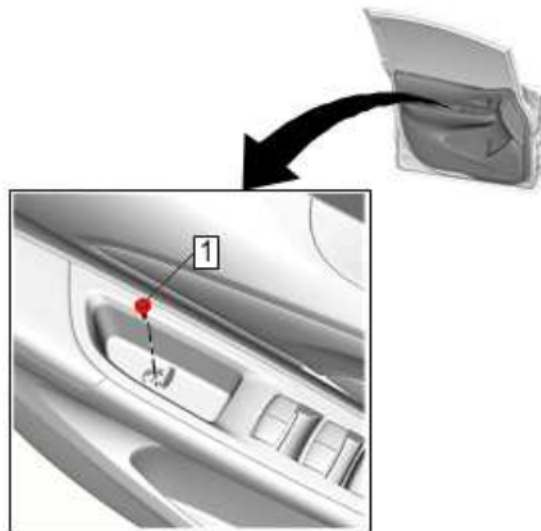
**Fig. 9: Front Side Door Armrest Pull Cup Bolt Cap**

7. Front Side Door Armrest Pull Cup Fastener (1) - Install and tighten to 2.5 N.m (22 lb in)
8. Install the front side door armrest pull cup fastener cap.

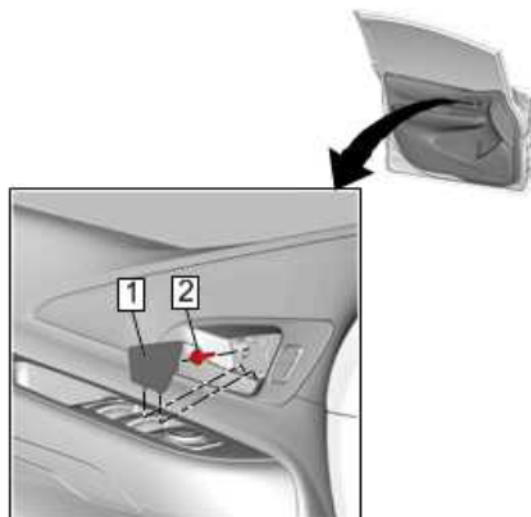
**Fig. 10: Front Side Door Inside Handle Fastener Finish Cap**  
Courtesy of GENERAL MOTORS COMPANY

9. Front Side Door Inside Handle Fastener (2) - Install and tighten to 2.5 N.m (22 lb in)
10. Install the front side door inside handle fastener finish cap (1).

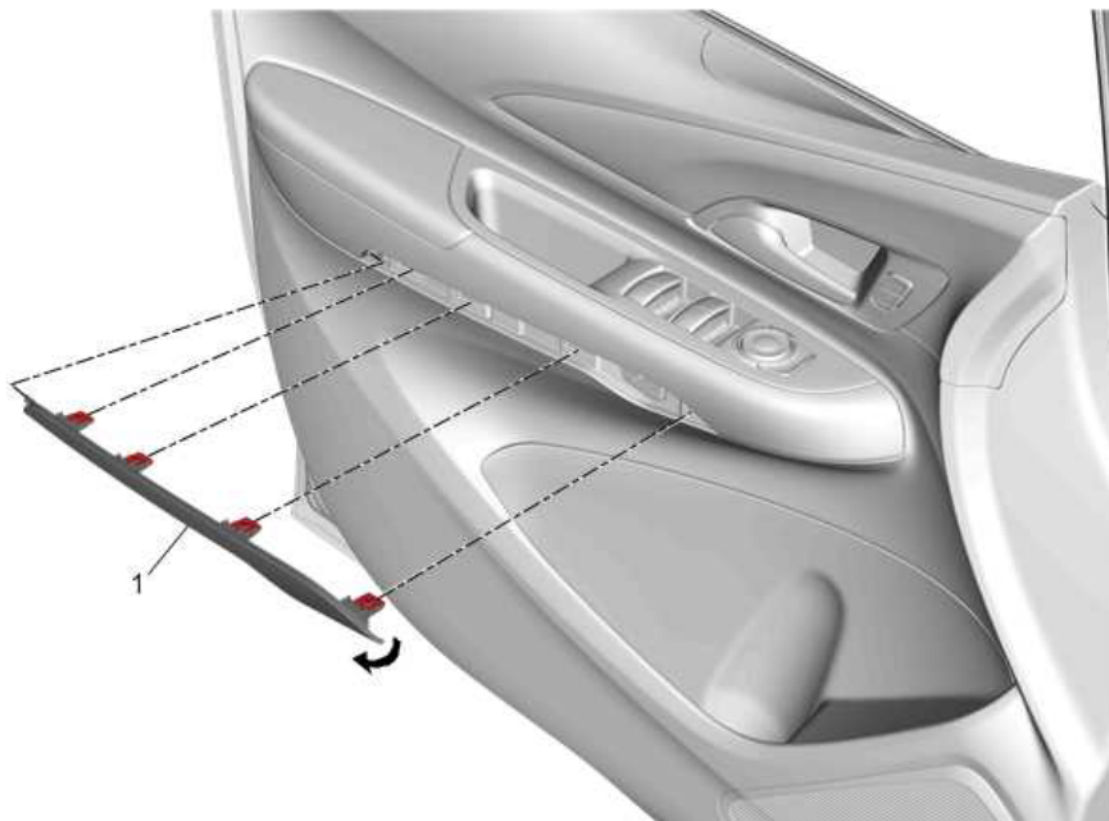
**Fig. 11: Front Side Door Trim Panel Applique**  
Courtesy of GENERAL MOTORS COMPANY

| Callout | Component Name |
|---|---|
| 1 | Front Side Door Trim Panel Applique<br><br><b>Procedure</b><br><br>1. Using a flat-bladed plastic trim tool, gently lift the front side door trim panel applique from the door trim panel, starting from the forward edge.<br>2. Pull the rear edge of the front side door trim panel applique forward to disengage from the door trim panel. |

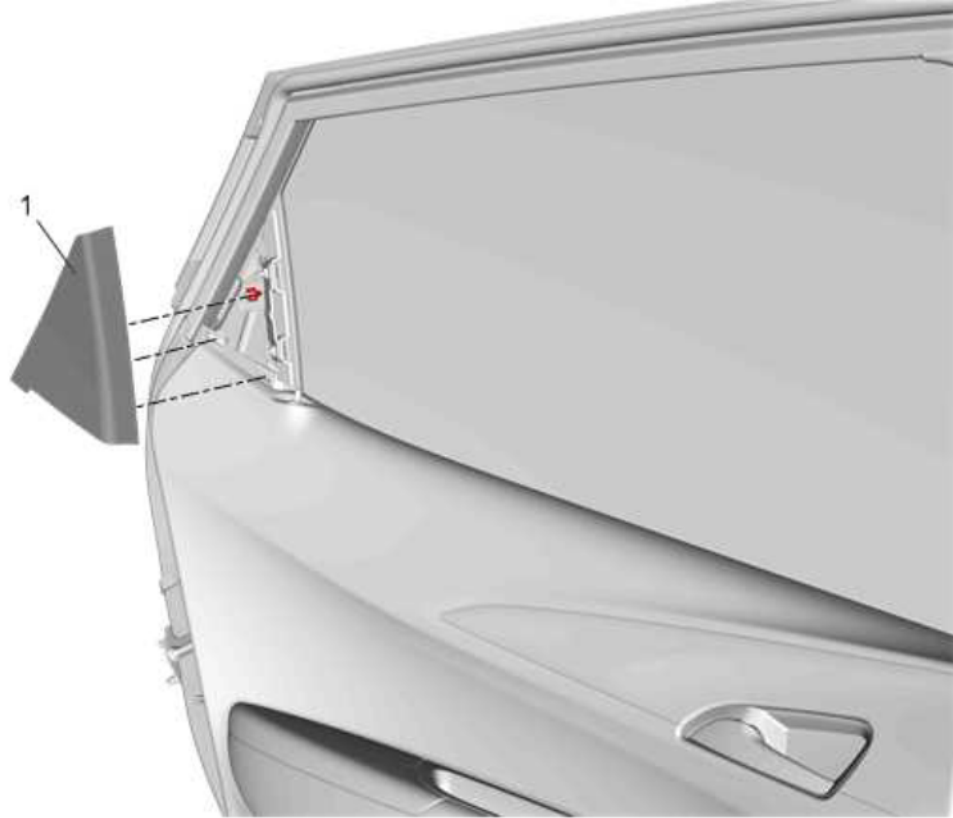
**Fig. 12: Rear Side Door Upper Rear Trim Panel**  
 Courtesy of GENERAL MOTORS COMPANY

| Callout | Component Name |
|---|---|
| 1 | Rear Side Door Upper Rear Trim Panel<br><b>Procedure</b><br>Pull the door upper rear trim panel away from the rear side door. |

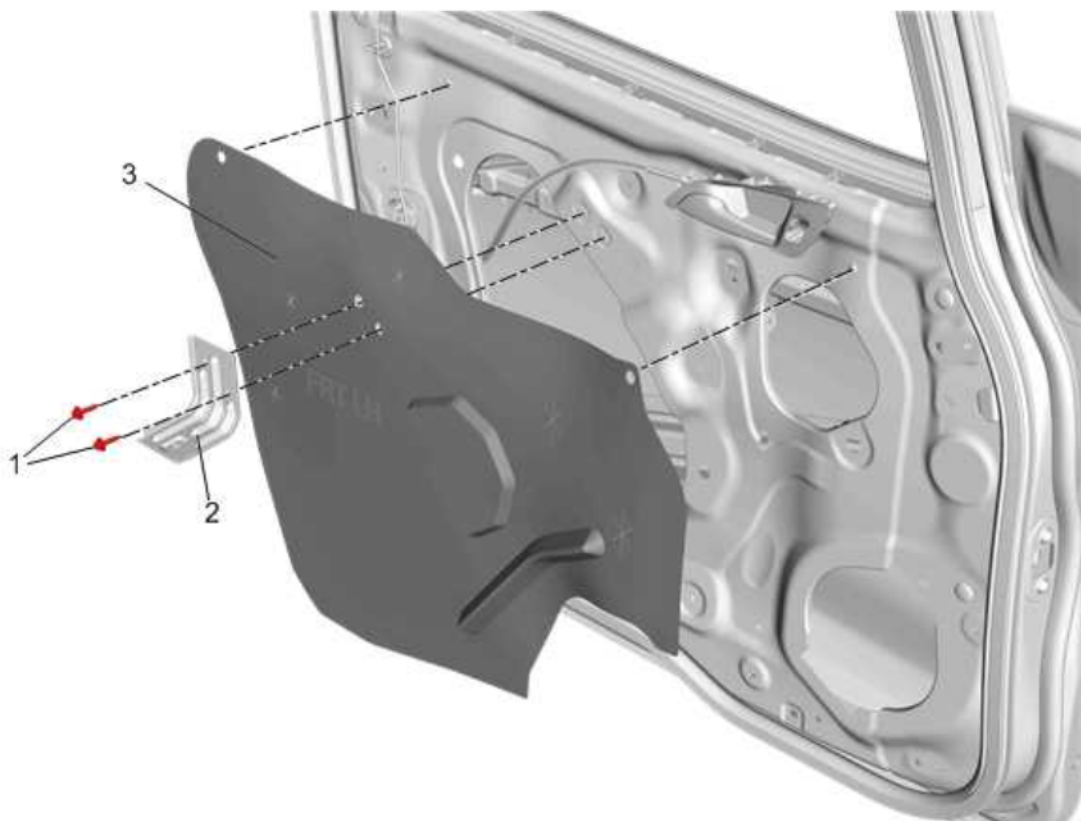
**Fig. 13: Front Side Door Water Deflector**  
 Courtesy of GENERAL MOTORS COMPANY

| Callout | Component Name |
|---|---|
| 1 | Front Side Door Armrest Bracket Bolt<br><br><b>CAUTION:</b><br>Refer to <a href="#">Fastener Caution</a> .<br><br><b>Tighten</b><br>2.5 N.m (22 lb in) |
| 2 | Front Side Door Armrest Bracket |
| 3 | Front Side Door Water Deflector<br><b>Procedure</b><br>Disconnect, unclip and guide the electrical connectors and door lock cable through the water deflector while removing it from the door.<br><br><b>NOTE:</b><br>Make sure that the front side door water deflector is leakproof. |

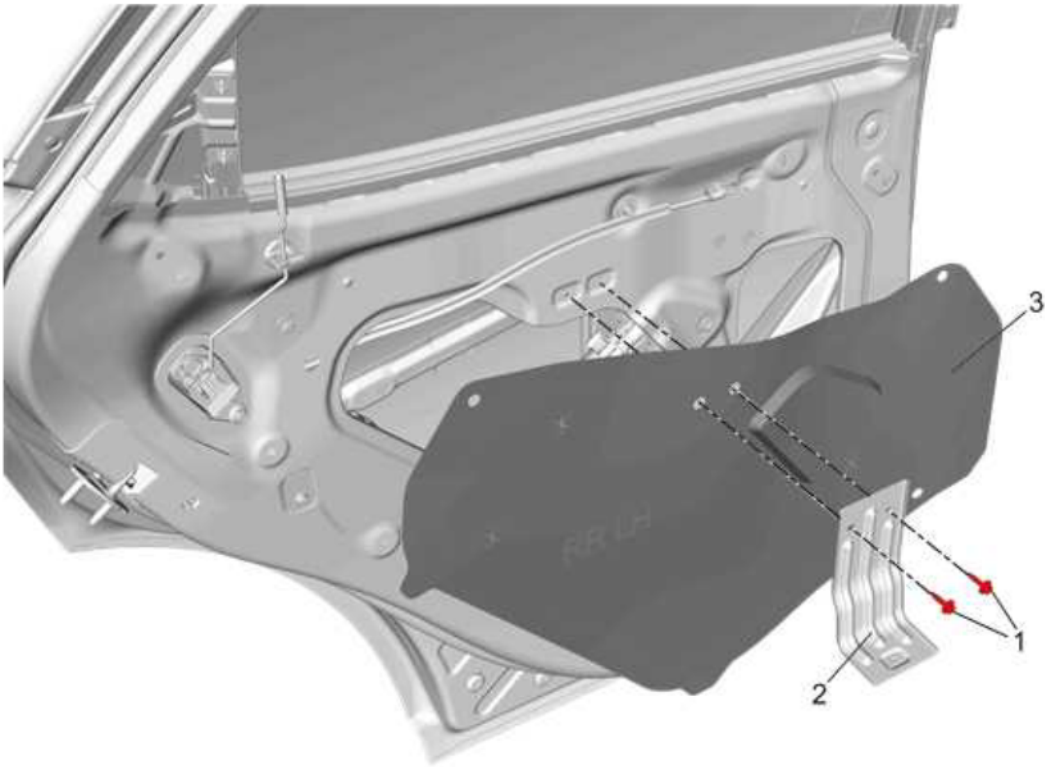
**Fig. 14: Rear Side Door Water Deflector**  
 Courtesy of GENERAL MOTORS COMPANY

| Callout | Component Name |
|---|---|
| 1 | Rear Side Door Armrest Bracket Bolt<br><br><b>CAUTION:</b><br>Refer to <a href="#">Fastener Caution</a> .<br><br><b>Tighten</b><br>2.5 N.m (22 lb in) |
| 2 | Rear Side Door Armrest Bracket |
| 3 | Rear Side Door Water Deflector<br><b>Procedure</b><br>Disconnect, unclip and guide the electrical connectors and door lock cable through the water deflector while removing it from the door.<br><br><b>NOTE:</b><br>Secure that the rear side door water deflector is leakproof. |

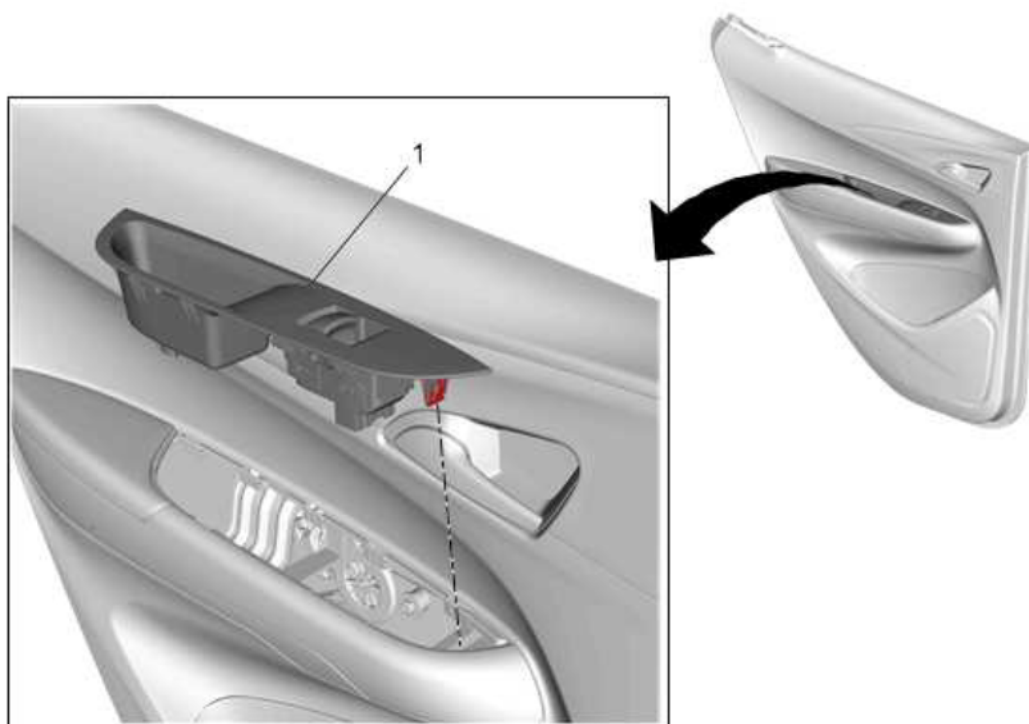
**Fig. 15: Rear Side Door Armrest Switch Mount Plate**  
Courtesy of GENERAL MOTORS COMPANY

| Callout | Component Name |
|---|---|
| 1 | Rear Side Door Armrest Switch Mount Plate<br><br><b>Procedure</b> <ol style="list-style-type: none"> <li>1. Remove the cloth sound deadening material from the trim panel.</li> <li>2. Release the integral retainers from the inside of the door trim. Lift up and outward.</li> <li>3. Transfer components as necessary.</li> </ol> |

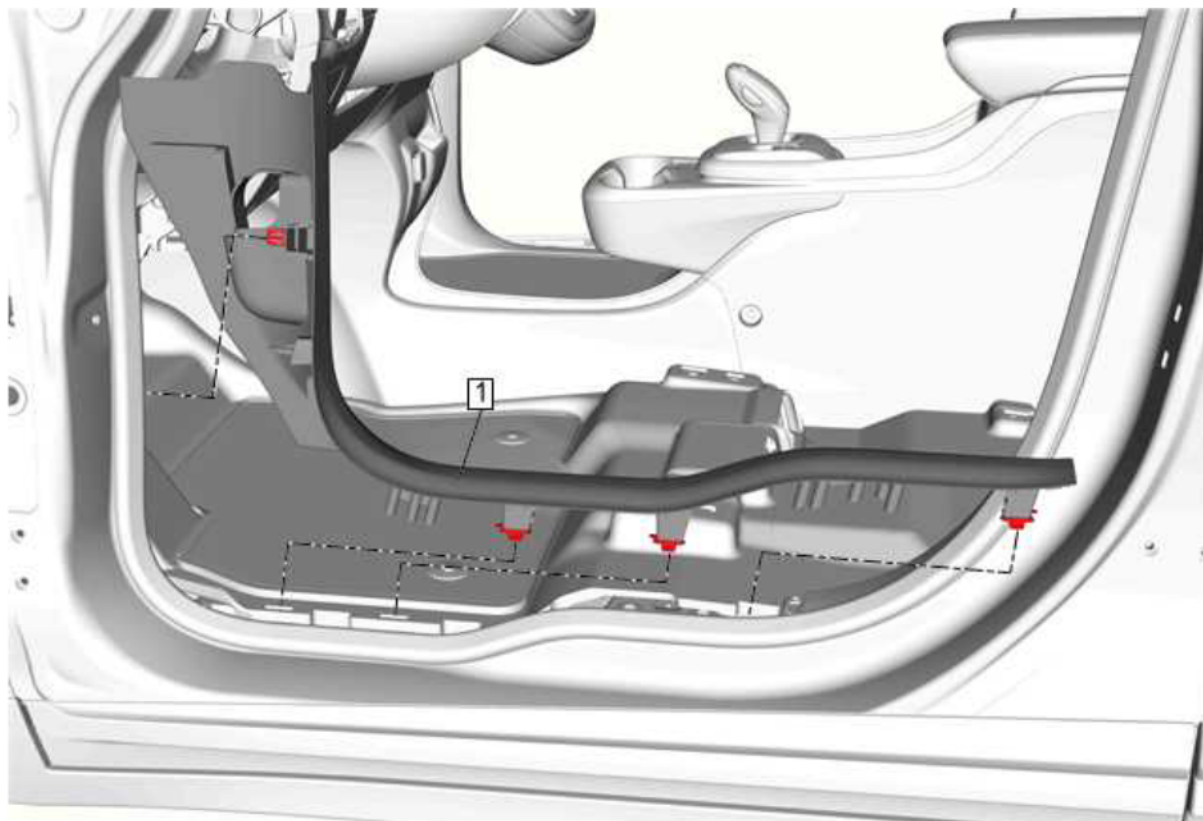
**Fig. 16: Front Side Door Sill Garnish Molding**  
Courtesy of GENERAL MOTORS COMPANY

| Callout | Component Name |
|---|---|
| 1 | Front Side Door Sill Garnish Molding<br><br><b>Procedure</b><br><br>1. Starting at the rear of the garnish molding, pull upward at the B-Pillar joint to disengage garnish molding.<br>2. Work your way forward disengaging all of the garnish molding clips then pull rearward to disengage the clip on the forward vertical wall.<br>3. Reposition the door weatherstrip as needed.<br>4. Replace the retainers as required. |

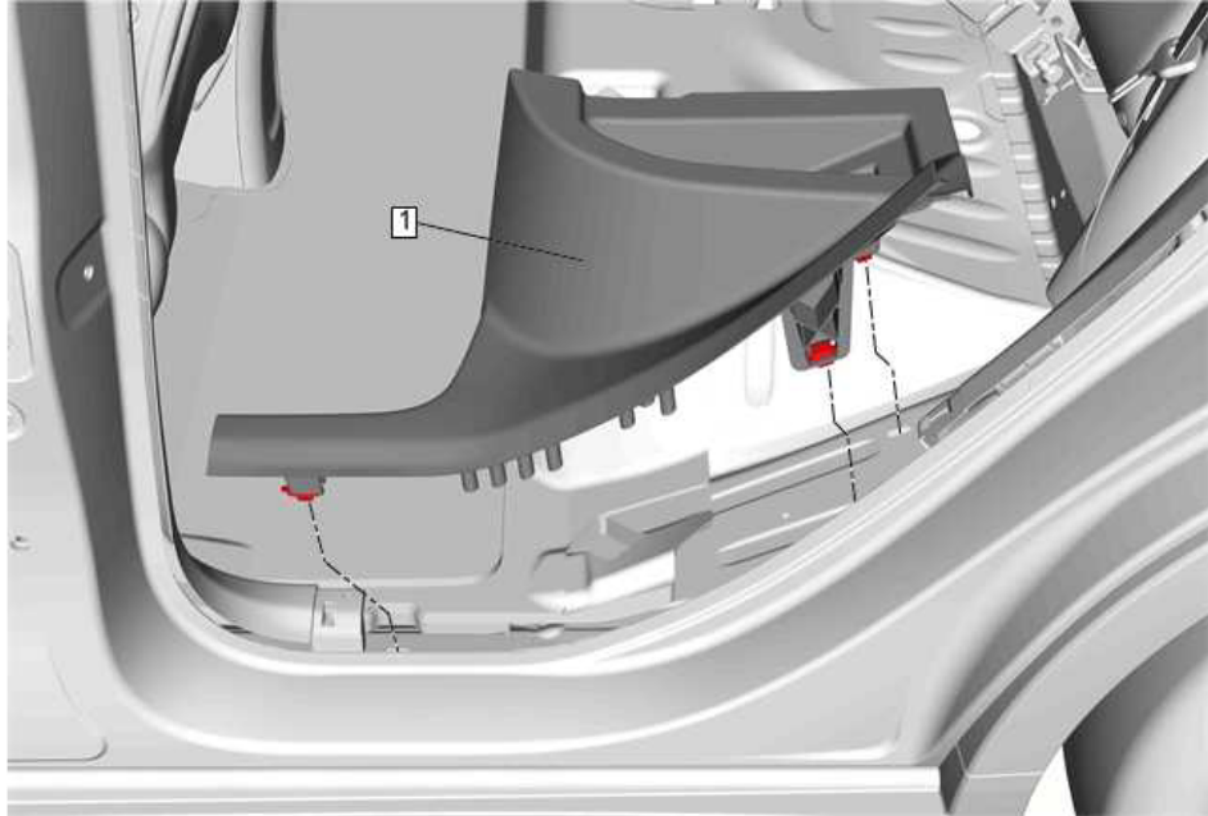
**Fig. 17: Rear Side Door Sill Garnish Molding**  
 Courtesy of GENERAL MOTORS COMPANY

| Callout | Component Name |
|---|---|
| 1 | Rear Side Door Sill Garnish Molding<br><br><b>Procedure</b> <ol style="list-style-type: none"> <li>1. Starting at the front of the sill garnish molding, pull upward at the B-Pillar joint to disengage sill garnish molding.</li> <li>2. Work your way rearward disengaging all of the garnish molding clips then pull forward to disengage from the C-Pillar lower.</li> <li>3. Replace the retainers as required.</li> </ol> |

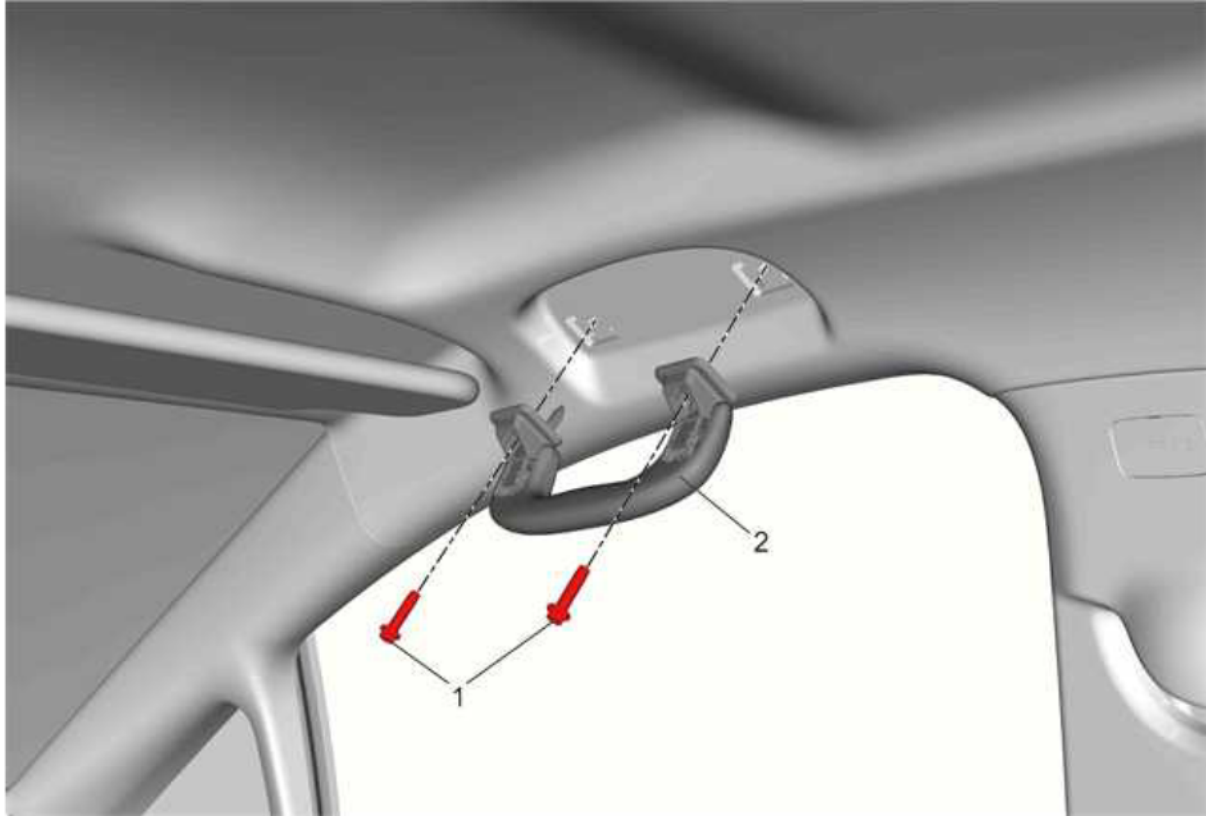
**Fig. 18: Roof Rail Assist Handle**

| Callout | Component Name |
|---|---|
| 1 | <p>Roof Rail Assist Handle Fastener</p> <p><b>CAUTION:</b><br/>Refer to <b>Fastener Caution</b> .</p> <p><b>Procedure</b></p> <ol style="list-style-type: none"> <li>1. Fold the roof rail assist handle downward and hold.</li> <li>2. Use a small flat-bladed tool to open the roof rail assist handle covers to access the bolt.</li> </ol> <p><b>Tighten</b><br/>6 N.m (53 lb in)</p> |
| 2 | Roof Rail Assist Handle |

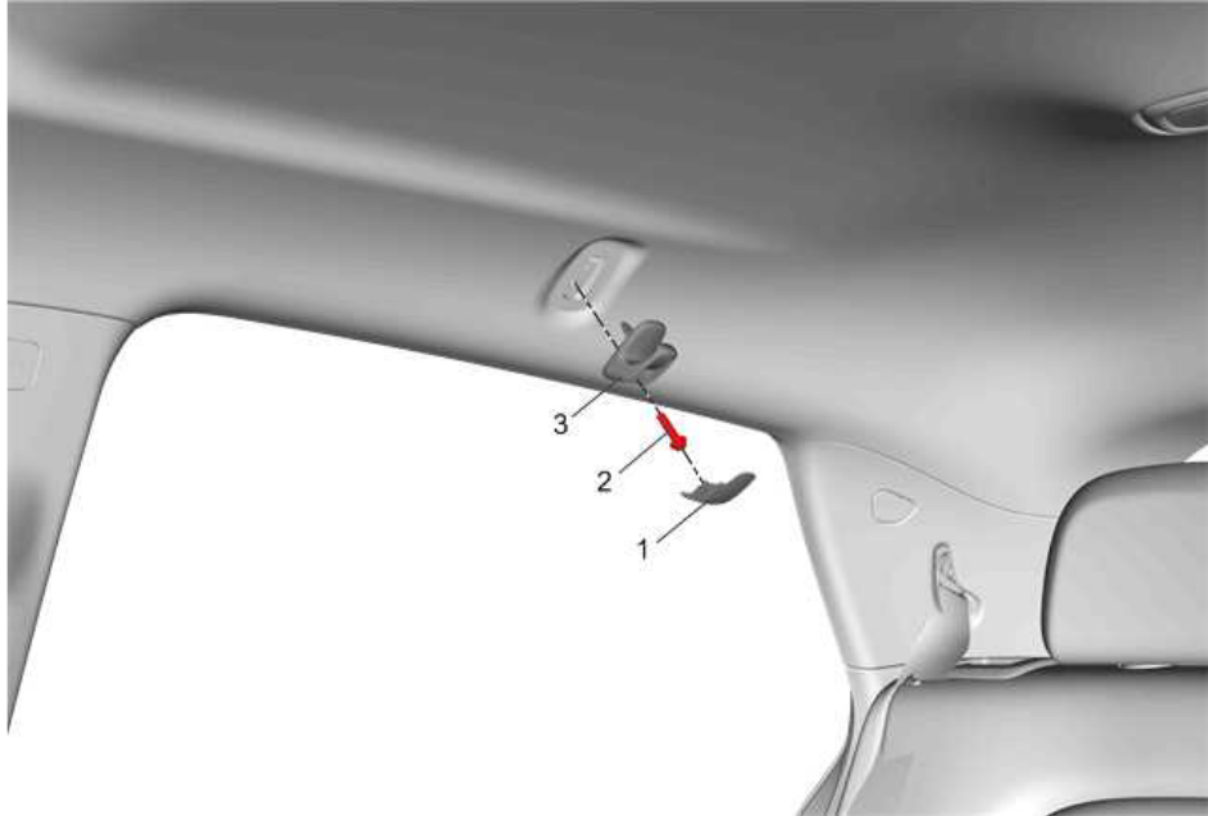
**Fig. 19: Coat Hook**

| Callout | Component Name |
|---|---|
| 1 | Coat Hook Cover |
| 2 | Coat Hook Bolt<br><br><b>CAUTION:</b><br>Refer to <a href="#">Fastener Caution</a> .<br><br><b>Procedure</b><br>Use a small flat-bladed tool to open the coat hook cover for access to the bolt.<br><b>Tighten</b><br>6 N.m (53 lb in) |
| 3 | Coat Hook |

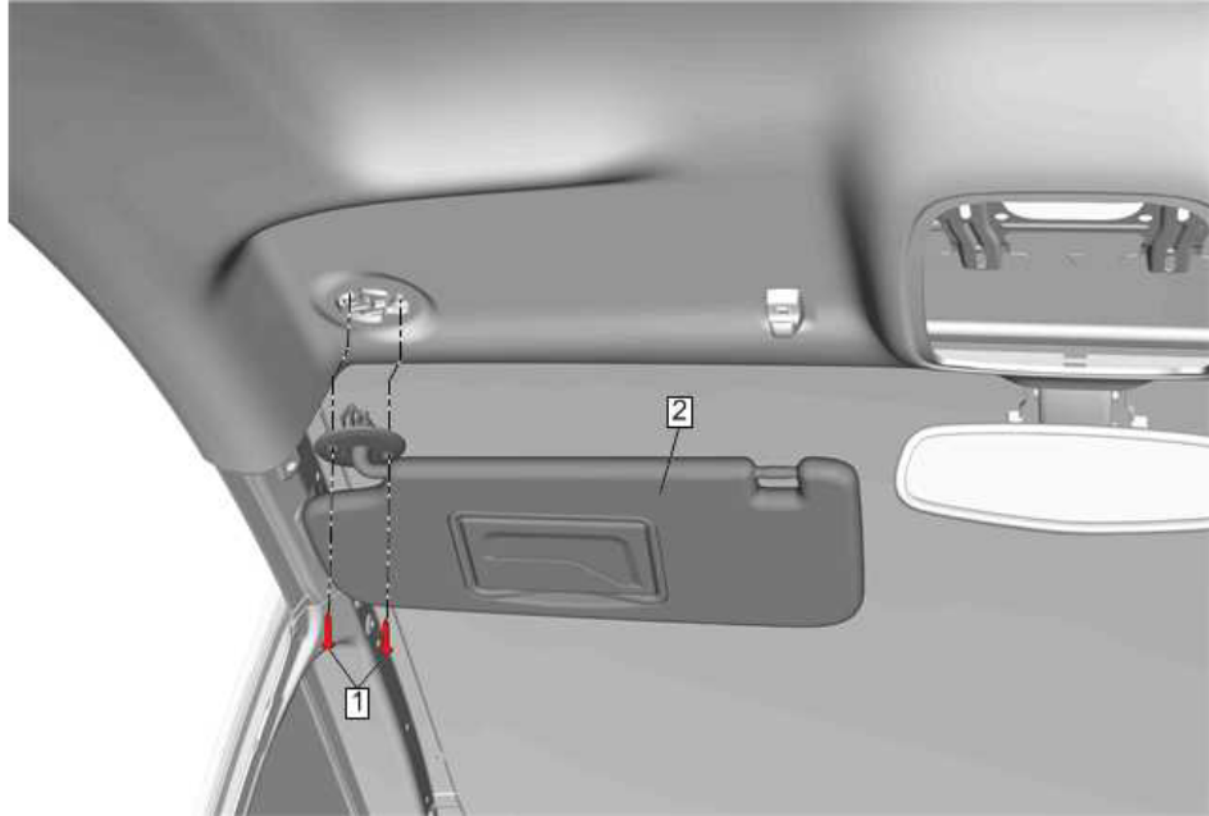
**Fig. 20: Sunshade**

| Callout | Component Name |
|---|---|
| 1 | <p>Sunshade Fastener</p> <p><b>CAUTION:</b><br/>Refer to <a href="#">Fastener Caution</a> .</p> <p><b>Tighten</b><br/>2.5 N.m (22 lb in)</p> |
| 2 | <p>Sunshade</p> <p><b>Procedure</b></p> <ol style="list-style-type: none"> <li>1. Lower the front portion of the headliner to access the sunshade electrical connector and sunshade retainer. <a href="#">Headlining Trim Panel Replacement</a></li> <li>2. Squeeze the tabs at the base of the sunshade assembly to detach it from the roof panel and allow the headliner with the sunshade attached to be lowered.</li> <li>3. Release the retainer attaching the sunshade to the headliner assembly.</li> </ol> |

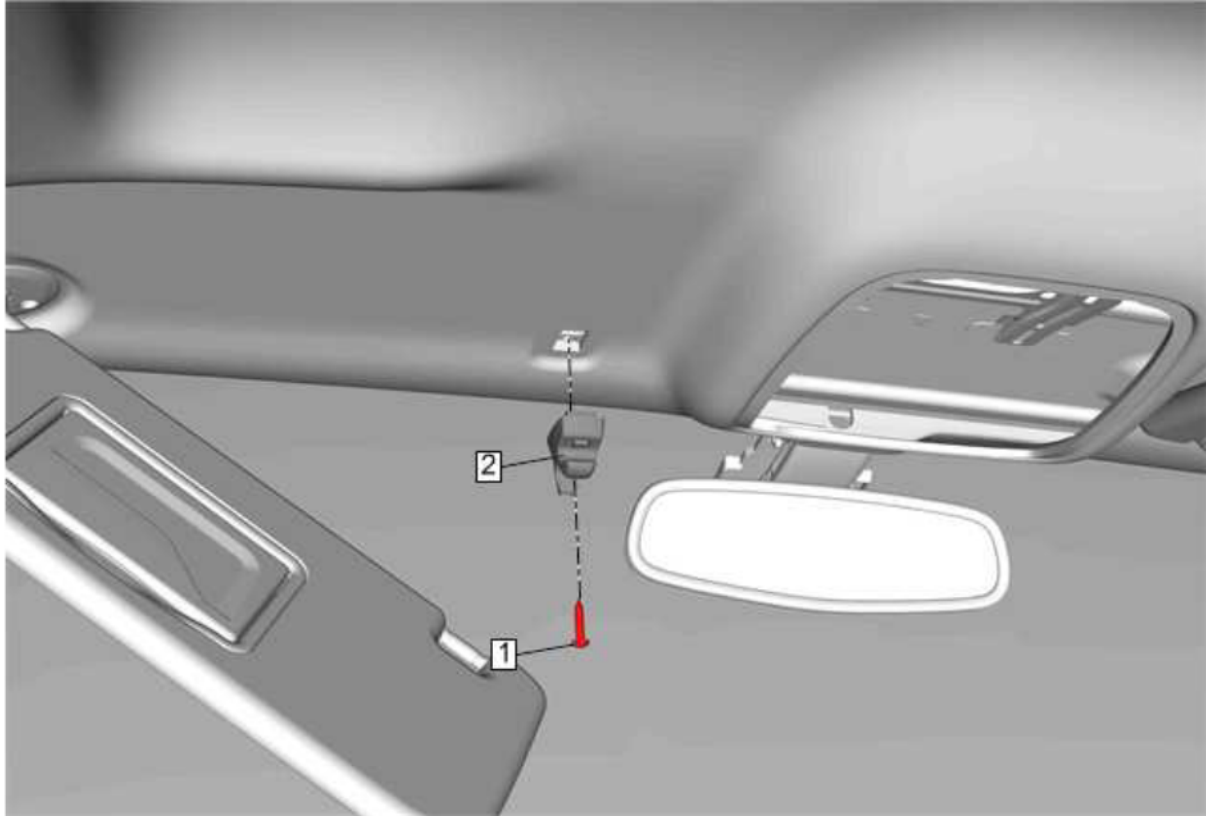
**Fig. 21: Sunshade Support**

| Callout | Component Name |
|---|---|
| 1 | <p>Sunshade Support Screw</p> <p><b>CAUTION:</b><br/>Refer to <a href="#">Fastener Caution</a> .</p> <p><b>Procedure</b><br/>Open the sunshade support screw access cover with a appropriate tool.<br/><b>Tighten</b><br/>2.5 N.m (22 lb in)</p> |
| 2 | <p>Sunshade Support</p> <p><b>Procedure</b><br/>Unclip the sunshade from the support and reposition.</p> |

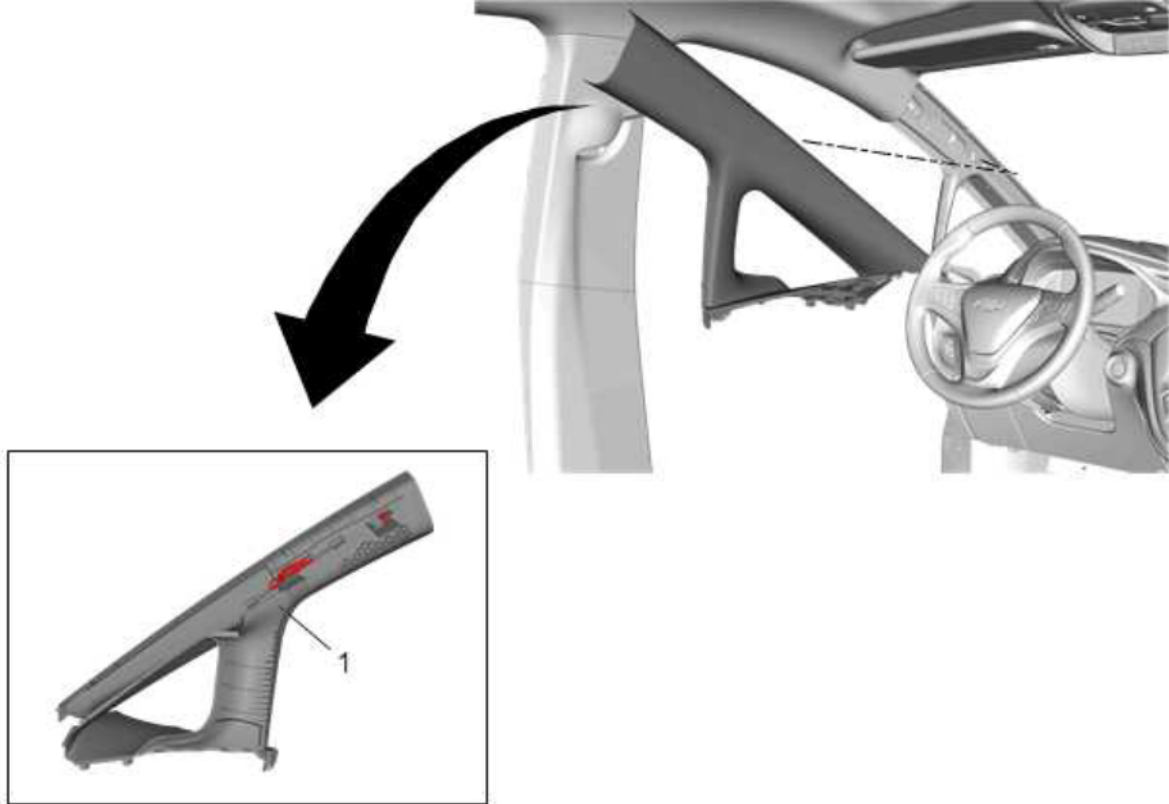
**Fig. 22: Windshield Garnish Molding**  
 Courtesy of GENERAL MOTORS COMPANY

| Callout | Component Name |
|---|---|
| 1 | Windshield Garnish Molding<br><br><b>Procedure</b> <ol style="list-style-type: none"> <li>1. Pull the top of the A-Pillar inward to disengage the upper clip.</li> <li>2. Carefully remove the tether from the garnish molding.</li> <li>3. Pull upward to disengage from the instrument panel.</li> <li>4. The tether clip at the center portion of the garnish molding MUST be replaced every time the windshield garnish molding is removed.</li> <li>5. Enable the SIR system. <a href="#">SIR Disabling and Enabling</a></li> </ol> |

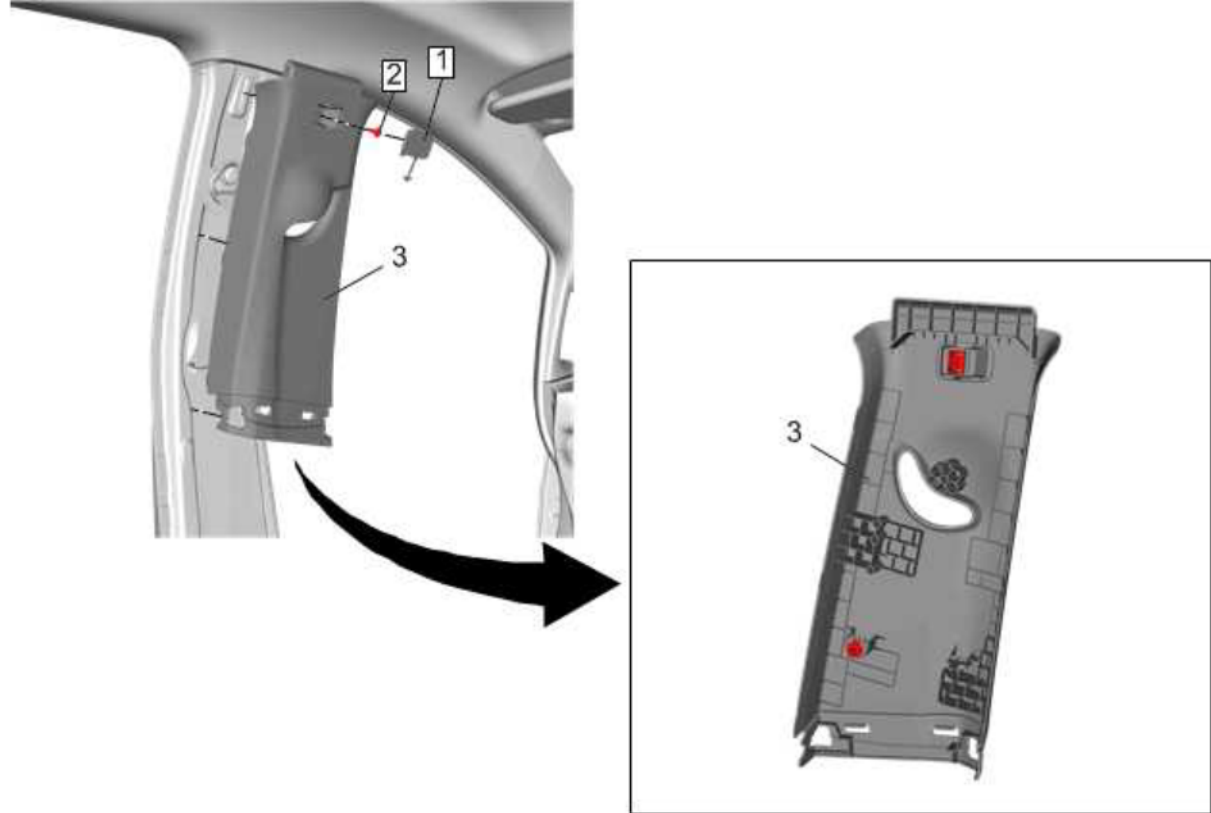
**Fig. 23: Center Pillar Upper Trim Panel**  
 Courtesy of GENERAL MOTORS COMPANY

| Callout | Component Name |
|---|---|
| 1 | Center Pillar Upper Trim Panel Bolt Cap |
| 2 | Center Pillar Upper Garnish Molding Bolt<br><br><b>CAUTION:</b><br>Refer to <a href="#">Fastener Caution</a> .<br><br><b>Tighten</b><br>3 N.m (27 lb in) |
| 3 | Center Pillar Upper Trim Panel<br><br><b>Procedure</b> <ol style="list-style-type: none"> <li>1. Pull the trim panel toward the inside of the vehicle to disengage the retainers and to clear the front seat tensioner assembly.</li> <li>2. When replacing the center pillar upper trim panel, feed the seat belt through the panel.</li> <li>3. Ensure the seat belt webbing does not become trapped during installation.</li> <li>4. Enable the SIR system. <a href="#">SIR Disabling and Enabling</a></li> </ol> |

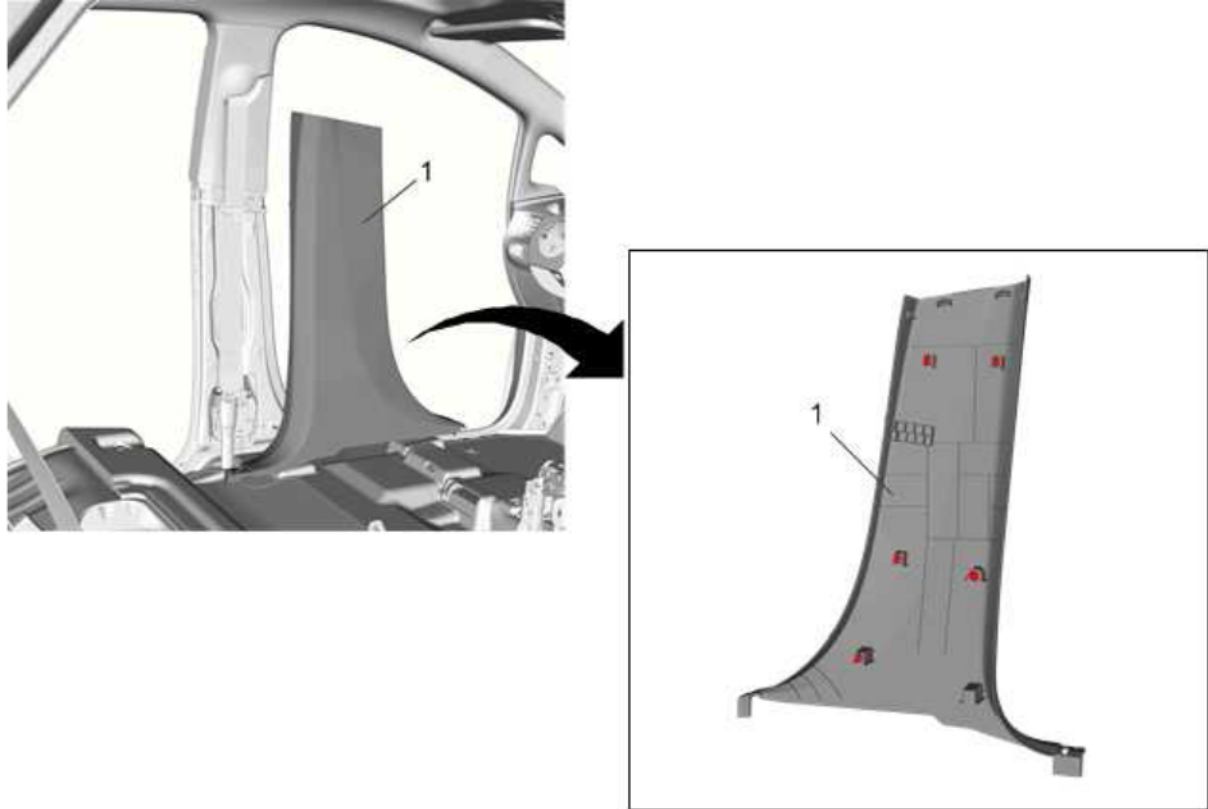
**Fig. 24: Center Pillar Lower Trim Panel**  
 Courtesy of GENERAL MOTORS COMPANY

| Callout | Component Name |
|---|---|
| 1 | Center Pillar Lower Trim Panel Assembly<br><b>Procedure</b><br>Pull the center pillar lower trim panel inward and upward to disengage the retainers. |

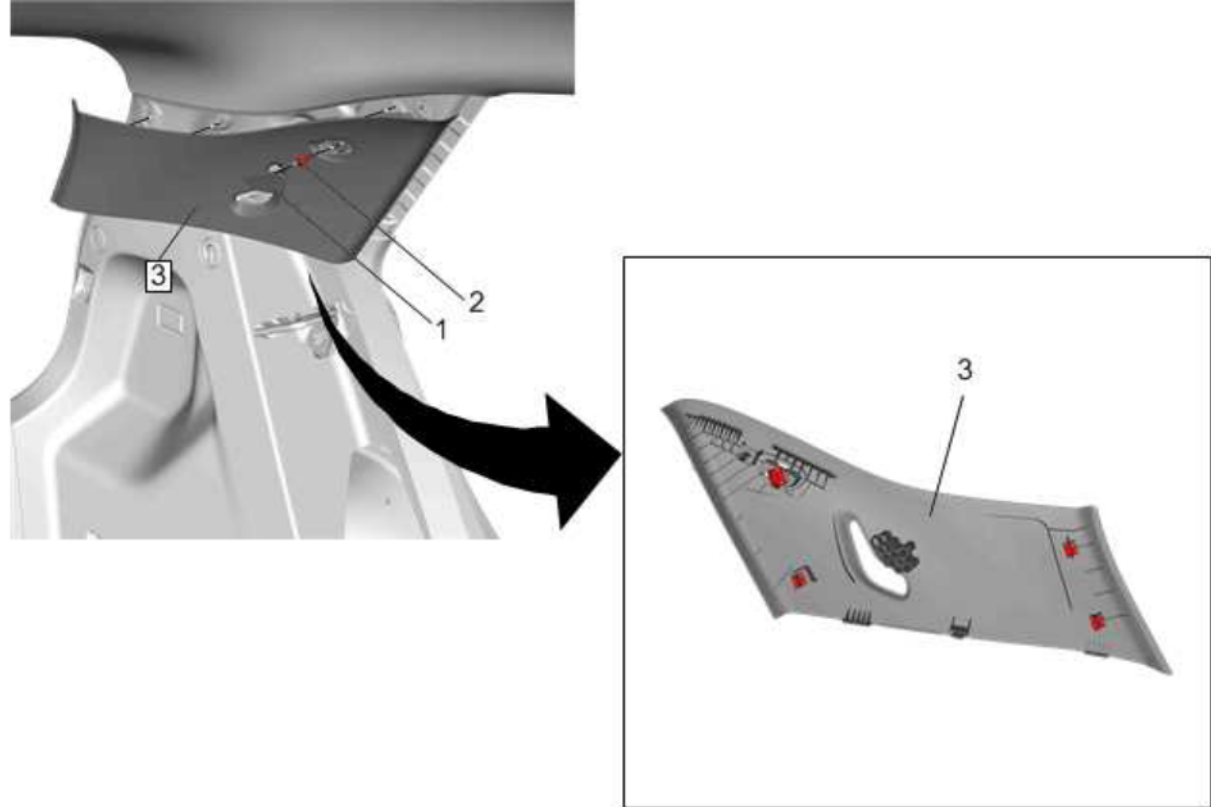
**Fig. 25: Body Lock Pillar Upper Trim Panel**  
 Courtesy of GENERAL MOTORS COMPANY

| Callout | Component Name |
|---|---|
| 1 | Body Lock Pillar Upper Trim Panel Bolt Cap |
| 2 | Body Lock Pillar Upper Trim Panel Bolt<br><br><b>CAUTION:</b><br><b><a href="#">Fastener Caution</a></b><br><br><b>Tighten</b><br>3 N.m (27 lb in) |
| 3 | Body Lock Pillar Upper Trim Panel<br><br><b>Procedure</b> <ol style="list-style-type: none"> <li>1. Use a flat bladed plastic trim tool.</li> <li>2. Grasp and gently pull up on the body lock pillar upper trim panel.</li> <li>3. Enable the SIR system. <a href="#">SIR Disabling and Enabling</a></li> </ol> |

| Callout | Component Name |
|---|---|
| <b>Preliminary Procedure</b> <ol style="list-style-type: none"> <li>1. Disable the SIR system. <a href="#">SIR Disabling and Enabling</a></li> <li>2. Remove the rear seat belt retractor bolt on the bottom of the body. <a href="#">Rear Seat Belt Retractor Replacement</a></li> </ol> | |

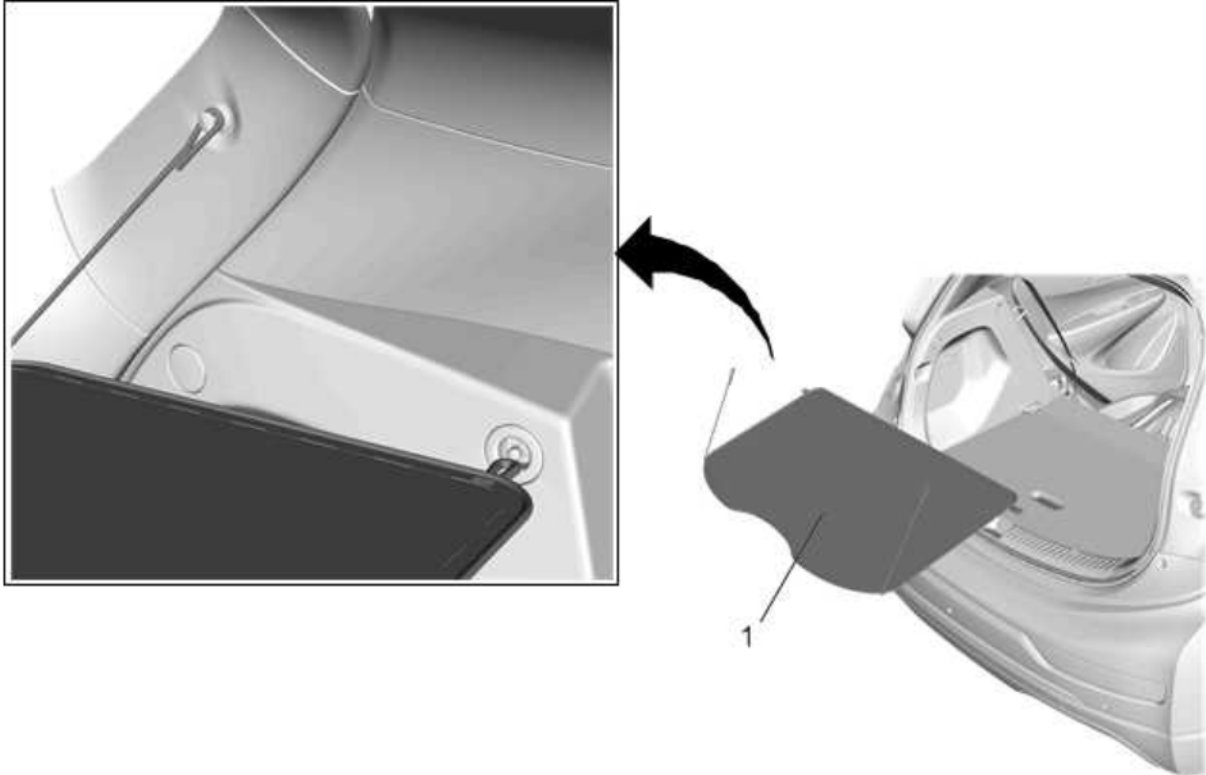
**Fig. 26: Luggage Shade**

1. Remove the luggage shade for either side. [Luggage Shade Replacement](#)

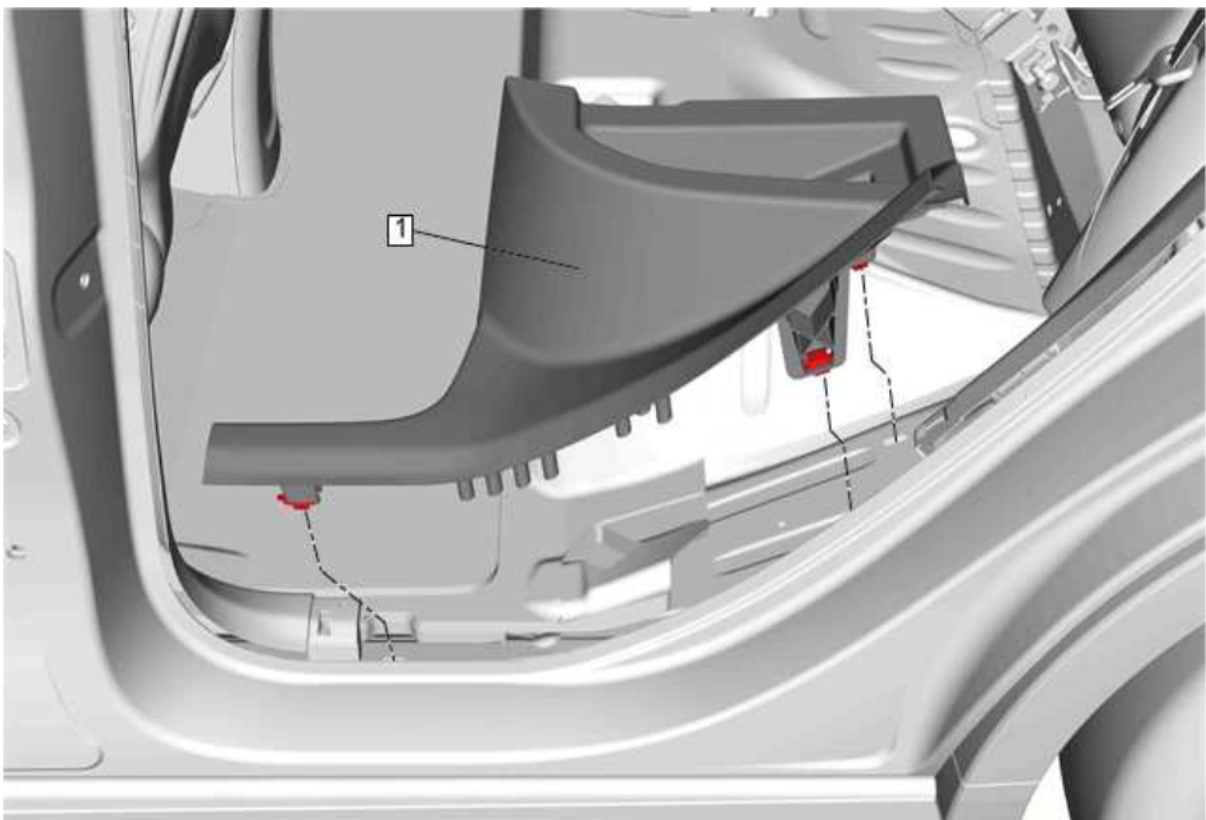
**Fig. 27: Rear Side Door Sill Garnish Molding**

2. Remove the rear side door sill garnish molding from side being worked on. [Rear Side Door Sill Garnish Molding Replacement](#)
