## 2017 ACCESSORIES AND EQUIPMENT

### Interior Trim and Paneling - Bolt EV

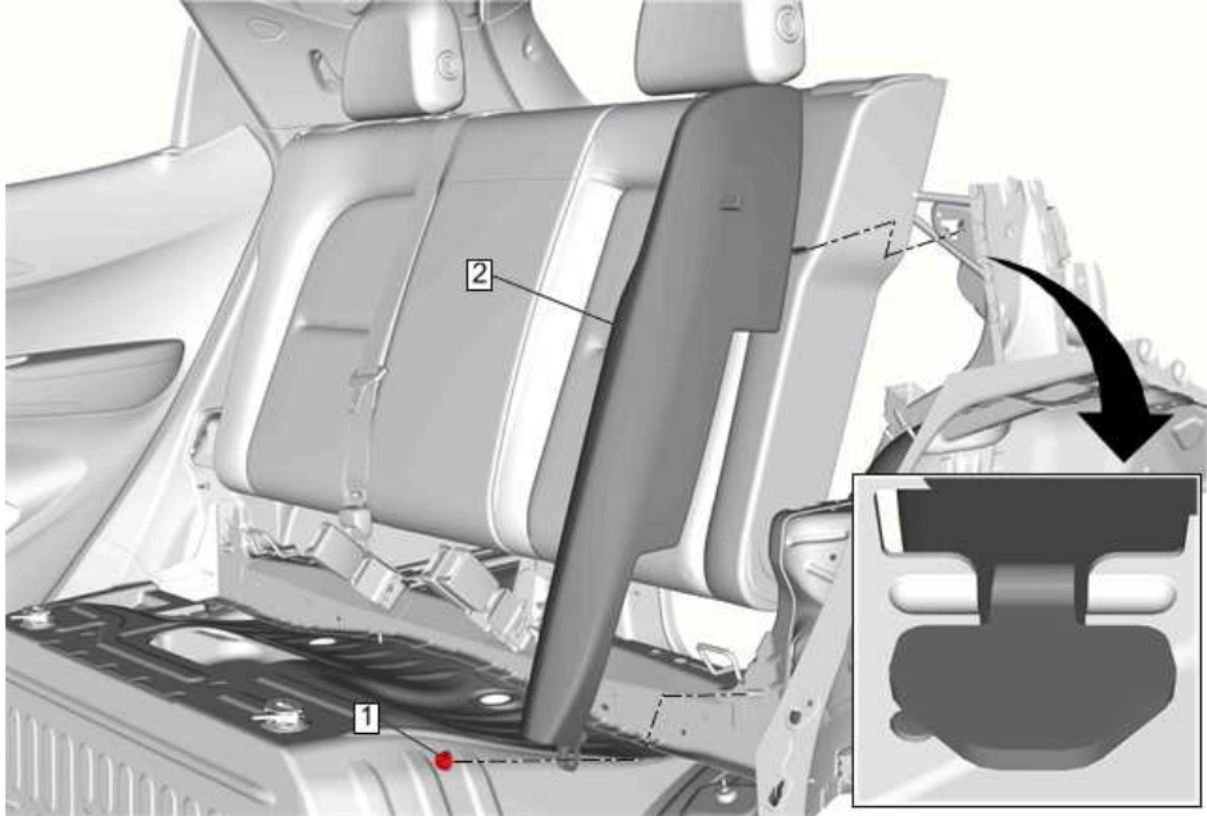
**Fig. 28: Rear Seat Back Bolster**

3. Remove the rear seat back bolster from side being worked on. [Rear Seat Back Bolster Replacement](#)

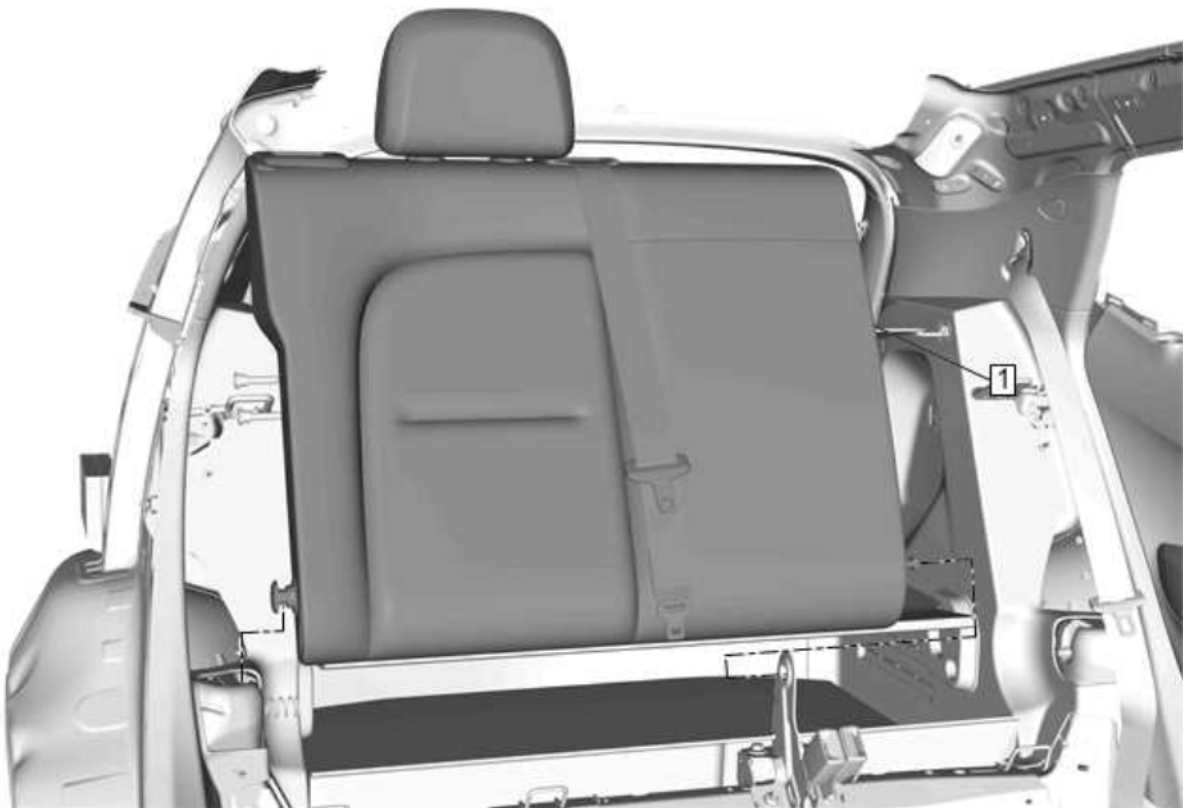
**Fig. 29: Rear Seat Back Cushion**

4. Remove 40% rear seat back cushion for left, 60% for right. [Rear Seat Back Cushion Removal and Installation \(40%\)](#) [Rear Seat Back Cushion Removal and Installation \(60%\)](#)

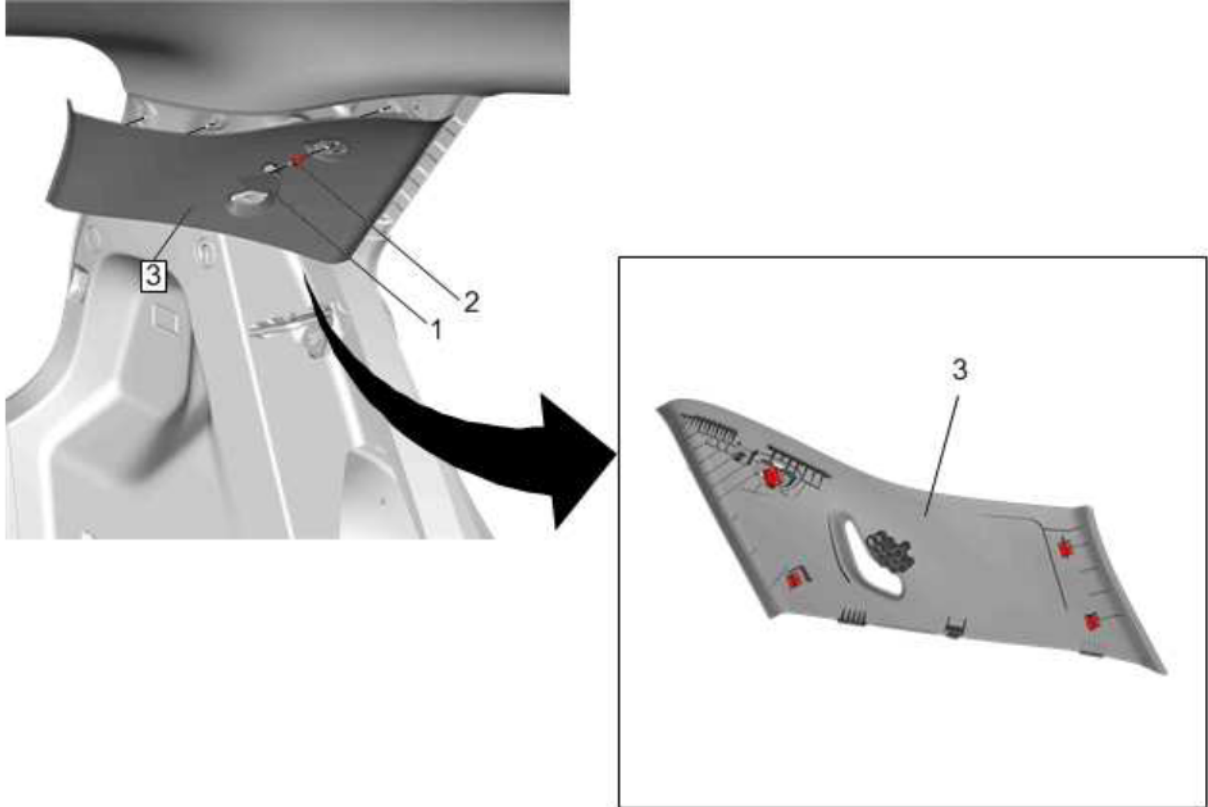
**Fig. 30: Body Lock Pillar Upper Trim Panel**  
**Courtesy of GENERAL MOTORS COMPANY**

5. Reposition the body lock pillar upper trim panel from side being worked on. **Body Lock Pillar Upper Trim Panel Replacement**

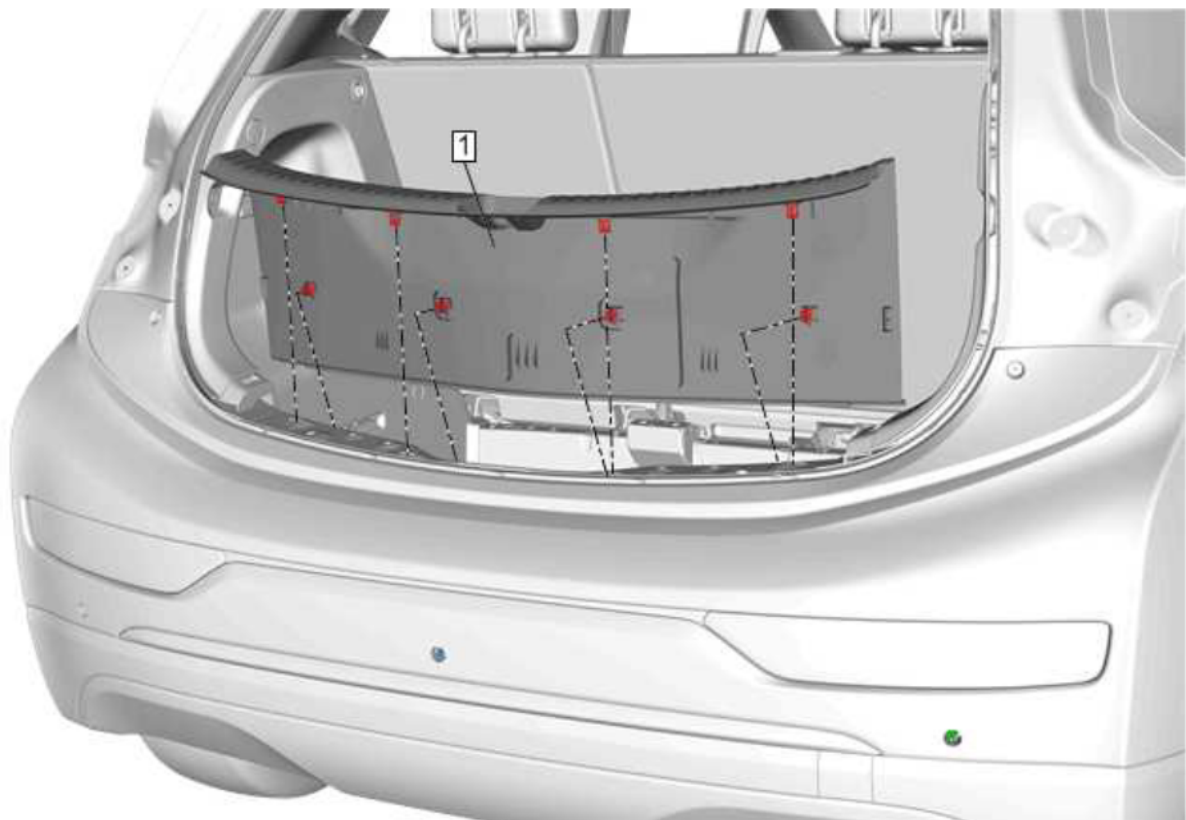
**Fig. 31: Lift Gate Sill Garnish Molding**  
**Courtesy of GENERAL MOTORS COMPANY**

6. Remove the lift gate sill garnish molding. **Liftgate Sill Garnish Molding Replacement**

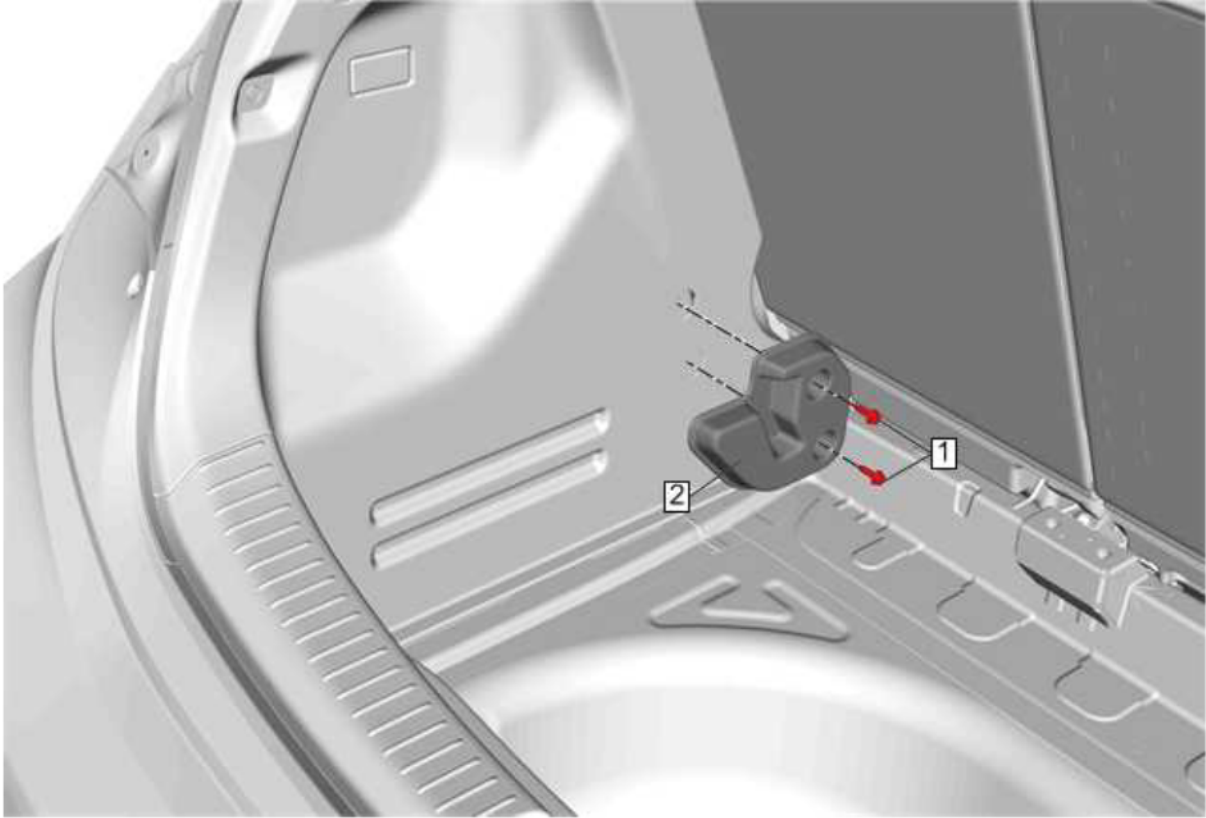
**Fig. 32: Oad Floor Stowage Compartment Cover Support**  
 Courtesy of GENERAL MOTORS COMPANY

7. Remove the load floor stowage compartment cover support from side being worked on. **Load Floor Stowage Compartment Cover Support Replacement**

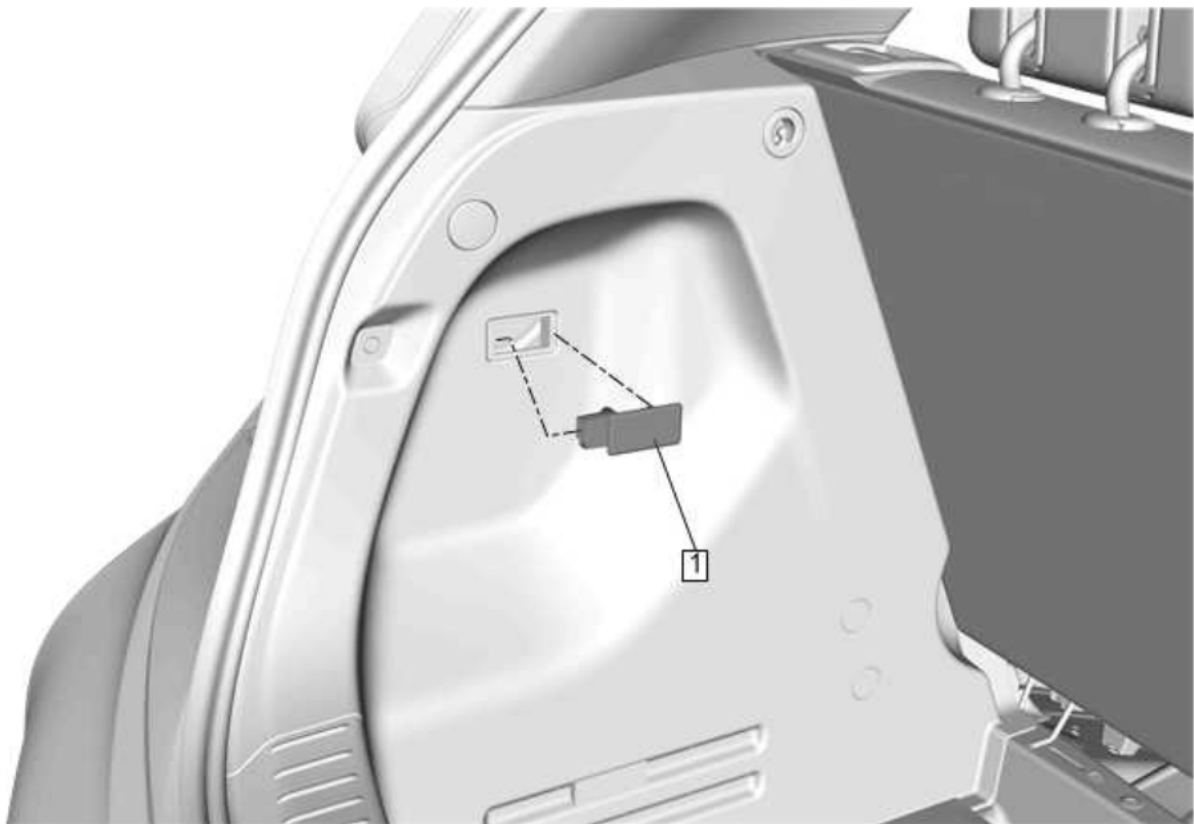
**Fig. 33: Cargo Center Courtesy Lamp On Left Side**  
 Courtesy of GENERAL MOTORS COMPANY

8. Remove the cargo center courtesy lamp on left side panel only. **Cargo Center Courtesy Lamp Replacement**

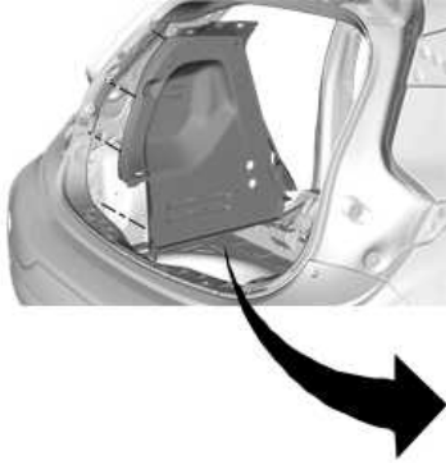
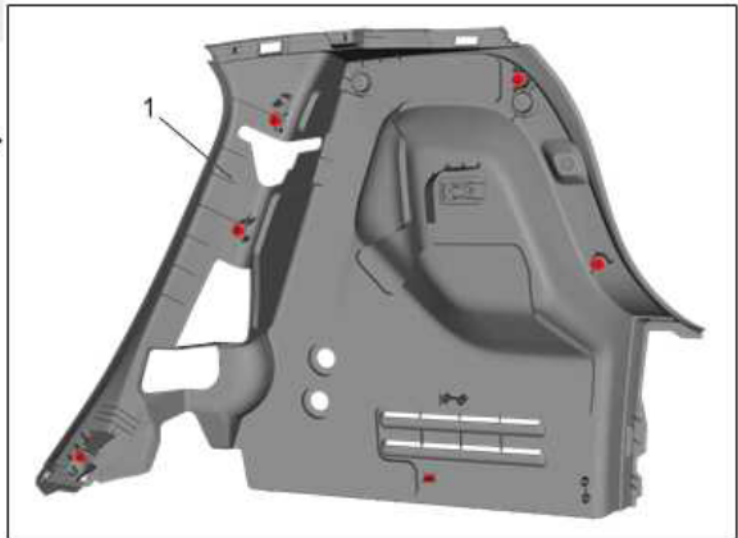
**Fig. 34: Quarter Lower Rear Trim Panel**  
 Courtesy of GENERAL MOTORS COMPANY

9. Use a flat-bladed plastic trim tool to release the quarter lower rear trim panel.
10. Quarter Lower Rear Trim Panel - Remove

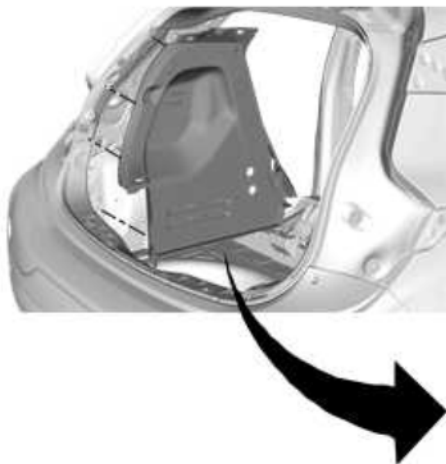
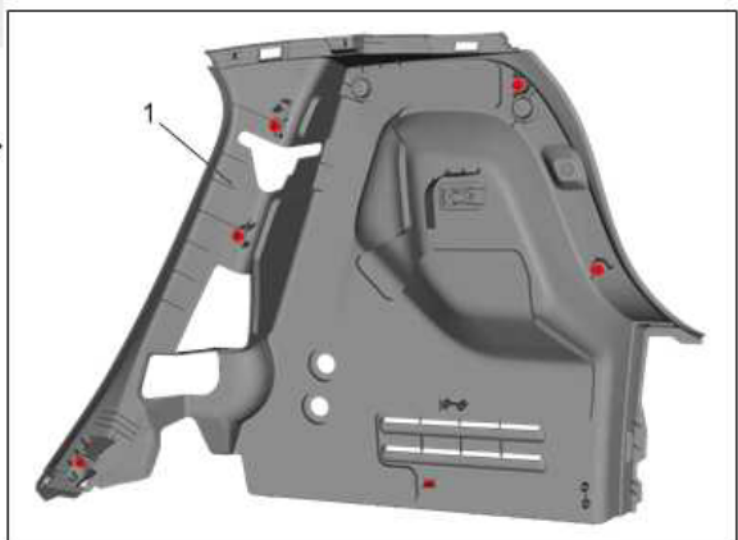
**Fig. 35: Quarter Lower Rear Trim Panel**  
 Courtesy of GENERAL MOTORS COMPANY

1. Quarter Lower Rear Trim Panel - Install

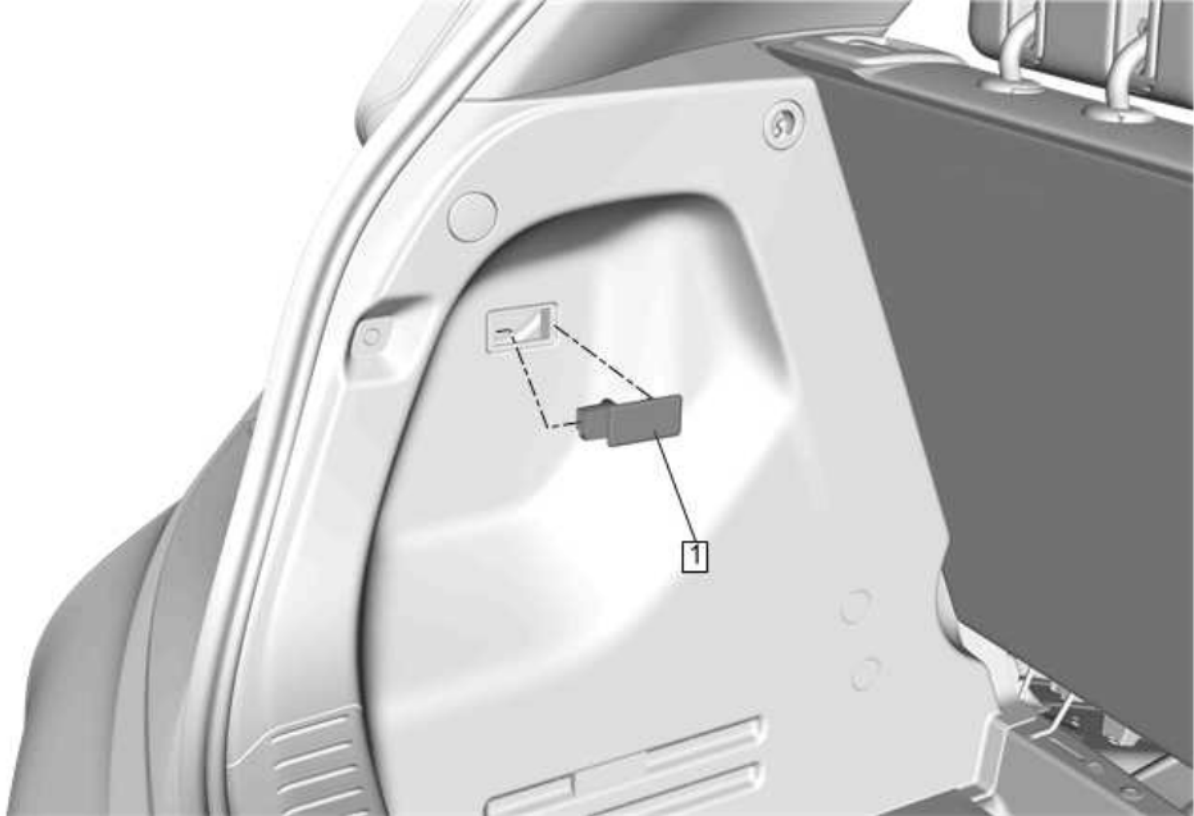
**Fig. 36: Cargo Center Courtesy Lamp On Left Side**  
 Courtesy of GENERAL MOTORS COMPANY

2. Install the cargo center courtesy lamp. [Cargo Center Courtesy Lamp Replacement](#)

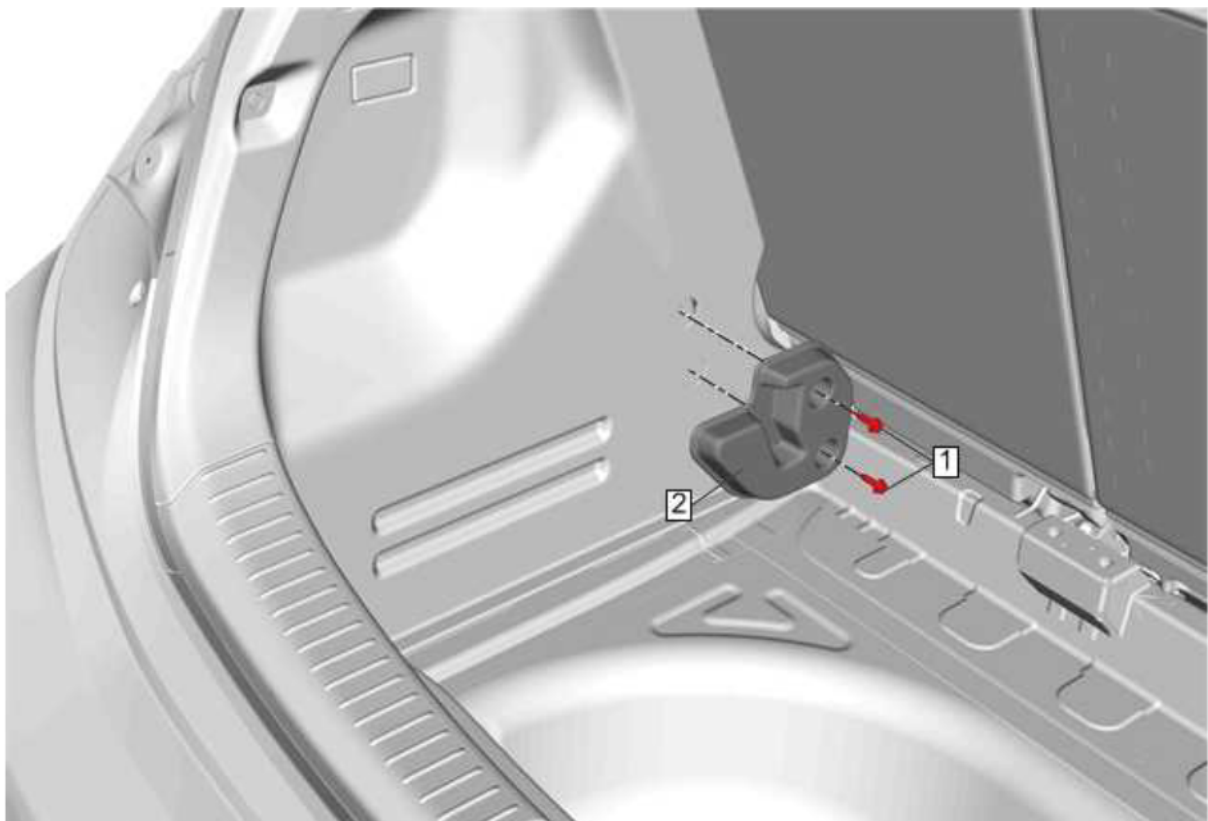
**Fig. 37: Load Floor Stowage Compartment Cover Support**  
 Courtesy of GENERAL MOTORS COMPANY

3. Install the load floor stowage compartment cover support. [Load Floor Stowage Compartment Cover Support Replacement](#)

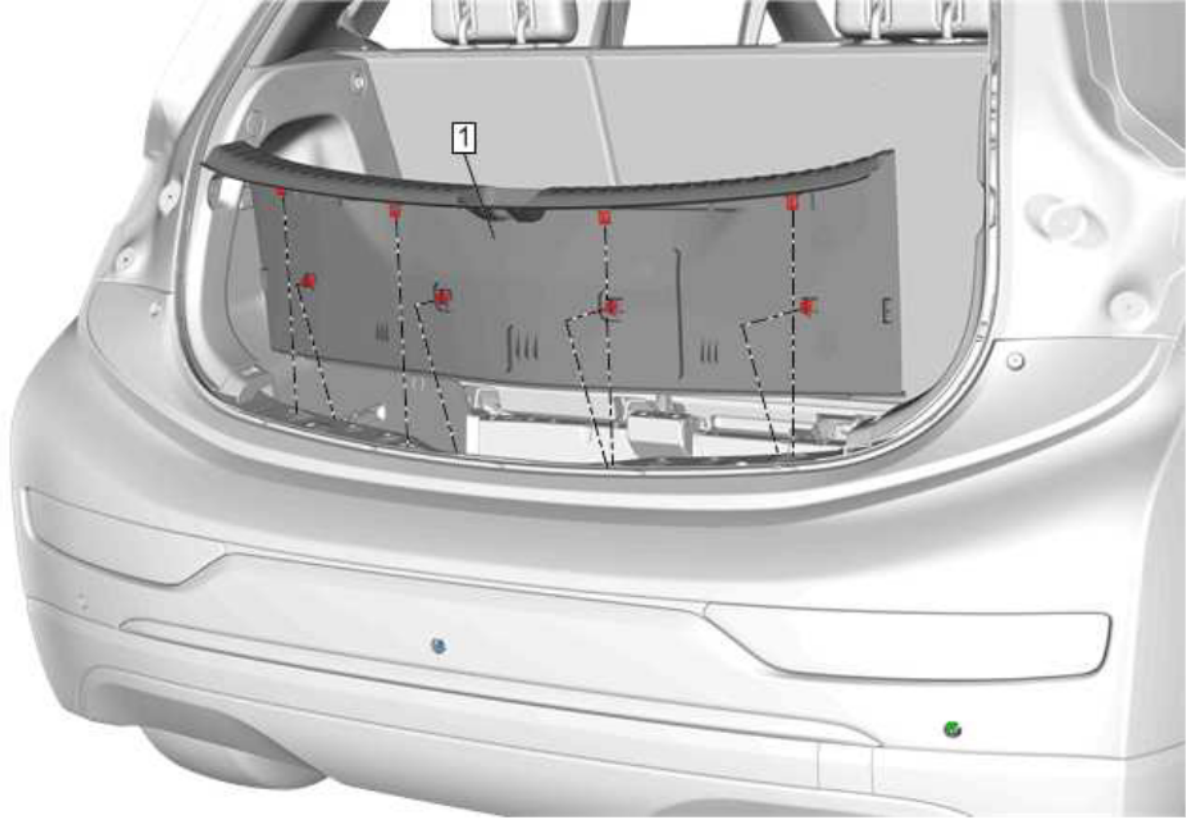
**Fig. 38: Lift Gate Sill Garnish Molding**  
 Courtesy of GENERAL MOTORS COMPANY

4. Install the lift gate sill garnish molding. [Liftgate Sill Garnish Molding Replacement](#)

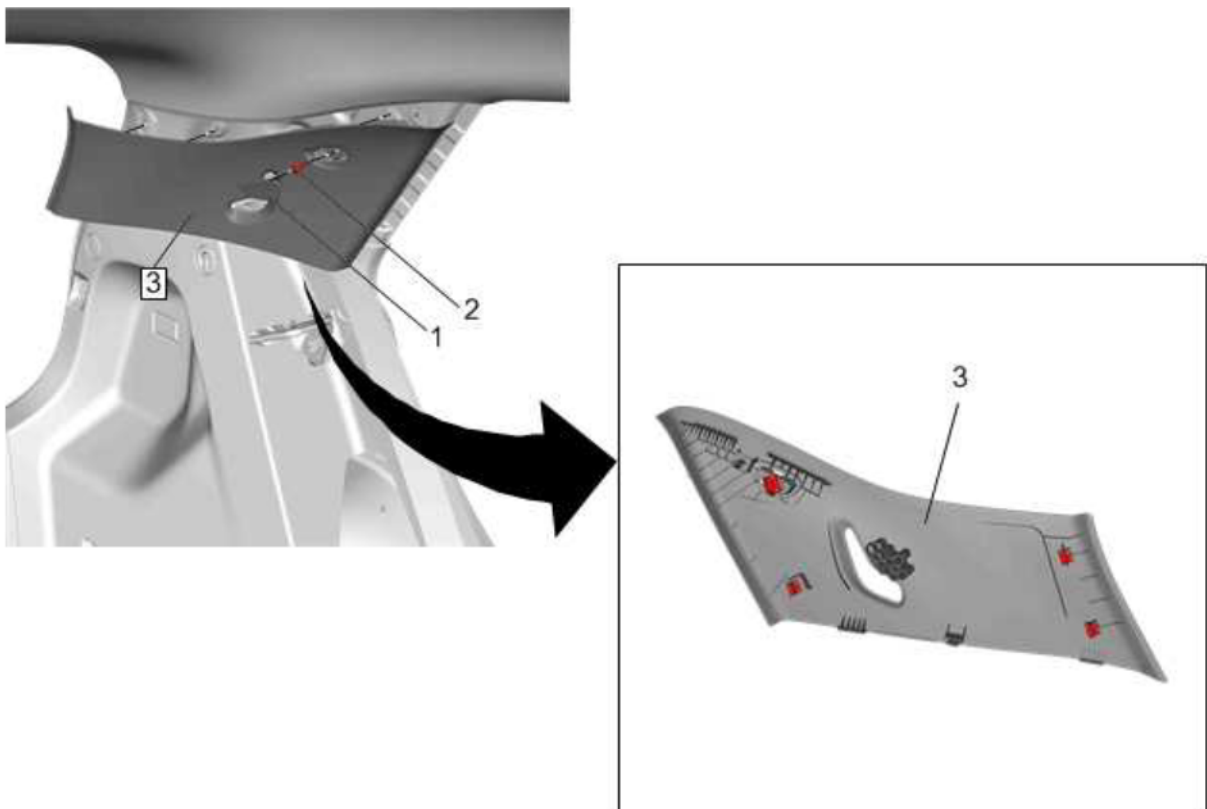
**Fig. 39: Body Lock Pillar Upper Trim Panel**  
 Courtesy of GENERAL MOTORS COMPANY

5. Install the body lock pillar upper trim panel. [Body Lock Pillar Upper Trim Panel Replacement](#)

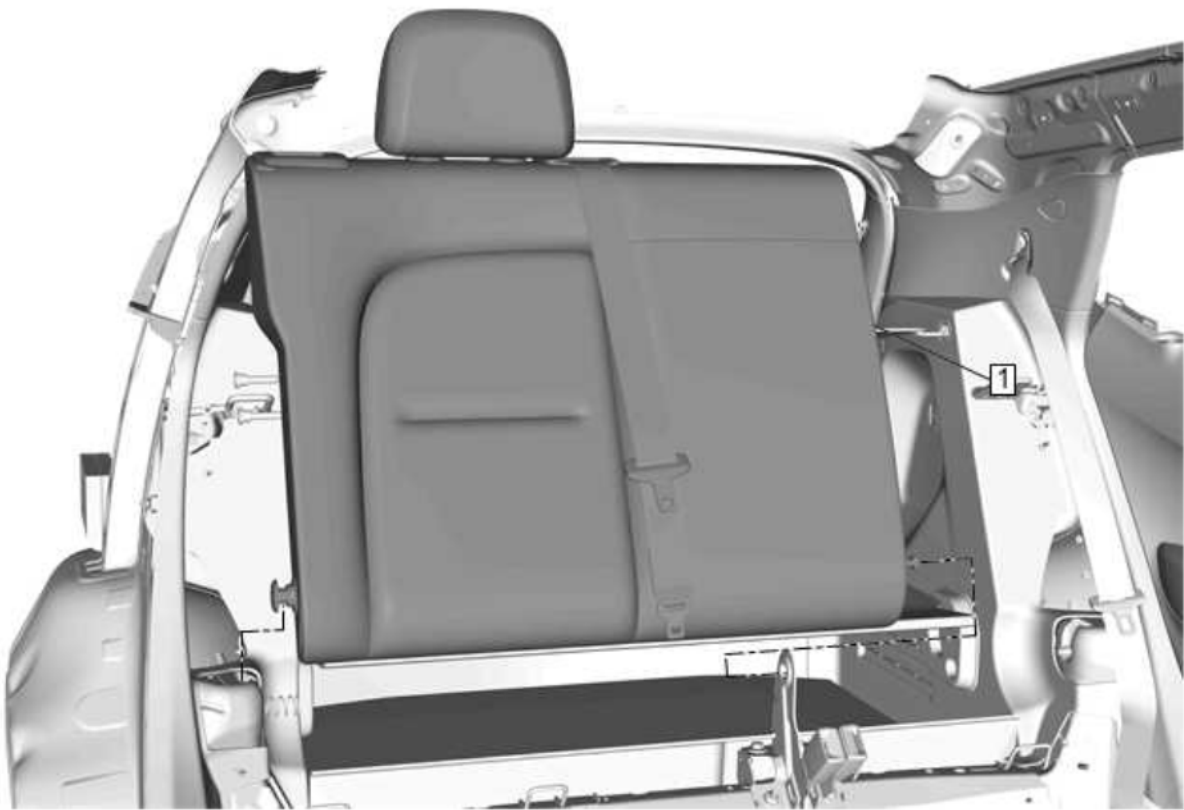
**Fig. 40: Rear Seat Back Cushion**

6. Install the rear seat back cushion. [Rear Seat Back Cushion Removal and Installation \(40%\)](#)  
[Rear Seat Back Cushion Removal and Installation \(60%\)](#)

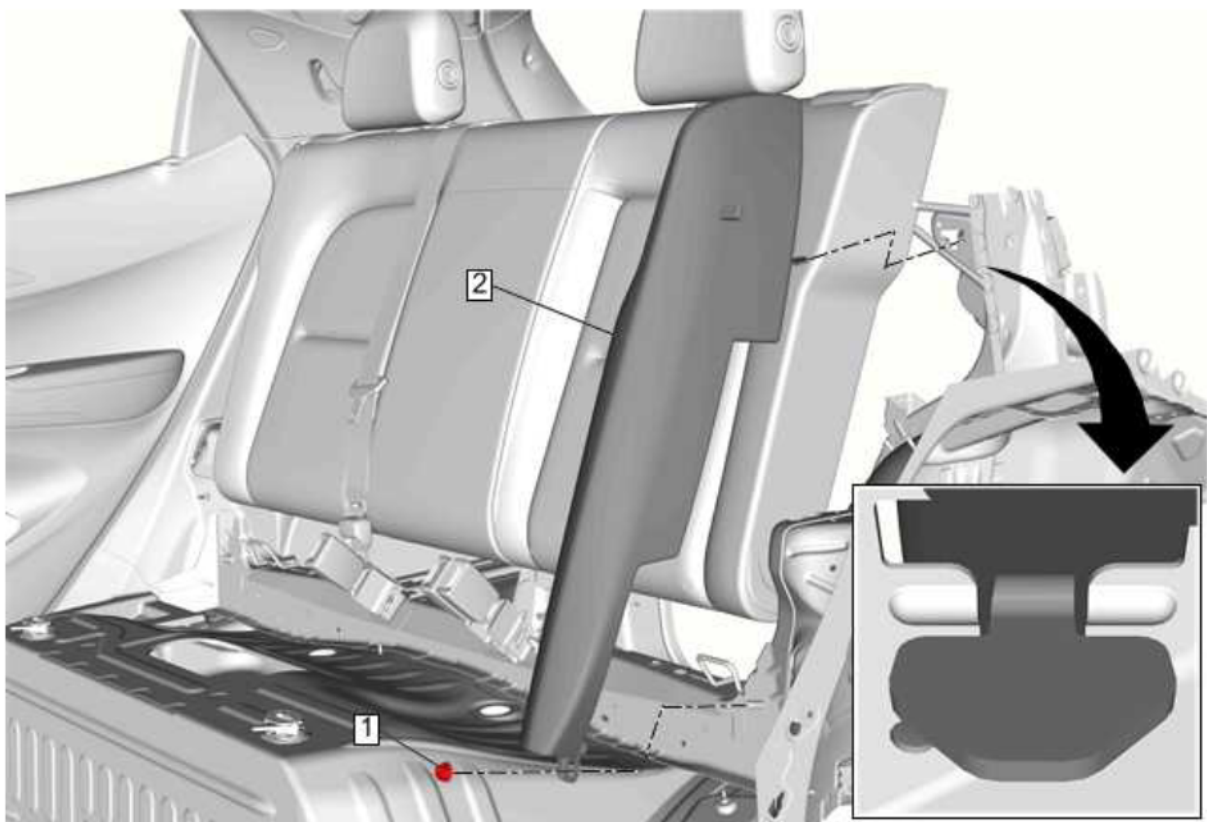
**Fig. 41: Rear Seat Back Bolster**

7. Install the rear seat back bolster. [Rear Seat Back Bolster Replacement](#)

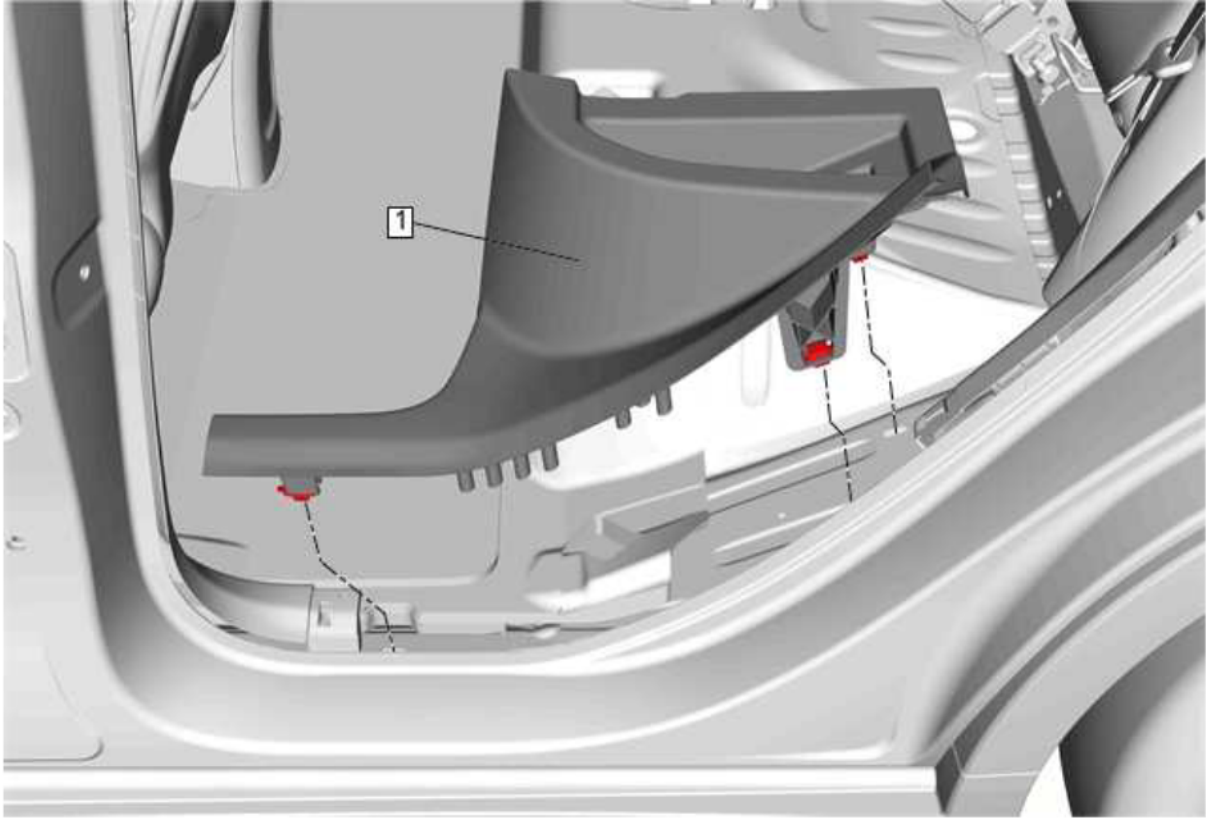
**Fig. 42: Rear Side Door Sill Garnish Molding**  
 Courtesy of GENERAL MOTORS COMPANY

8. Install the rear side door sill garnish molding. [Rear Side Door Sill Garnish Molding Replacement](#)

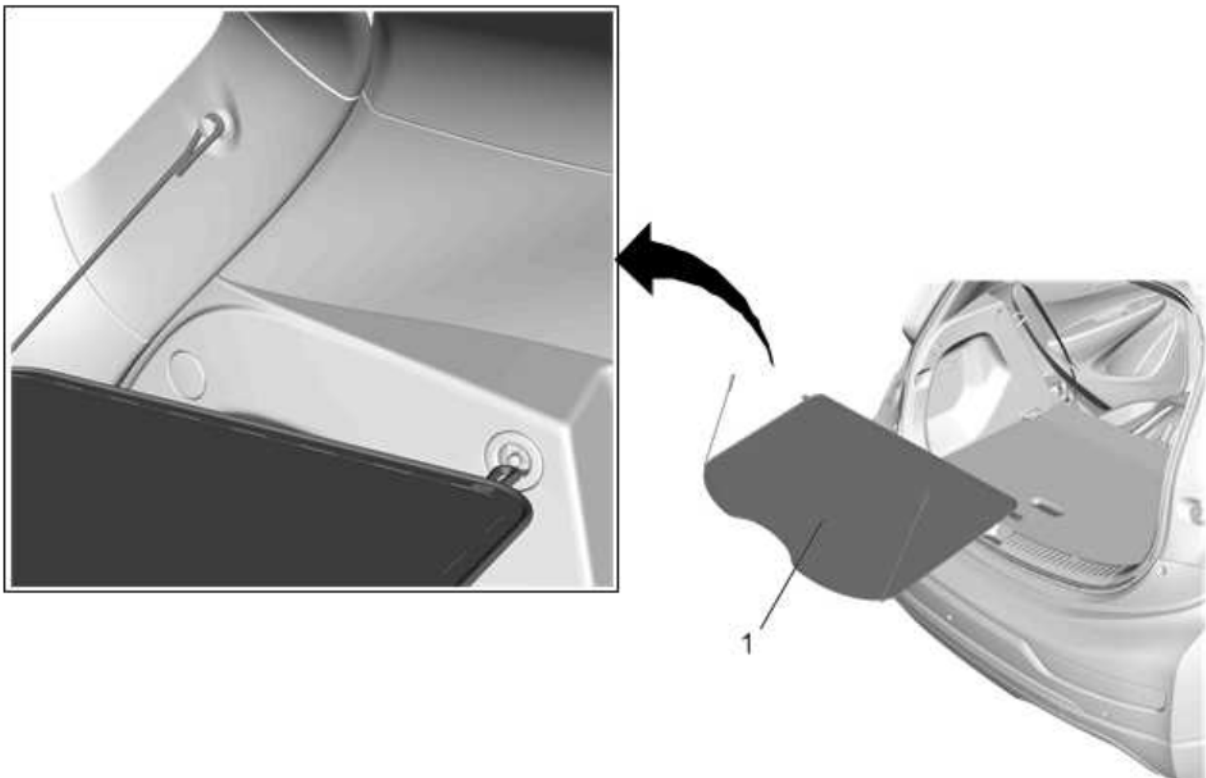
**Fig. 43: Luggage Shade**  
 Courtesy of GENERAL MOTORS COMPANY

9. Install the luggage shade. [Luggage Shade Replacement](#)

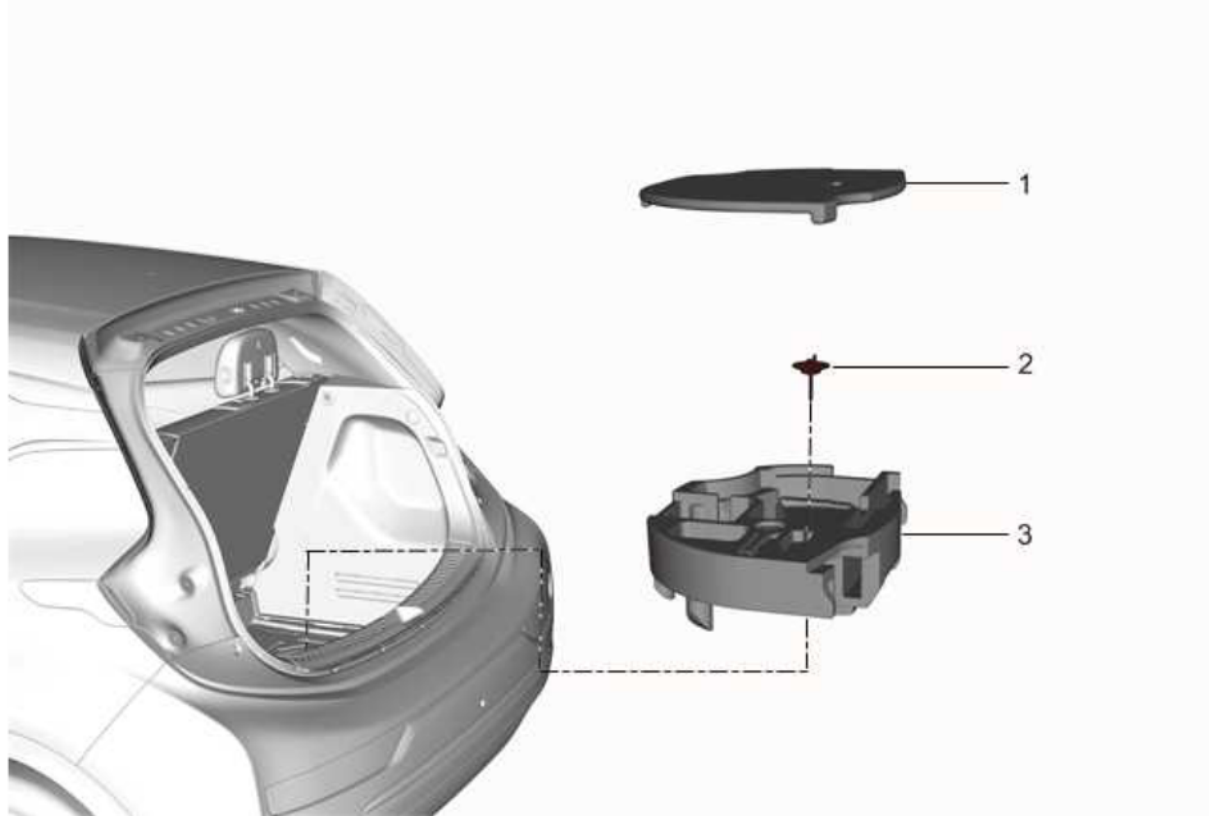
**Fig. 44: Tool Stowage Compartment**  
 Courtesy of GENERAL MOTORS COMPANY

| Callout | Component Name |
|---|---|
| 1 | Tool Stowage Compartment Cover |
| 3 | Tool Stowage Compartment<br><b>Procedure</b><br>Transfer components as necessary. |

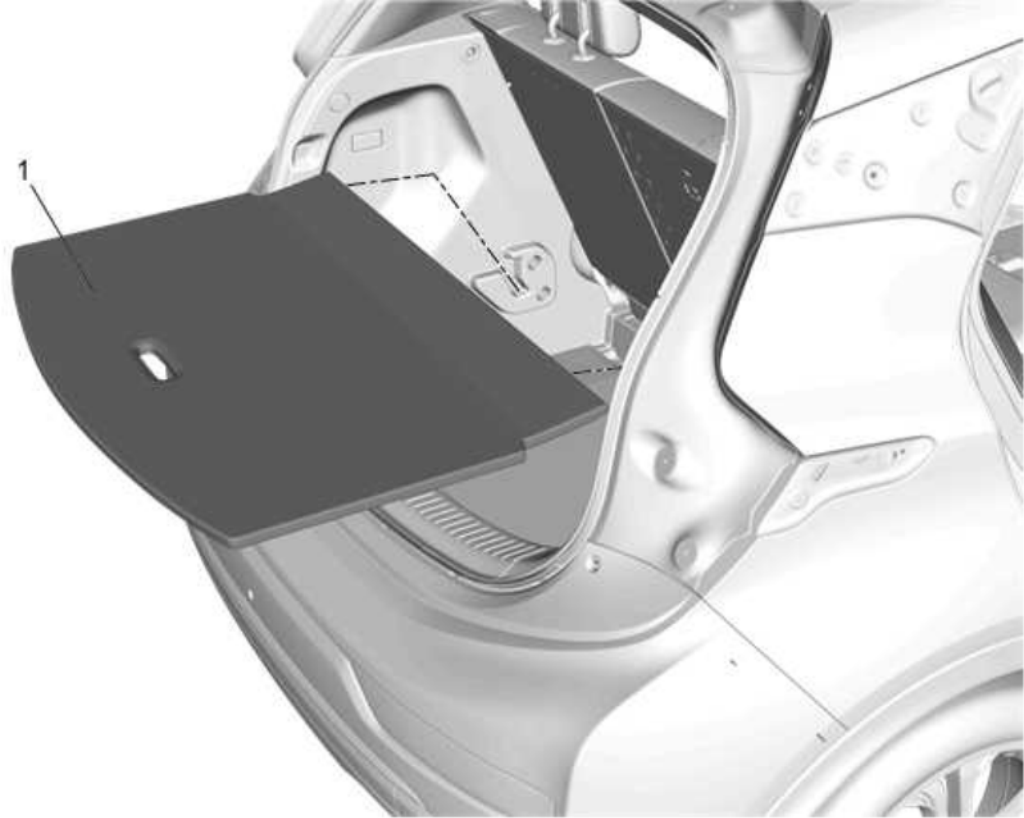
**Fig. 45: Rear Compartment Stowage Shelf**  
 Courtesy of GENERAL MOTORS COMPANY

| Callout | Component Name |
|---|---|
| 1 | Rear Compartment Stowage Shelf |

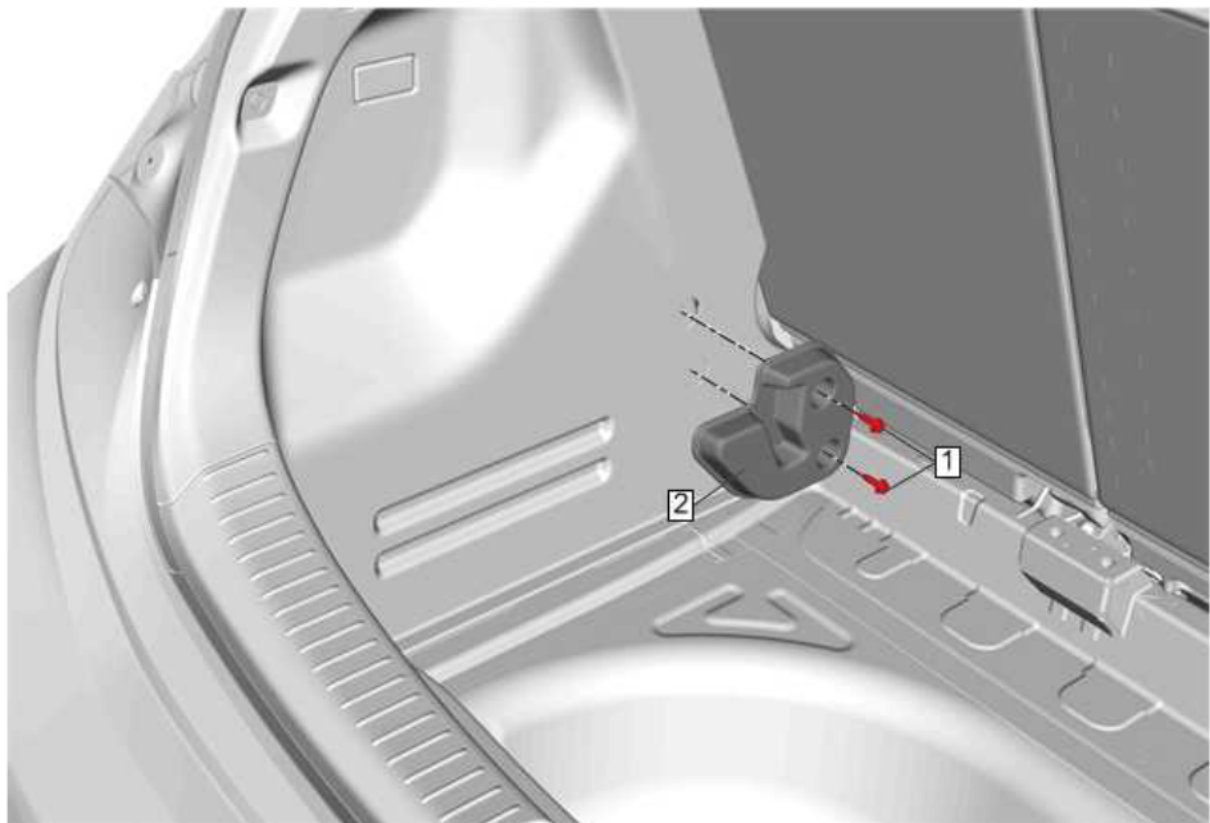
**Fig. 46: Load Floor Stowage Compartment Cover Support**  
 Courtesy of GENERAL MOTORS COMPANY

| Callout | Component Name |
|---|---|
| 2 | Load Floor Stowage Compartment Cover Support |

| Application | Specification |
|---|---|
| Load Floor Stowage Compartment Cover Support Bolt | 5 N.m (44 lb in) |

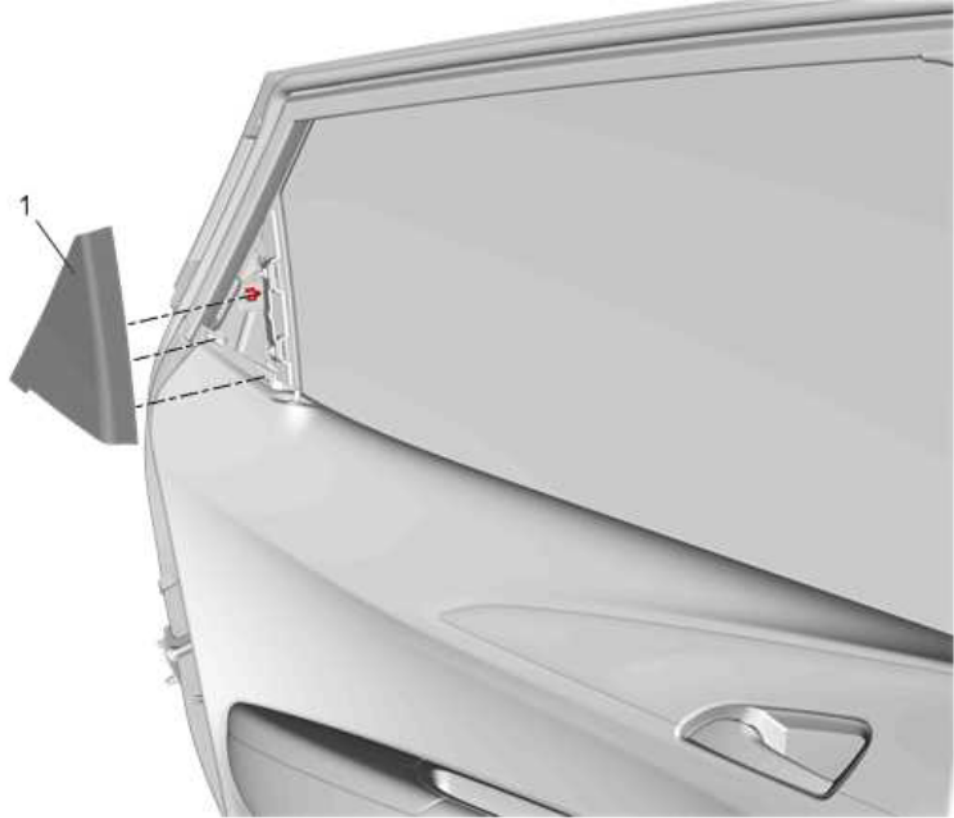
**Fig. 48: Rear Side Door Upper Rear Trim Panel**

1. Remove the rear side door upper rear trim panel. **Rear Side Door Upper Rear Trim Panel Replacement**

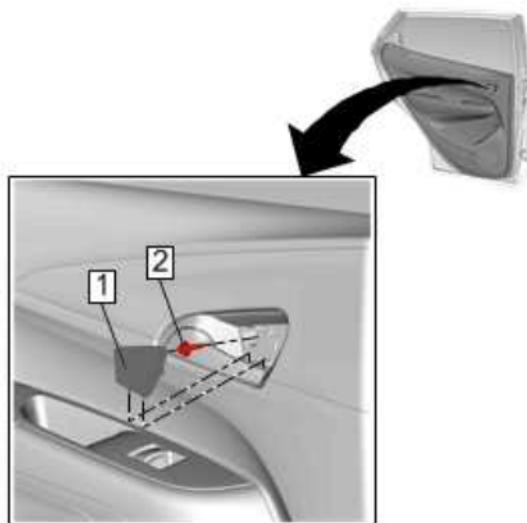
**Fig. 49: Rear Side Door Inside Handle Fastener Finish Cap**

2. Remove the rear side door inside handle fastener finish cap (1).
3. Remove the rear side door inside handle fastener (2).

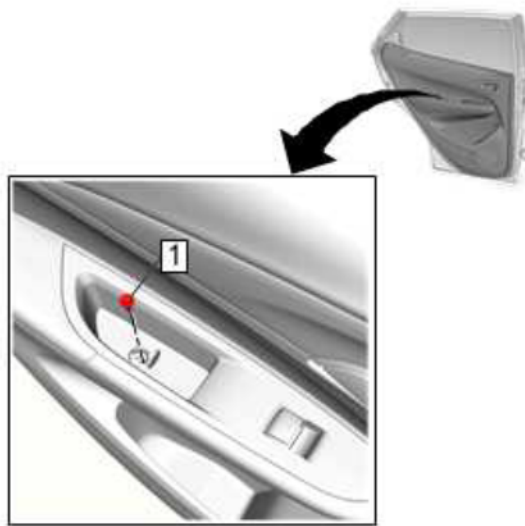
**Fig. 50: Rear Side Door Armrest Pull Cup Fastener Cap**  
 Courtesy of GENERAL MOTORS COMPANY

4. Use a flat bladed plastic trim tool to release the rear side door armrest pull cup fastener cap.
5. Remove the rear side door armrest pull cup fastener (1).

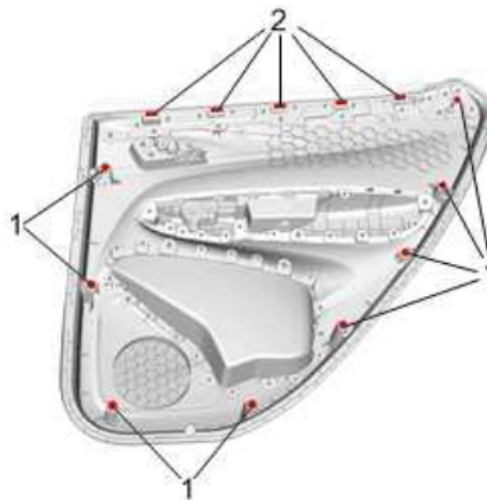
**Fig. 51: Door Trim Panel Retainer**  
 Courtesy of GENERAL MOTORS COMPANY

6. Use a appropriate plastic trim tool loosen the retainer (1) (Qty: 8) along the bottom of the door trim panel.
7. When the panel is sufficiently loosened, grasp with both hands and lift up and release the belt line clip (2) (Qty: 5) with the belt molding.
8. Disconnect the door lock retainer cable from the door trim panel and the inside handle.
9. Disconnect the electrical connector.

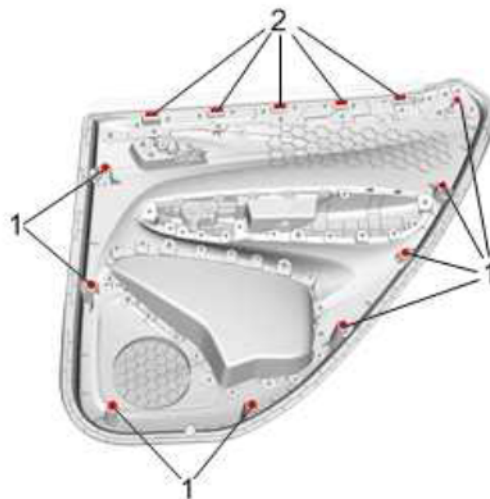
**Fig. 53: Door Trim Panel Retainer**

1. Make sure the belt line clip (2) (Qty: 5) are replaced with new clips before re-attaching the door trim, even if they weren't damaged.
2. Install the belt molding to the rear side door trim assembly.
3. The retainer (1) (Qty: 8) that are destroyed during removal must be replaced with new retainers to properly reattach the door trim.

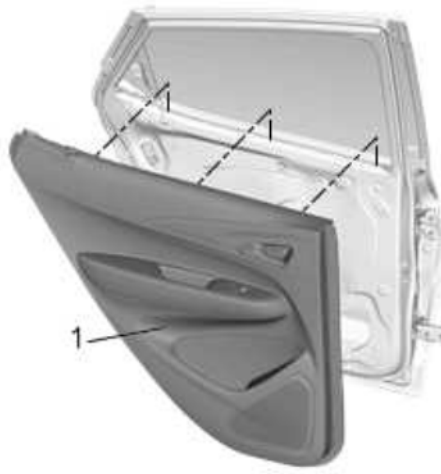
**Fig. 54: Rear Side Door Trim**

4. Connect the electrical connector.
5. Connect the door lock retainer cable to the door trim panel and the inside handle.
6. Install the rear side door trim (1)

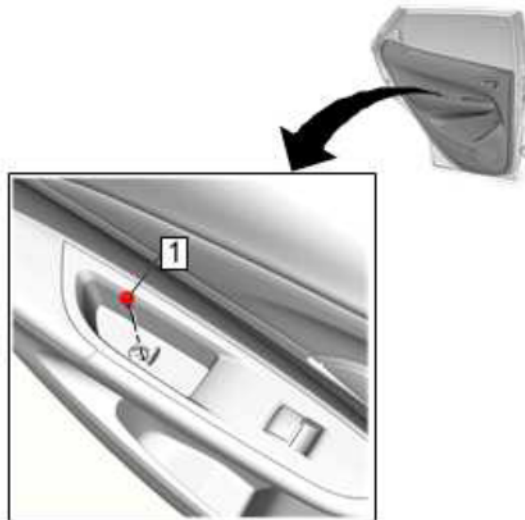
**Fig. 55: Rear Side Door Armrest Pull Cup Fastener Cap**

7. Rear Side Door Armrest Pull Cup Fastener (1) - Install and tighten to 2.5 N.m (22 lb in)
8. Install the rear side door armrest pull cup fastener cap.

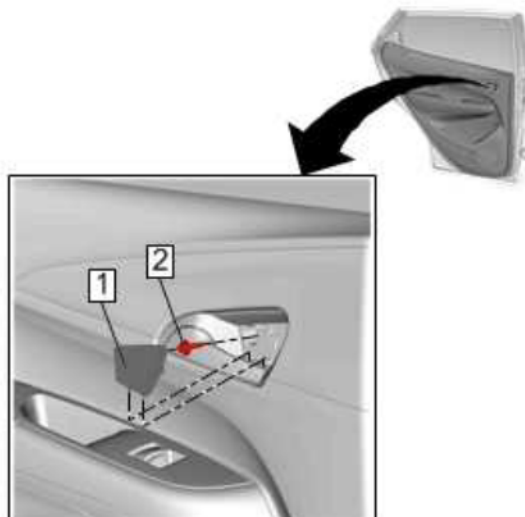
**Fig. 56: Rear Side Door Inside Handle Fastener Finish Cap**  
Courtesy of GENERAL MOTORS COMPANY

9. Rear Side Door Inside Handle Fastener (2) - Install and tighten to 2.5 N.m (22 lb in)
10. Install the rear side door inside handle fastener finish cap (1).

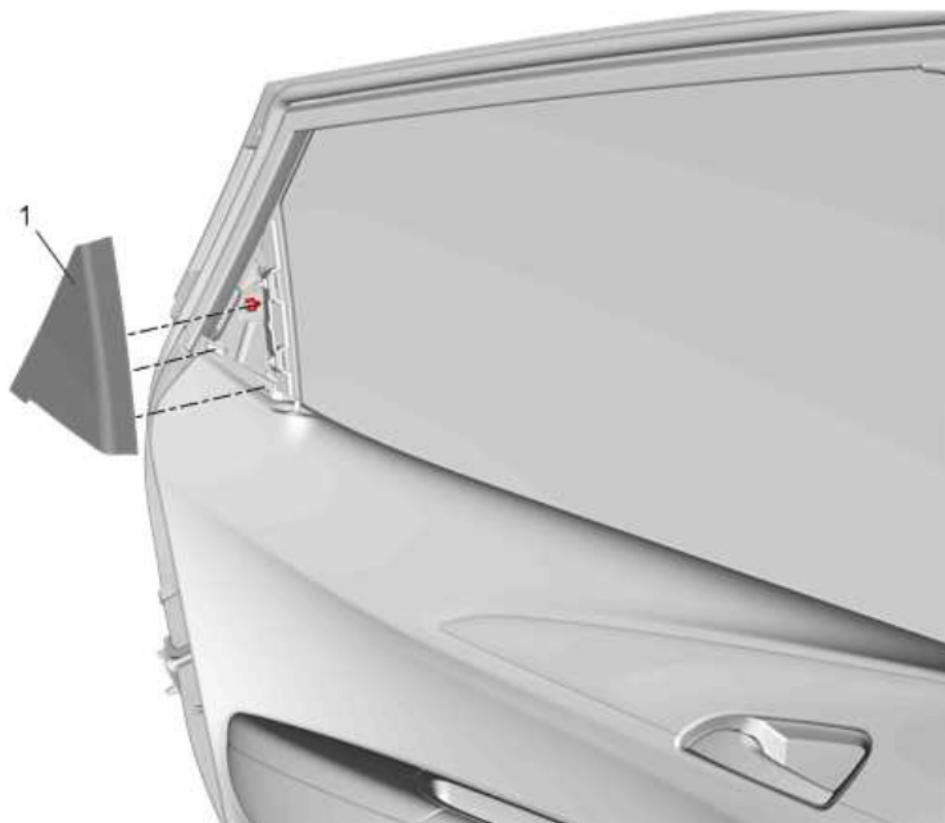
**Fig. 57: Rear Side Door Upper Rear Trim Panel**  
Courtesy of GENERAL MOTORS COMPANY

11. Install the rear side door upper rear trim panel. [Rear Side Door Upper Rear Trim Panel Replacement](#)
