## 2017 ACCESSORIES AND EQUIPMENT

### Interior Trim and Paneling - Bolt EV

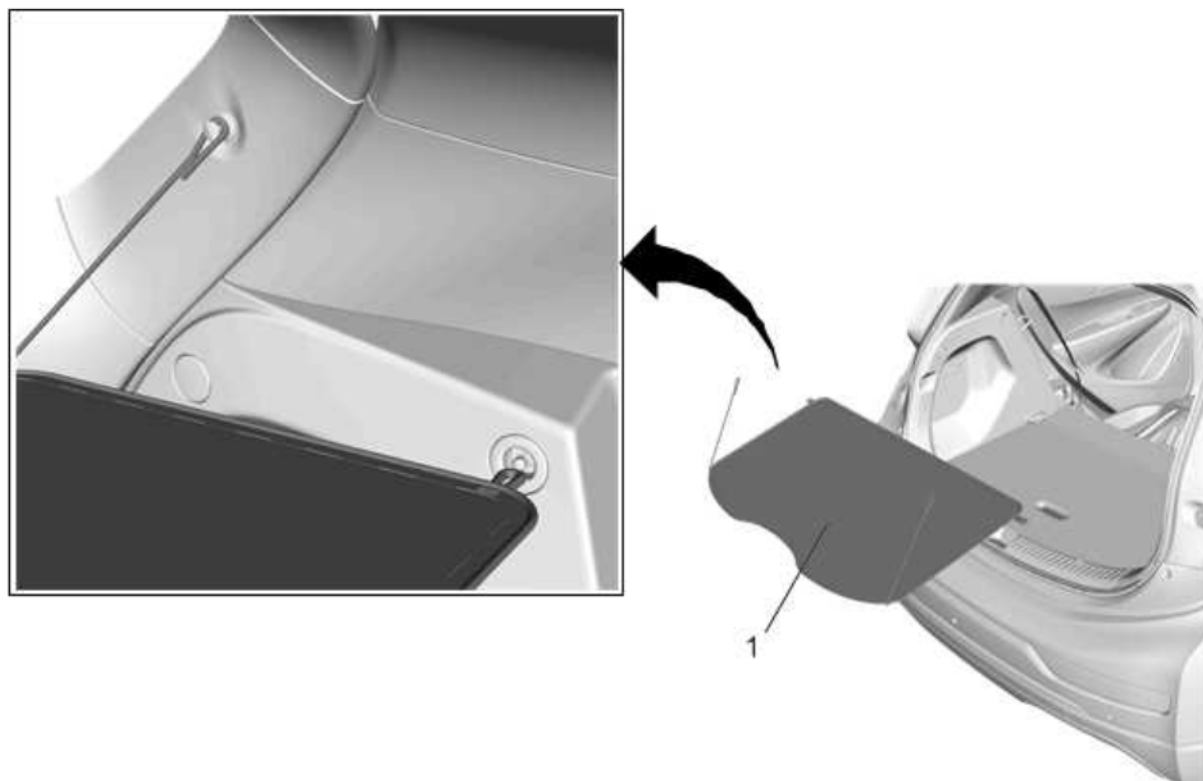
**Fig. 58: Luggage Shade**  
 Courtesy of GENERAL MOTORS COMPANY

| Callout | Component Name |
|---|---|
| 1 | Luggage Shade<br><b>Procedure</b><br>Release the luggage shade straps from the cargo screen retainers. |

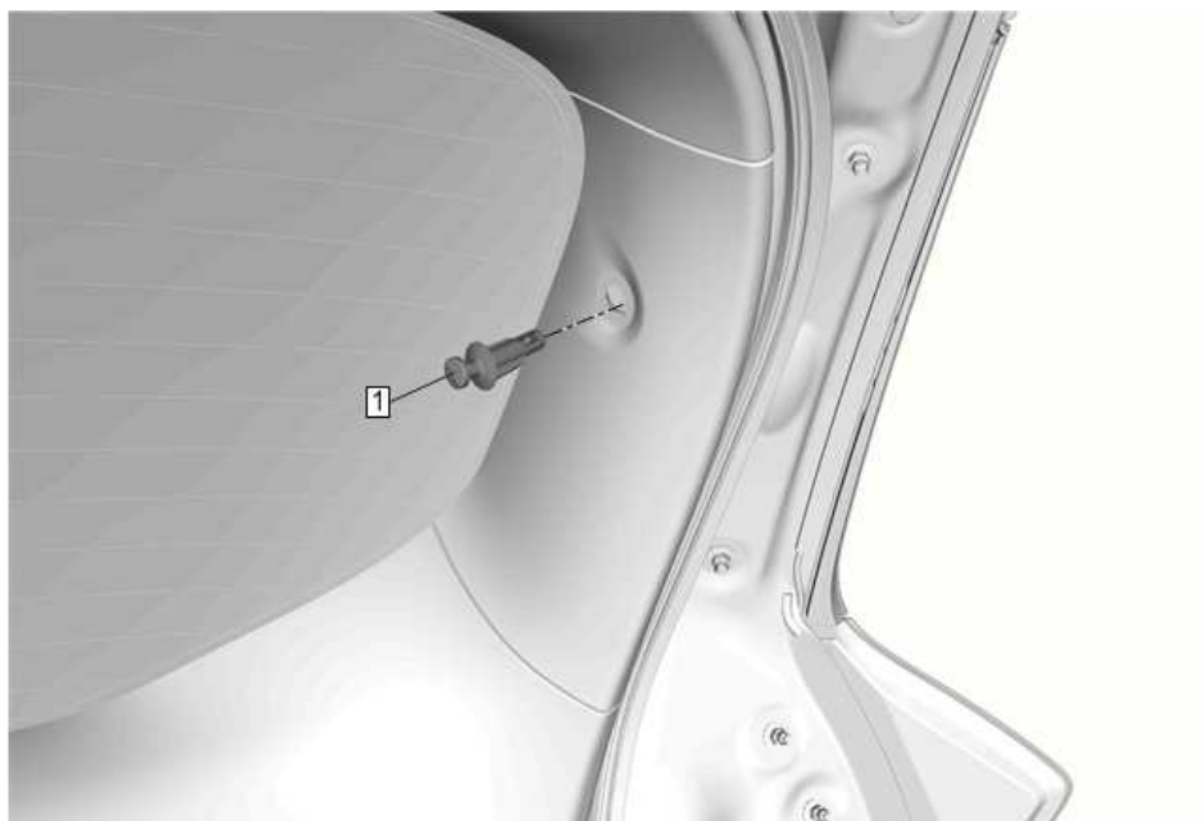
**Fig. 59: Luggage Shade Pivot**  
 Courtesy of GENERAL MOTORS COMPANY

| Callout | Component Name |
|---|---|
| 1 | Luggage Shade Pivot<br><b>Procedure</b><br>Release the luggage shade strap.<br><br><b>NOTE:</b><br>The luggage shade pivots are a one-time use component and will break upon removal. |

| Application |
|---|
| Luggage Shade Pivot |

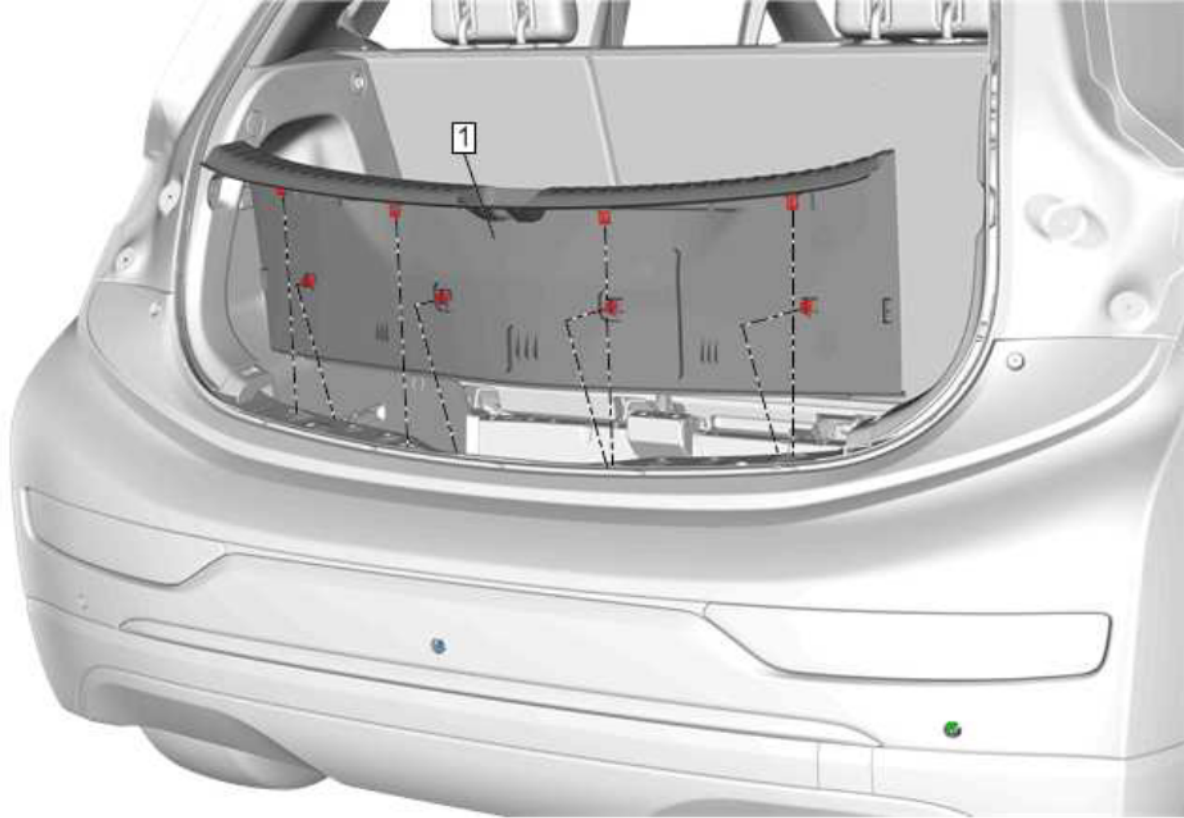
**Fig. 60: Liftgate Sill Garnish Molding**  
Courtesy of GENERAL MOTORS COMPANY

| Callout | Component Name |
|---|---|
| 1 | Liftgate Sill Garnish Molding<br><b>Procedure</b><br>Grasp and gently pull inward on the bottom of the panel to release the lower retainers and then up on the rear end trim finish panel in order to release the integral retaining clips. |

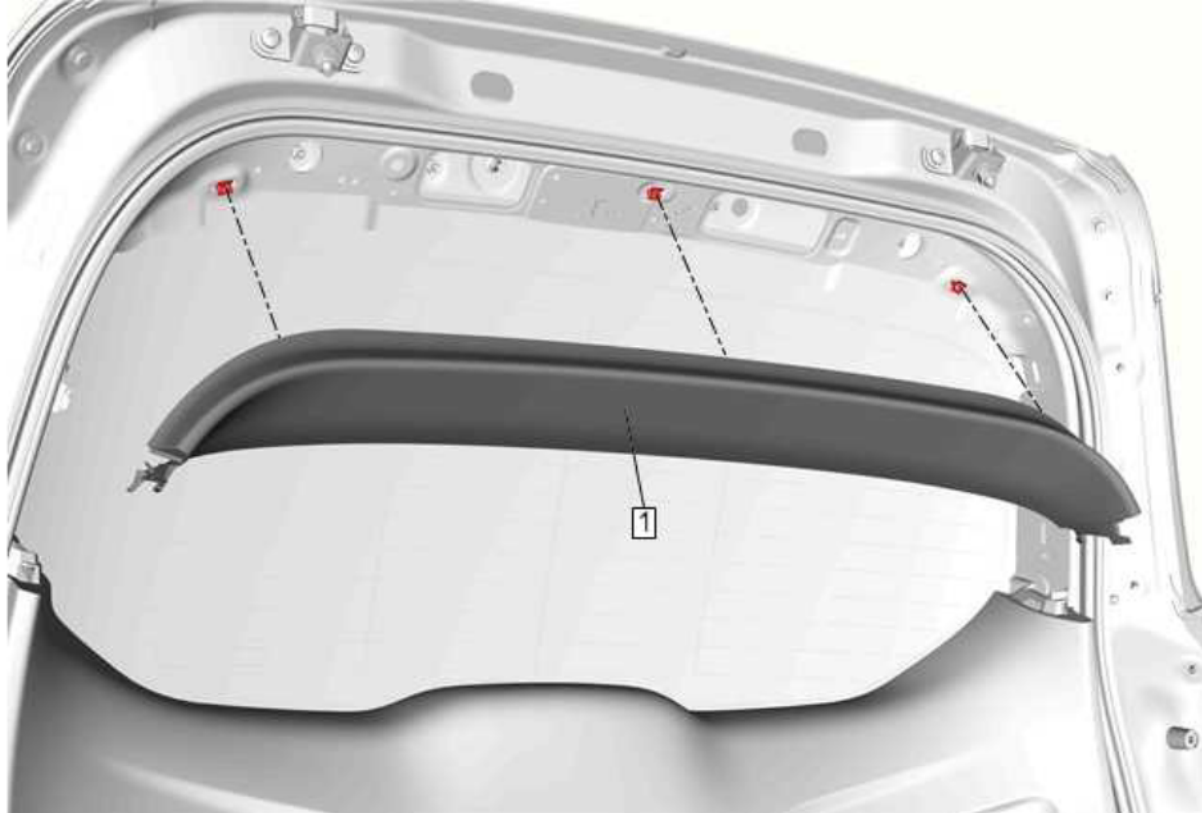
**Fig. 61: Liftgate Upper Center Trim Finish Panel**

| Callout | Component Name |
|---|---|
| 1 | Liftgate Upper Center Trim Finish Panel |

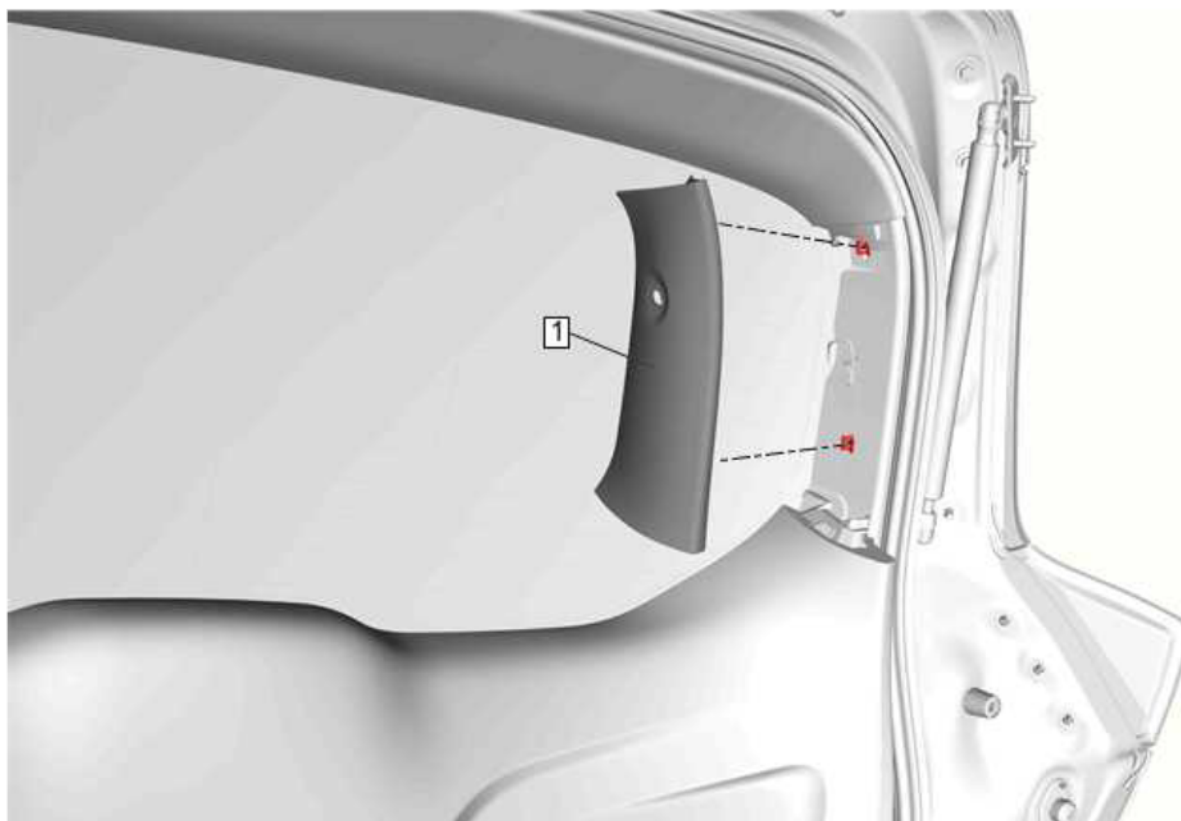
**Fig. 62: Liftgate Upper Side Trim Finish Panel**

| Callout | Component Name |
|---|---|
| 1 | Liftgate Upper Side Trim Finish Panel |

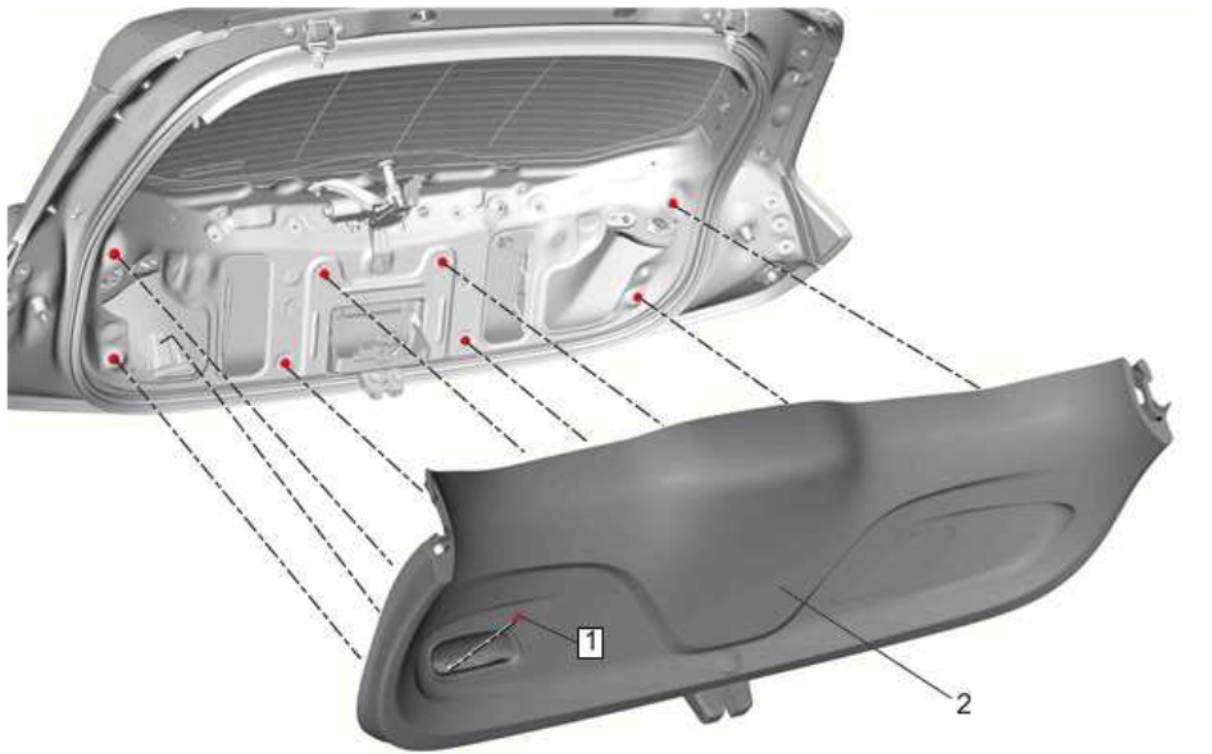
Fig. 63: Liftgate Lower Trim Finish Panel  
Courtesy of GENERAL MOTORS COMPANY

| Callout | Component Name |
|---|---|
| 2 | Liftgate Lower Trim Finish Panel<br><br><b>Procedure</b> <ol style="list-style-type: none"> <li>1. Use a trim panel removal tool to aid in the removal of the trim panel from the liftgate assembly.</li> <li>2. Start at the top clip on the right-hand side of liftgate lower trim finish panel.</li> </ol> |
