**ACCESSORIES & EQUIPMENT****Luggage Rack and Roof Trim - Escalade, Suburban, Tahoe, Yukon****SPECIFICATIONS****FASTENER SPECIFICATIONS**

**REPAIR INSTRUCTIONS****LUGGAGE CARRIER SIDE RAIL REPLACEMENT (SHORT WHEELBASE, BUILT PRIOR TO 9/1/2014)**

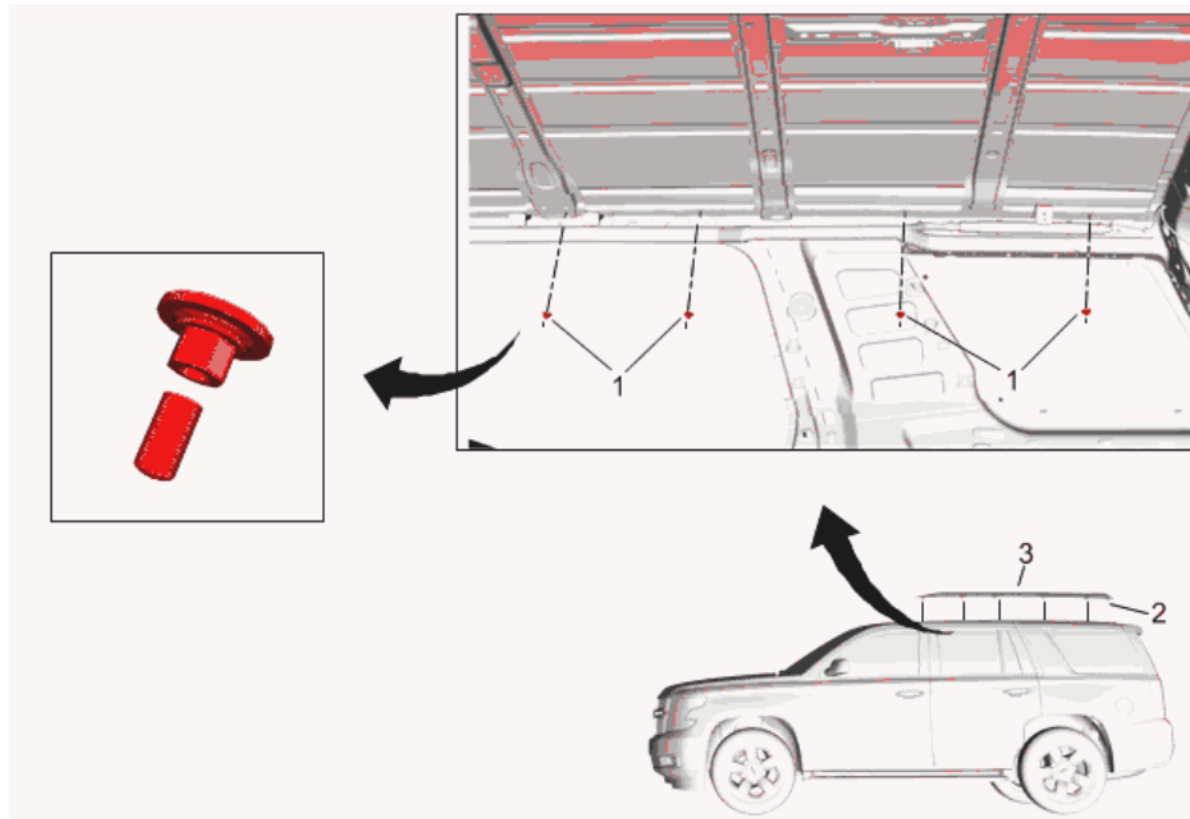
**Fig. 1: Luggage Carrier Side Rail (Short Wheelbase, Built Prior to 9/1/2014)**

| Callout | Component Name |
|---|---|
| 1 | Luggage Carrier Side Rail Nut (Qty: 4)<br><br><b>CAUTION:</b><br><b>Refer to</b><br><b><u>Fastener</u></b><br><b><u>Caution</u></b> . |

| Callout | Component Name |
|---|---|
| | <p><b>Procedure</b></p> <ol style="list-style-type: none"> <li>1. The fasteners are located on the underside of the side rail.</li> <li>2. Clean all traces of the old gasket seal from all the fastener hole. Use a 50/50 mixture of isopropyl alcohol and water.</li> <li>3. Ensure that the new side rail nuts have a gasket seal applied. This will prevent water leaks.</li> <li>4. Ensure that the cap is replaced with the nut to cover the stud completely.</li> </ol> <p><b>Tighten</b><br/>9 N.m (80 lb in)</p> |
| 2 | Luggage Carrier Side Rail Retainer (Qty: 2) |
| 3 | <p>Luggage Carrier Side Rail</p> <p><b>Procedure</b></p> <ol style="list-style-type: none"> <li>1. Transfer all necessary components.</li> <li>2. Water test the vehicle for leaks on the side rail that was replaced, install the headliner.</li> </ol> |

| Callout | Component Name |
|---|---|
| <b>Preliminary Procedure</b><br>It is only necessary to lower the headliner. Only do those steps in the headliner replacement procedure that will lower the headliner enough to gain access to the part. Refer to <b><u>Headlining Trim Panel Replacement (Standard Wheelbase)</u></b> . | |

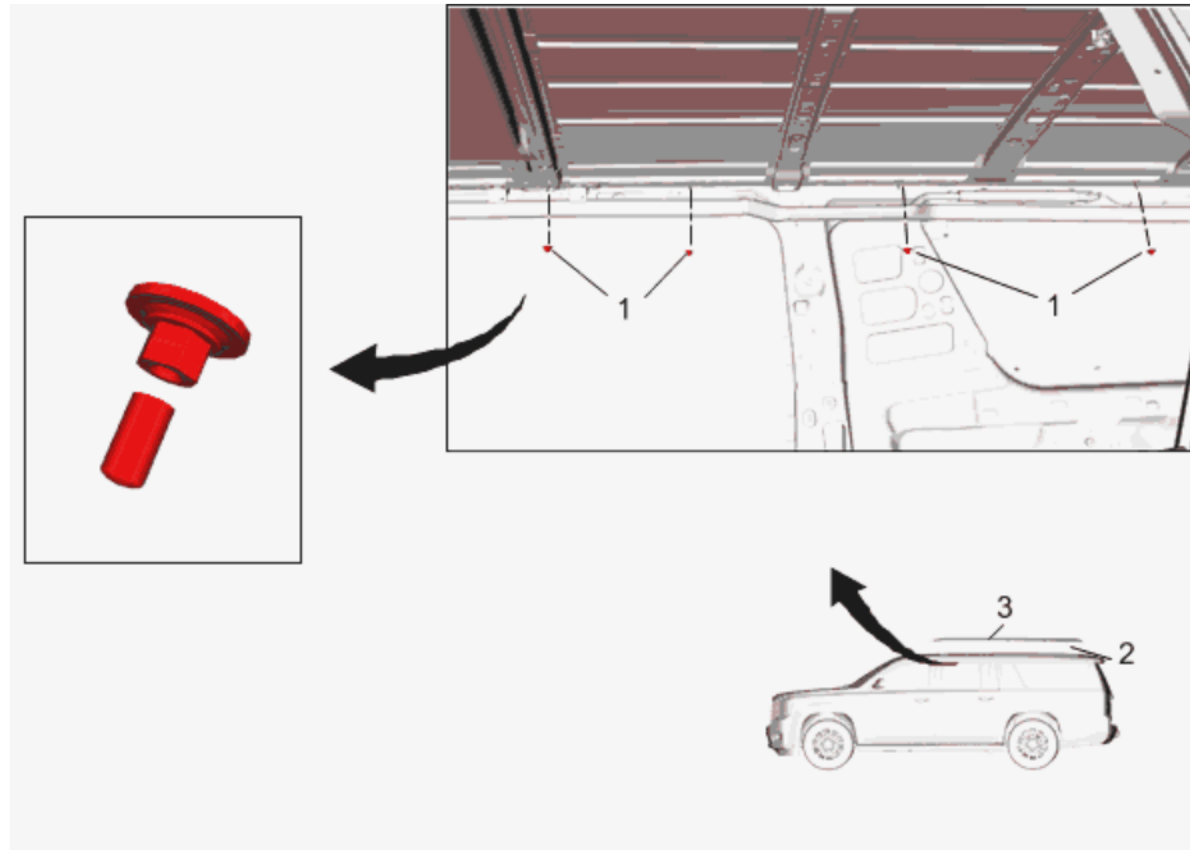
**Fig. 2: Luggage Carrier Side Rail (Long Wheelbase, Built Prior to 9/1/2014)**

| Callout | Component Name |
|---|---|
| 1 | Luggage Carrier Side Rail Nut (Qty: 5)<br><br><b>CAUTION:</b><br>Refer to <a href="#">Fastener</a> |

| Callout | Component Name |
|---|---|
| | <p><b><u>Caution</u></b> .</p> <p><b>Procedure</b></p> <ol style="list-style-type: none"> <li>1. The fasteners are located on the underside of the side rail.</li> <li>2. Clean all traces of the old gasket seal from all the fastener hole. Use a 50/50 mixture of isopropyl alcohol and water.</li> <li>3. Ensure that the new side rail nuts have a gasket seal applied. This will prevent water leaks.</li> <li>4. Ensure that the cap is replaced with the nut to cover the stud completely.</li> </ol> <p><b>Tighten</b><br/>9 N.m (80 lb in)</p> |
| 2 | Luggage Carrier Side Rail Retainer (Qty: 2) |
| 3 | <p>Luggage Carrier Side Rail</p> <p><b>Procedure</b></p> <ol style="list-style-type: none"> <li>1. Transfer all necessary components.</li> <li>2. Water test the vehicle for leaks on the side rail that was replaced, install the headliner.</li> </ol> |

| Callout | Component Name |
|---|---|
| <b>Preliminary Procedure</b><br>It is only necessary to lower the headliners. Only do those steps in the headliner replacement procedure that will lower the headliner enough to gain access to the part. Refer to <a href="#">Headlining Trim Panel Replacement (Extended Wheelbase)</a> , and <a href="#">Headlining Rear Trim Panel Replacement</a> . | |

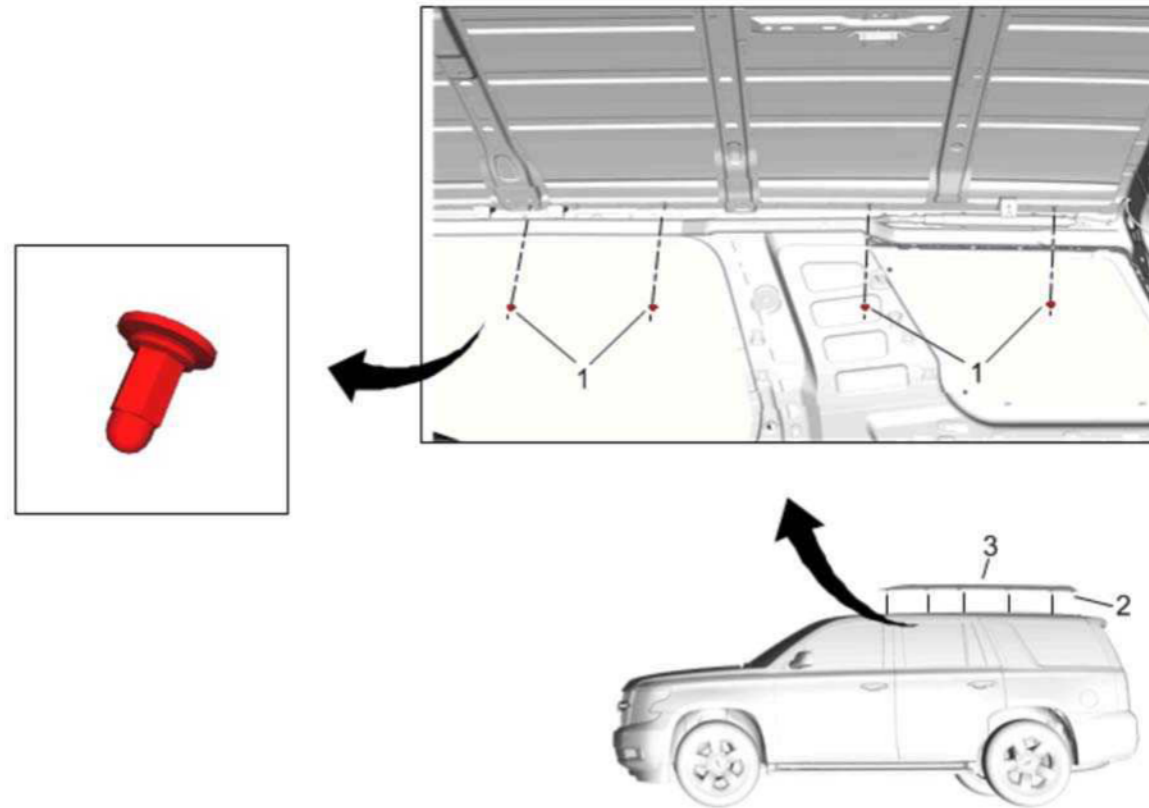
**Fig. 3: Luggage Carrier Side Rail (Short Wheelbase, Built After 9/2/2014)**

| Callout | Component Name |
|---|---|
| 1 | Luggage Carrier Side Rail Nut (Qty: 4)<br><br><b>CAUTION:</b><br>Refer to <a href="#">Fastener Caution</a> . |

| Callout | Component Name |
|---|---|
| | <p><b>Procedure</b></p> <ol style="list-style-type: none"> <li>1. The fasteners are located on the underside of the side rail.</li> <li>2. Clean all traces of the old gasket seal from all the fastener hole. Use a 50/50 mixture of isopropyl alcohol and water.</li> <li>3. Ensure that the new side rail nuts have a gasket seal applied. This will prevent water leaks.</li> </ol> <p><b>Tighten</b><br/>9 N.m (80 lb in)</p> |
| 2 | Luggage Carrier Side Rail Retainer (Qty: 2) |
| 3 | <p>Luggage Carrier Side Rail</p> <p><b>Procedure</b></p> <ol style="list-style-type: none"> <li>1. Transfer all necessary components.</li> <li>2. Water test the vehicle for leaks on the side rail that was replaced, install the headliner.</li> </ol> |

| Callout | Component Name |
|---|---|
| <b>Preliminary Procedure</b><br>It is only necessary to lower the headliner. Only do those steps in the headliner replacement procedure that will lower the headliner enough to gain access to the part. Refer to <a href="#">Headlining Trim Panel Replacement (Standard Wheelbase)</a> . | |

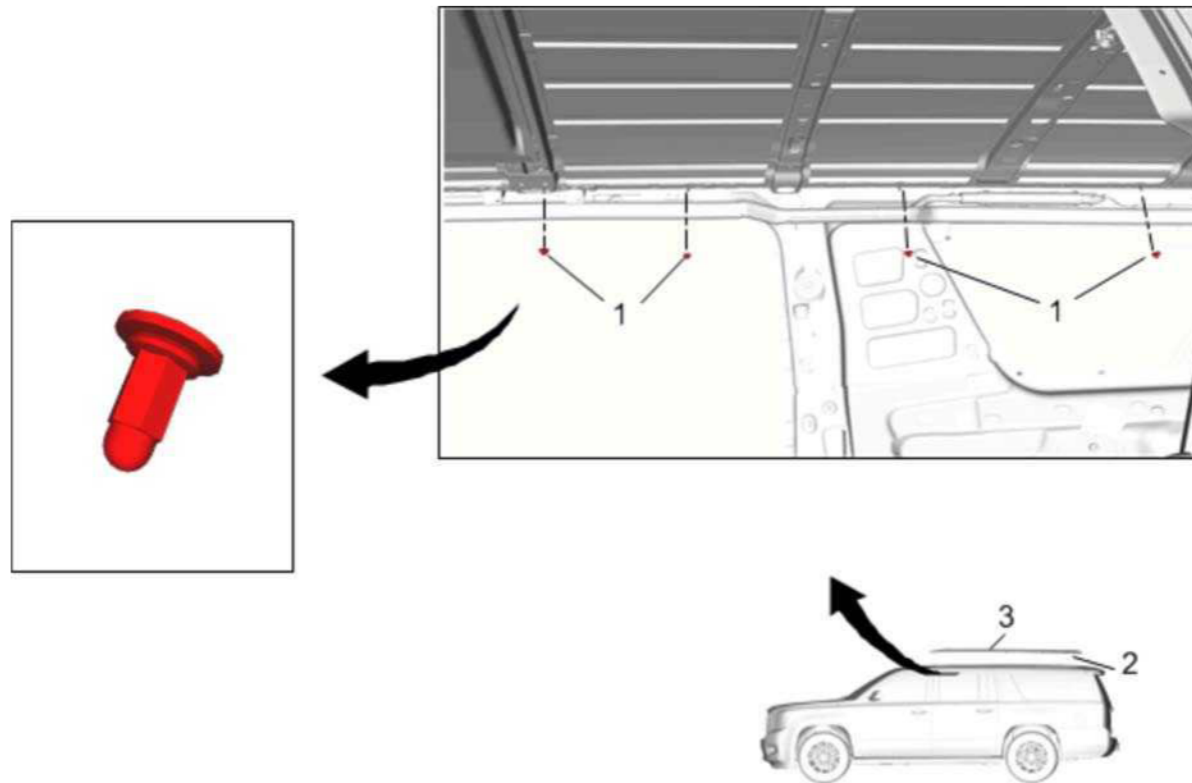
**Fig. 4: Luggage Carrier Side (Long Wheelbase, Built After 9/2/2014)**

| Callout | Component Name |
|---|---|
| 1 | Luggage Carrier Side Rail Nut (Qty: 5)<br><br><b>CAUTION:</b><br>Refer to <a href="#">Fastener</a> |

| Callout | Component Name |
|---|---|
| | <p><b><u>Caution</u></b> .</p> <p><b>Procedure</b></p> <ol style="list-style-type: none"> <li>1. The fasteners are located on the underside of the side rail.</li> <li>2. Clean all traces of the old gasket seal from all the fastener hole. Use a 50/50 mixture of isopropyl alcohol and water.</li> <li>3. Ensure that the new side rail nuts have a gasket seal applied. This will prevent water leaks.</li> </ol> <p><b>Tighten</b><br/>9 N.m (80 lb in)</p> |
| 2 | Luggage Carrier Side Rail Retainer (Qty: 2) |
| 3 | <p>Luggage Carrier Side Rail</p> <p><b>Procedure</b></p> <ol style="list-style-type: none"> <li>1. Transfer all necessary components.</li> <li>2. Water test the vehicle for leaks on the side rail that was replaced, install the headliner.</li> </ol> |

| Callout | Component Name |
|---|---|
| <b>Preliminary Procedure</b><br>It is only necessary to lower the headliners. Only do those steps in the headliner replacement procedure that will lower the headliner enough to gain access to the part. Refer to <a href="#">Headlining Trim Panel Replacement (Extended Wheelbase)</a> , and <a href="#">Headlining Rear Trim Panel Replacement</a> . | |
