# **BRAKE SYSTEM**

## INDUCTION TO BRAKE SYSTEM

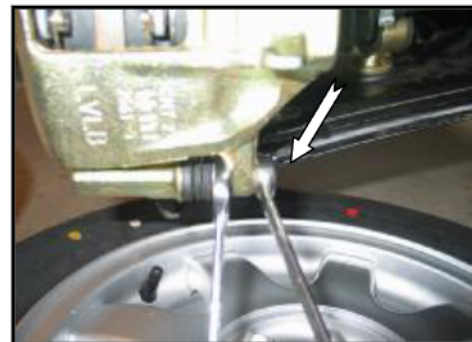
- Lift up the vehicle and remove the front wheel.
- Loosen and remove the fixing bolt (where the arrow points).
- Detach the caliper housing and then remove the brake lining.

- The brake lining with a larger friction surface shall be installed outside when installing the brake block.
- The brake linings on both sides shall be replaced at the same time with the products provided by the same one manufacturer when replacing.
- The tightening torque of securing bolt shall be  $25 \pm 2 \text{ N} \cdot \text{m}$  (as shown in the figure).
- The tightening torque of wheel bolt shall be  $110 \pm 10 \text{ N} \cdot \text{m}$ .
- The brake disc shall be replaced when the wear limit of 10 mm reaches. Remove the caliper housing firstly before replacing the brake disc. Remove the dirt and anti-rust oil on the friction surface of new brake disc before it is installed.

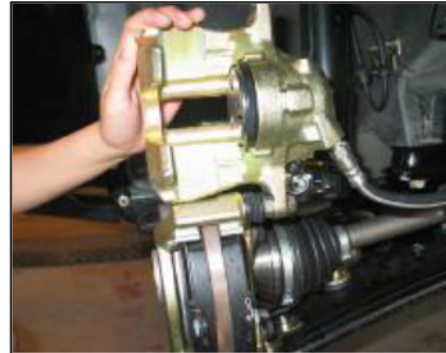
- Lift up the vehicle and remove the front wheel, and then detach the lower fixing bolt of the caliper housing.
- Lift up the brake caliper from the bottom to top, and remove the brake lining (as shown in the figure).

- Press the caliper piston back into the caliper housing. Use a suction hose to pump some fluids out from the brake fluid reservoir if its fluid level is too high before the piston is pressured back, the purpose of which is to prevent the brake fluid from overflowing and damaging the paintwork. Since the brake fluid is corrosive and toxic, it shall be stored in a special plastic bottle or other containers.

- Install the inside brake lining on the brake caliper bracket of the steering knuckle, and then refit the outside brake lining.
- Ensure that the return spring shall be in its proper position when installing the brake caliper; otherwise it may cause the brake noise.

- Tighten the lower fixing bolt of the caliper housing.
- Keep the vehicle in its original position after the completion of installation, and forcefully step on the brake pedal several times so as to make the brake lining in its normal working position.

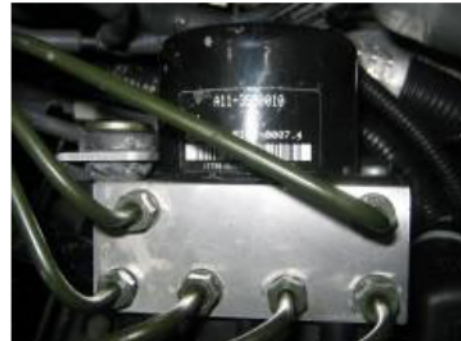
- Remove the whole HECU from its support.
