## REAR SUSPENSION ASSEMBLY

## REMOVAL AND INSTALLATION

## UPPER ARM ASSEMBLY

## TRAILING ARM ASSEMBLY

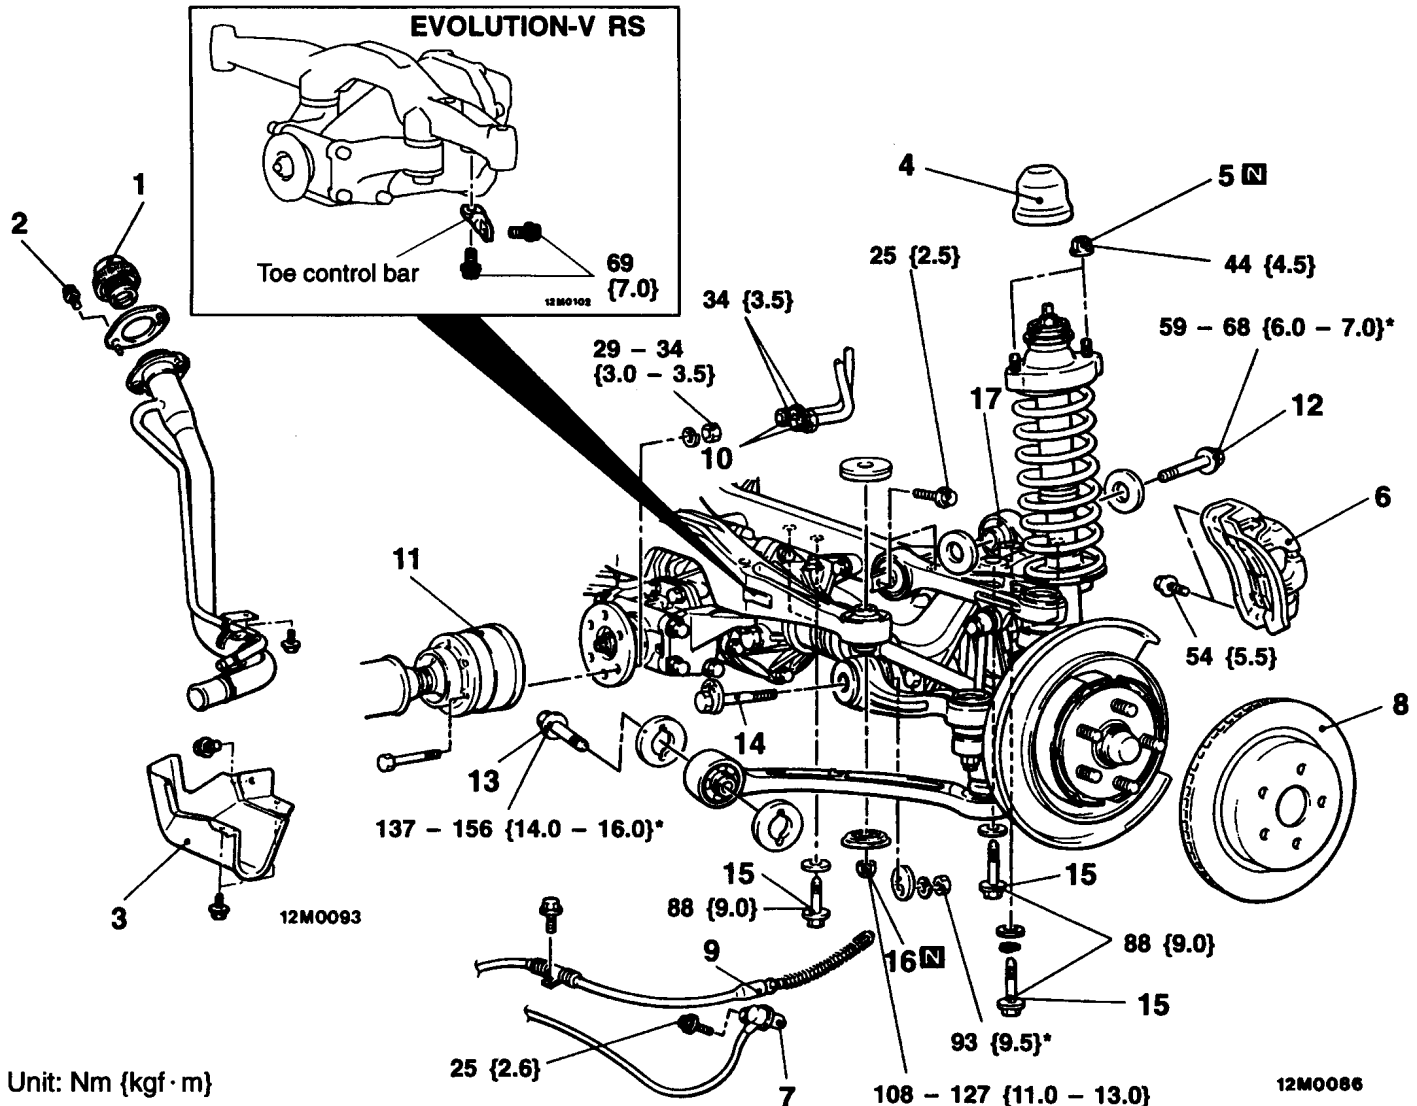
**Removal steps**

1. Fuel filler cap
2. Bolt
3. Filler neck protector
4. Cap
5. Shock absorber mounting nut
6. Brake caliper assembly
7. Rear speed sensor <vehicles with AYC>
8. Brake disc
9. Parking brake cable end (Refer to GROUP 36.)
10. AYC fluid line connection <vehicles with AYC>

11. Propeller shaft connection
12. Upper arm mounting bolt
13. Trailing arm mounting bolt
14. Toe control arm mounting bolt
15. Crossmember mounting bolt
16. Differential support assembly mounting bolt
17. Rear suspension assembly

The parts marked with \* should be first temporarily tightened, then torqued to specification with the vehicle on the ground in unloaded condition.

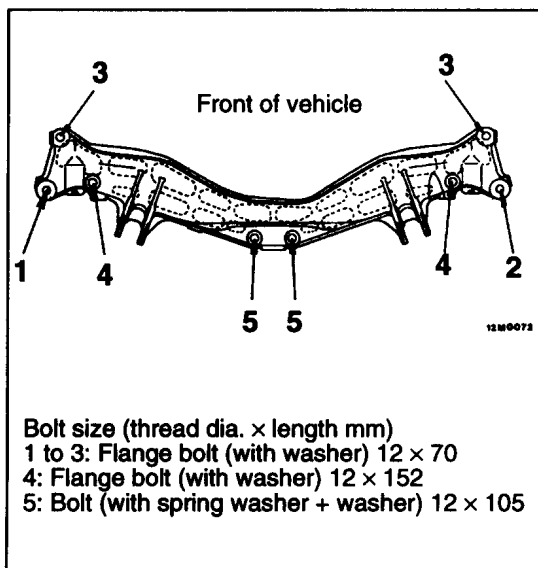
### ▶A◀ CROSSMEMBER MOUNTING BOLT INSTALLATION

Tighten the mounting bolts in the numerical order shown.

To ensure both good installation accuracy and ease of installation, the crossmember mounting holes have different diameters between front and rear. This is the reason for specifying the tightening sequence of the mounting bolts.

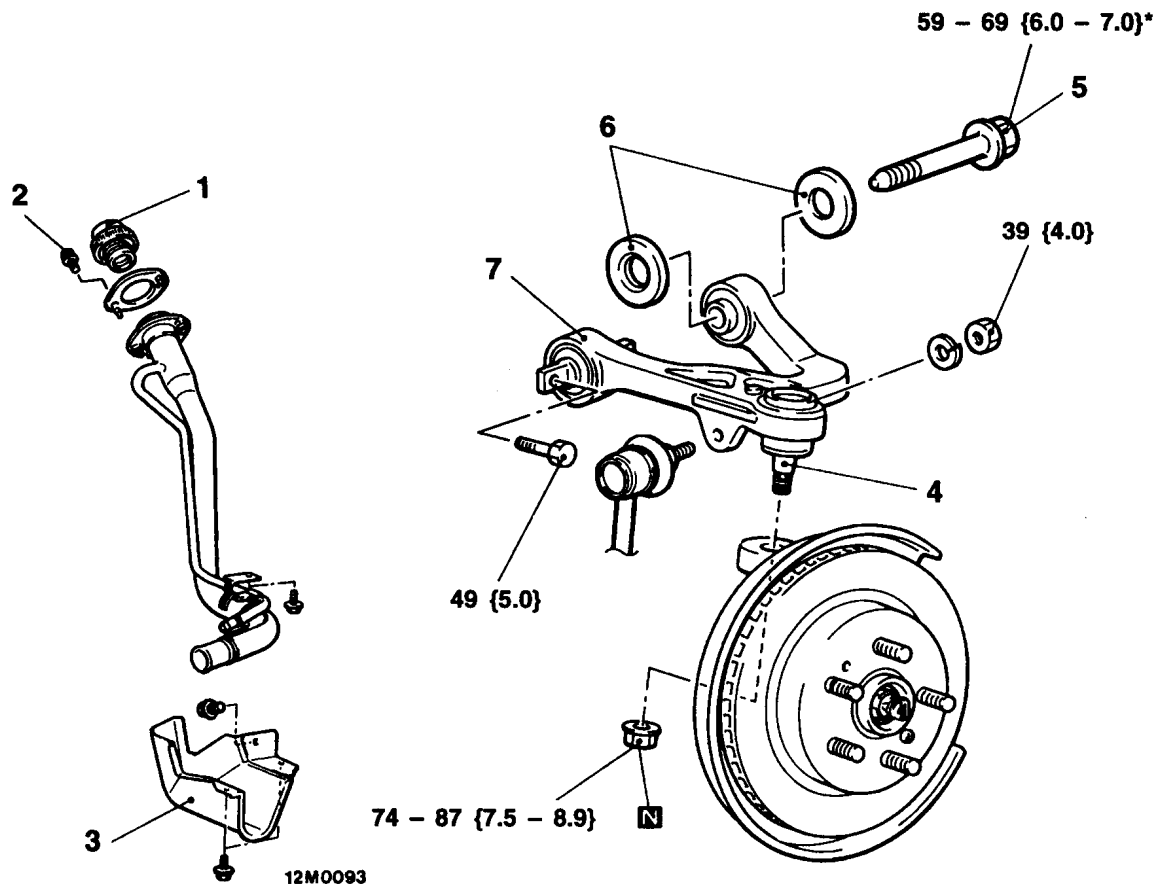
**Removal steps**

1. Fuel filler cap\*
2. Bolt\*
3. Filler neck protector\*
4. Upper arm assembly to knuckle coupling
5. Upper arm assembly mounting bolt
6. Stopper
7. Upper arm assembly

Parts marked with \* apply only when RH side is removed and installed.

The part marked with \* should be first temporarily tightened, then torqued to specification with the vehicle on the ground in unloaded condition.

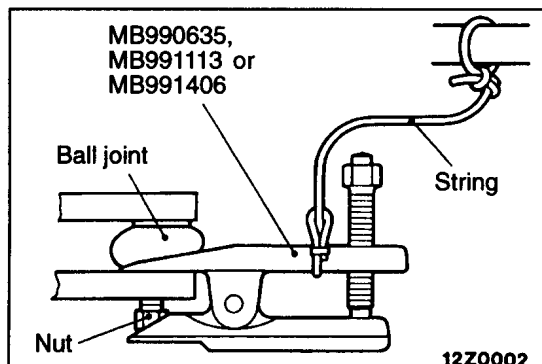
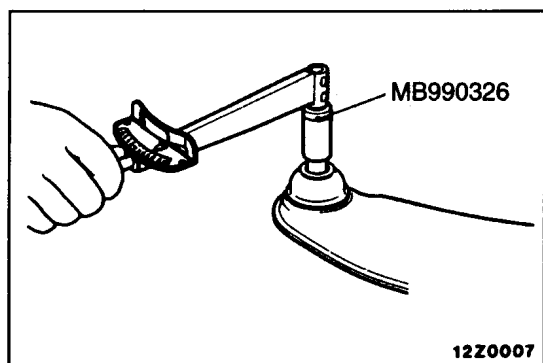
**REMOVAL SERVICE POINT****◀▶ UPPER ARM ASSEMBLY DISCONNECTION FROM KNUCKLE****Caution**

- (1) Only loosen the nut, and not remove it from the ball joint, and use the special tool.
- (2) Hang the special tool with a string to prevent the parts including the tool from falling apart.

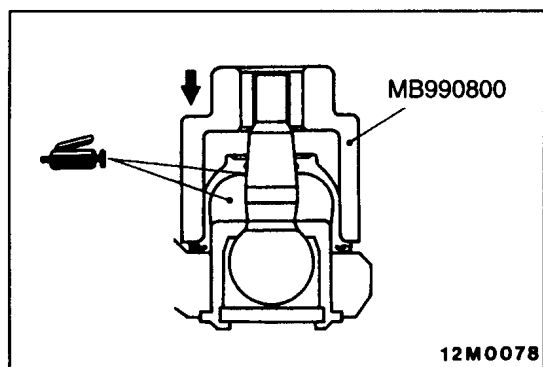
## UPPER ARM BALL JOINT DUST COVER REPLACEMENT

- (1) Remove the dust cover.
- (2) Pack and apply the specified grease to the inside and lips of the dust cover.

- (3) Using the special tool, press the dust cover until it contacts the snap ring.
- (4) Push the dust cover with a finger to ensure that it is free from cracks or damage.

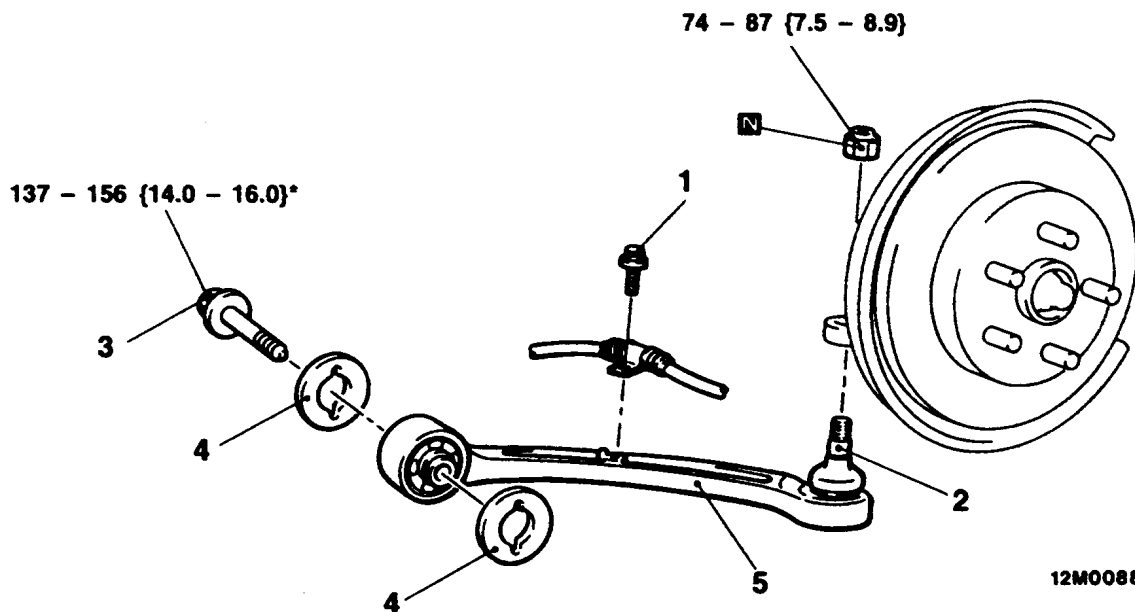
**Removal steps**

1. Parking brake cable bolt
2. Trailing arm assembly to knuckle coupling
3. Trailing arm assembly mounting bolt
4. Stopper
5. Trailing arm assembly

The part marked with \* should be first temporarily tightened, then torqued to specification with the vehicle on the ground in unloaded condition.

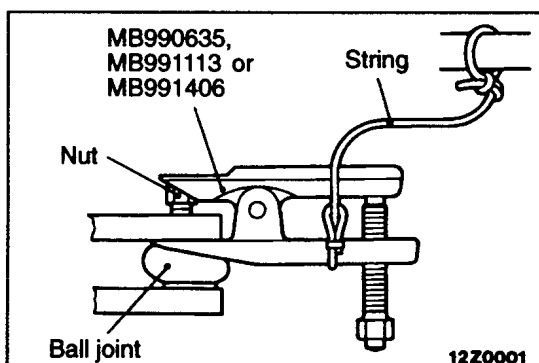
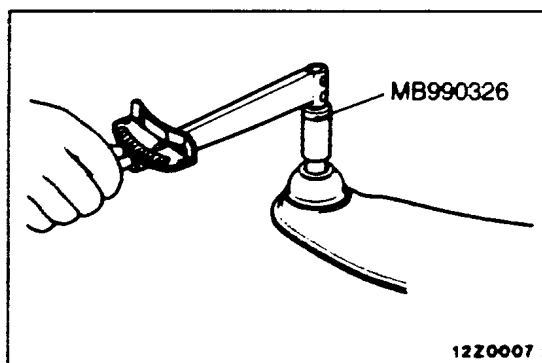
**REMOVAL SERVICE POINT****◀▶ TRAILING ARM ASSEMBLY DISCONNECTION FROM KNUCKLE****Caution**

- (1) Only loosen the nut, and not remove it from the ball joint, and use the special tool.
- (2) Hang the special tool with a string to prevent the parts including the tool from falling apart.

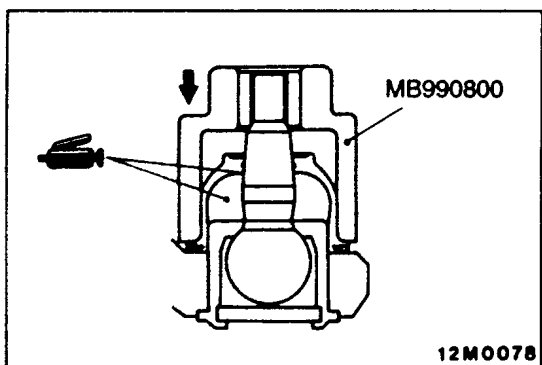
## TRAILING ARM BALL JOINT DUST COVER REPLACEMENT

- (1) Remove the dust cover.
- (2) Pack and apply the specified grease to the inside and lips of the dust cover.

- (3) Using the special tool, press the dust cover until it contacts the snap ring.
- (4) Push the dust cover with a finger to ensure that it is free from cracks or damage.

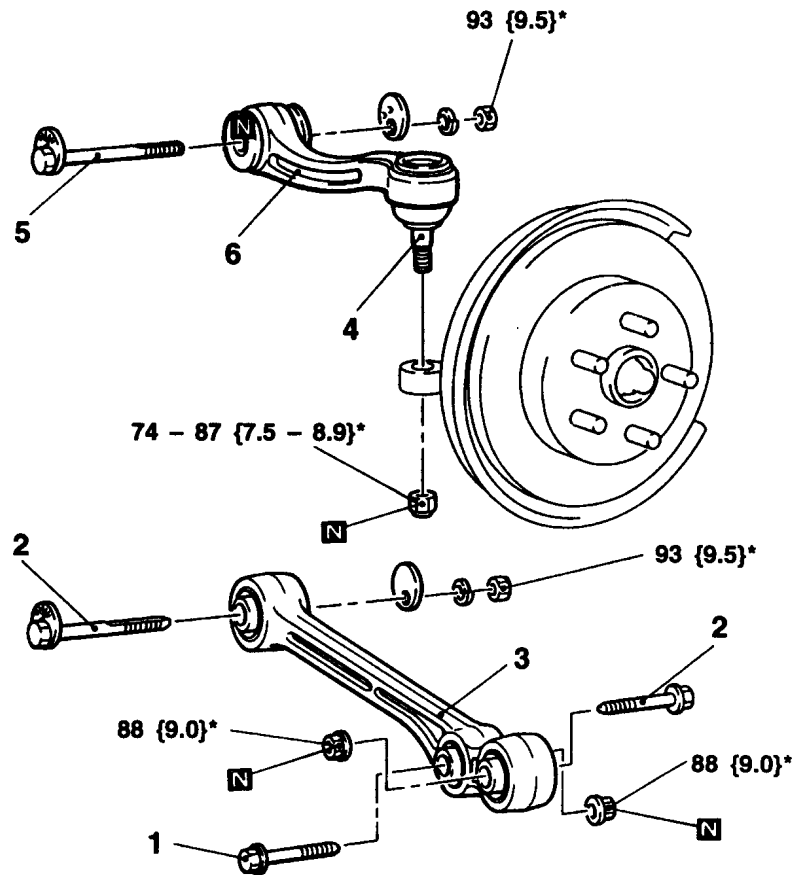
12M0089

#### Lower arm assembly removal steps

1. Lower arm assembly and shock absorber connecting bolt
2. Lower arm assembly mounting bolt
3. Lower arm assembly

#### Toe control arm assembly removal steps

4. Toe control arm and knuckle connection
5. Toe control arm assembly mounting bolt
6. Toe control arm assembly

The part marked with \* should be first temporarily tightened, then torqued to specification with the vehicle on the ground in unloaded condition.

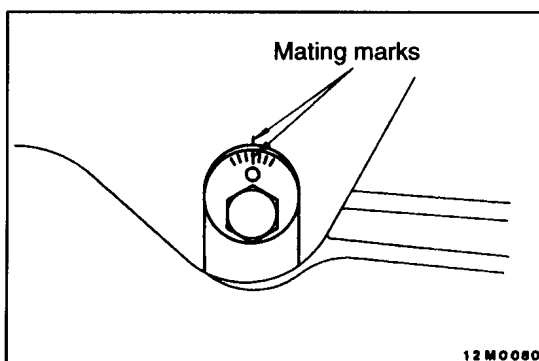
12M0080

#### ◀A▶ LOWER ARM ASSEMBLY MOUNTING BOLT REMOVAL

Place mating marks on the lower arm and the eccentric cam bolt before removal.

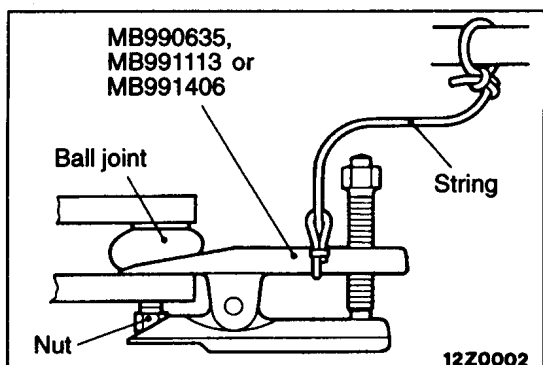
## ◀B▶ TOE CONTROL ARM AND KNUCKLE DISCONNECTION

### Caution

- (1) Use the special tool to loosen the nut only; do not removal it from the ball joint.
- (2) Tie the special tool with a cord not to let it fall off.

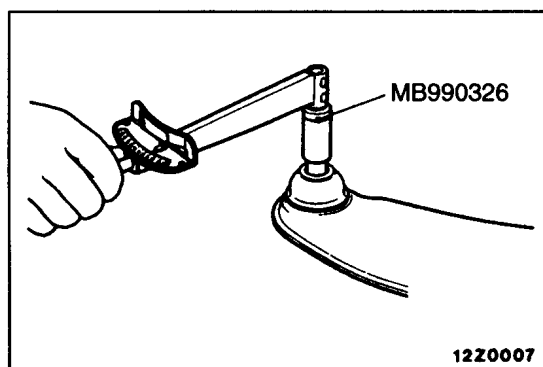
### ▶A◀ LOWER ARM ASSEMBLY INSTALLATION

Install the lower arm assemblies according to the identification mark stamped in the illustrated position.

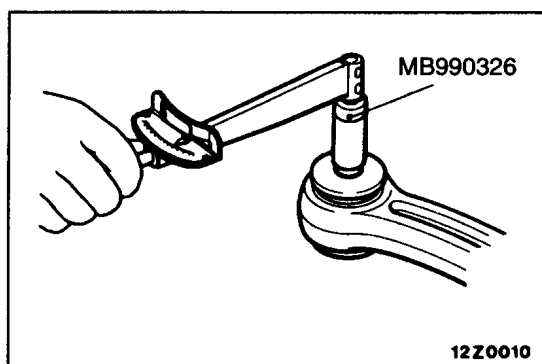
### 1. TOE CONTROL ARM BALL JOINT TURNING TORQUE CHECK

- (1) After shaking the ball joint stud several times, install the nut to the stud and use the special tool to measure the turning torque of the ball joint.

**Standard value: 0.5 – 2.5 Nm {5 – 25 kgf·cm}**

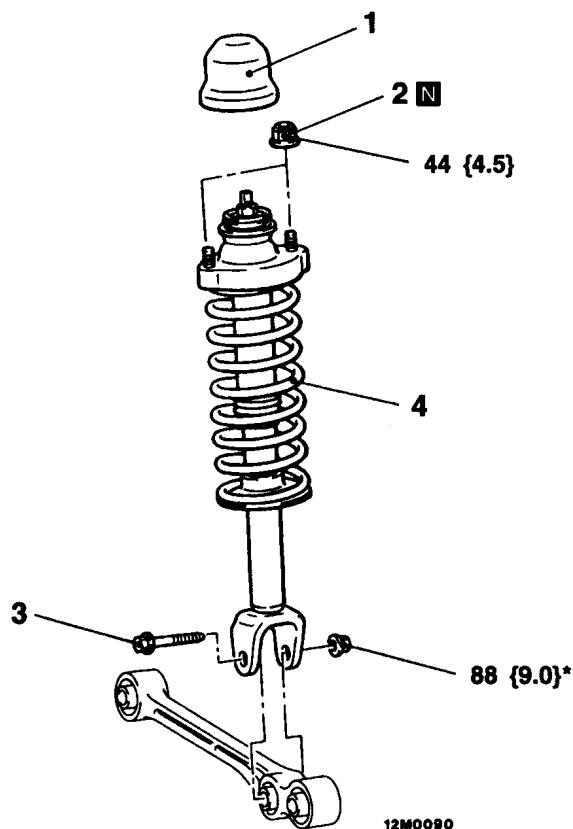
### Removal steps

1. Cap
2. Shock absorber mounting nuts
3. Bolt
4. Shock absorber assembly

The part marked with \* should be first temporarily tightened, then torqued to specification with the vehicle on the ground in unloaded condition.
