| <b>SERVICE BULLETIN</b> | | No.: ESB-98E00-012 | |
| <b>Subject:</b> CHANGE IN YEAR MODEL FOR '99 ECLIPSE | | <b>&lt;M/Y&gt;</b><br>99-10 | |

This Service Bulletin informs you of change in year model for the 1999 ECLIPSE.

## WORKSHOP MANUAL SUPPLEMENT

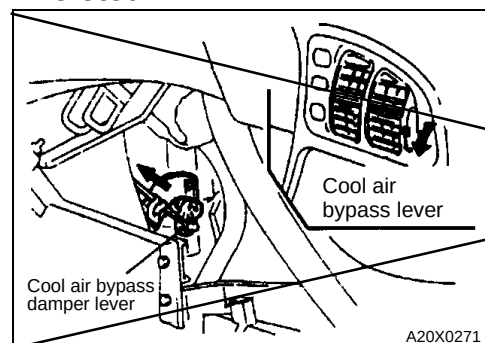
<Deleted>

- The centre air outlet assembly installation service point in the removal and installation procedures for the following parts has been deleted to correspond to the abolition of the cool air bypass lever.
- (1) GROUP 52A
  - Instrument panel
- (2) GROUP 54
  - Hazard warning lamp switch
  - rear window defogger switch

#### INSTALLATION SERVICE POINT CENTRE AIR OUTLET ASSEMBLY INSTALLATION

- (1) Turn the cool air bypass lever of the centre air outlet assembly fully downwards.
- (2) pull the cool air bypass damper lever on the heater unit side all the way towards you, and then connect the cable to the lever pin.
- (3) Push the outer cable in the direction of the arrow so that there is no looseness, and then secure it with the clip.

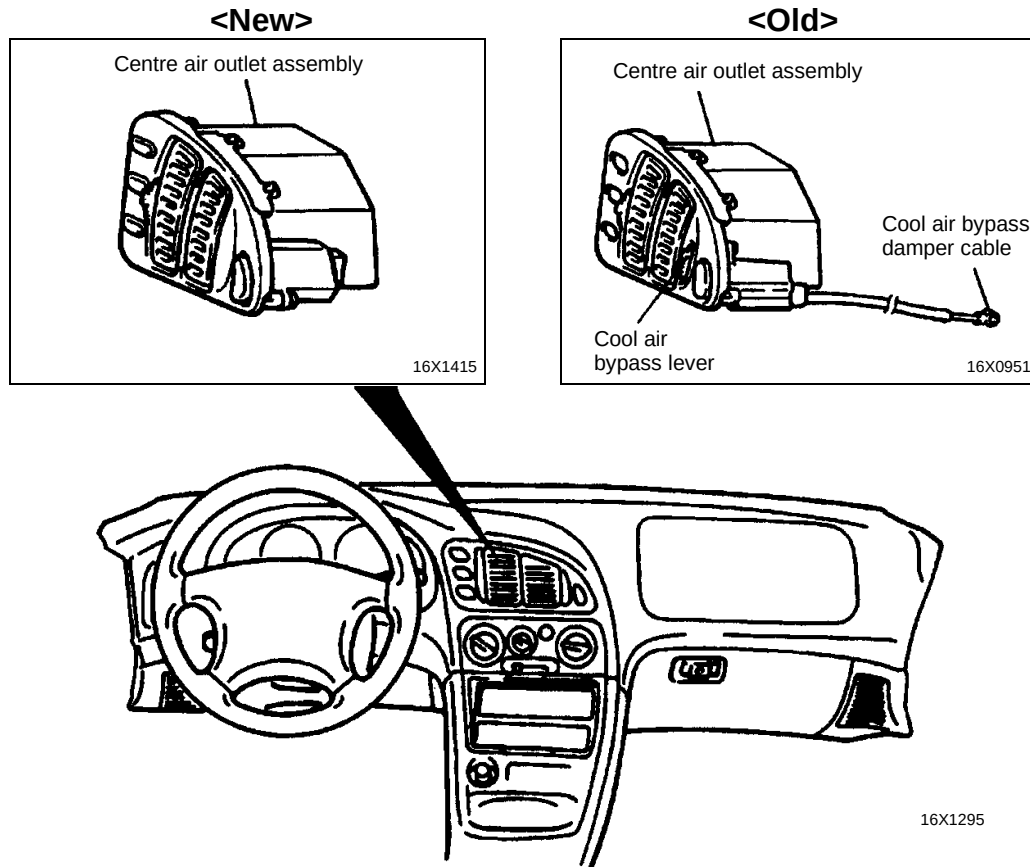
- The centre air outlet assembly cool air bypass lever has been no longer used.
- The centre air outlet assembly installation service point in the removal and installation procedures for the A/C switch has been deleted to correspond to the abolition of the cool air bypass lever. (Refer to GROUP 52A and 54.)
