Mando MGH-25 Anti-Lock Brake  
System  
User's Manual

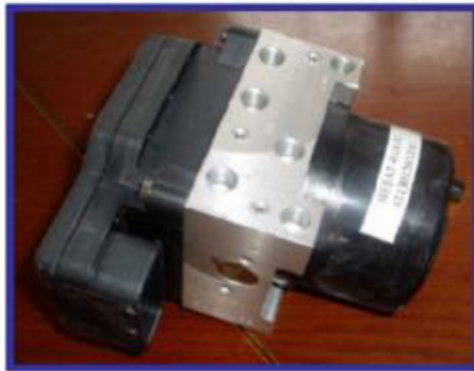
Dry Type

The biggest differentiation between the dry type HECU and wet type HECU is that the no air discharge is conducted in the 2nd circuit (namely the circuit from the normal close valve to the general pump) of the dry type HECU. Therefore, when the spare part is of wet type HECU, it's only necessary to conduct the air discharge and oil refill in accordance with the regular brake system after the replacement. When the spare part is of dry type HECU, besides that the air discharge and oil refill are required in accordance with the regular brake system after the replacement, it's necessary to conduct the air discharge and oil refill to the 2nd circuit of the HECU. In addition, for the appearance, the wet type HECU has the bolts for sealing purpose and the dry type HECU has the protection film. The product label located on the motor is marked with the part number of the products, through which the dry type HECU and wet type HECU can be differentiated.

Take the S21 model for instance, the dry type Mando product number is BH601-086-00 and the wet type Mando product number is BH602-386-00.

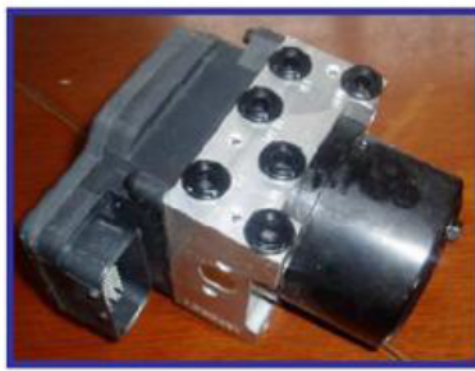
Wet Type

If the bolts on the wet type HECU are fallen off (such as during the transportation), besides that the air discharge and oil refill must be conducted for 1st circuit, maybe it's necessary to conduct the air discharge and oil refill to the 2nd circuit.

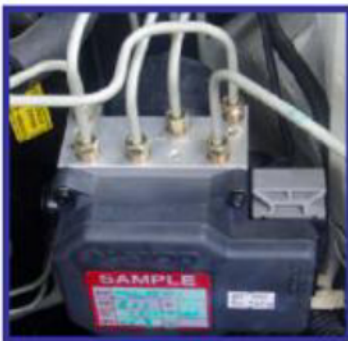
During the assembling of brake pipeline:

- ☐ Remove the protection film attached onto the HECU before the operation.
- ☐ Confirm the pipeline of general pump and wheel branch pump before the operation.  
(General pump: MCP, MCS Wheel branch pump: FR, FL, RR, RL)
- ☐ Confirm if the brake hose is tightened to 120~160 kgf·cm with special tool or torque wrench.
- ☐ Notice to keep away the impurity ingress into the HECU hole and brake hose during operation.

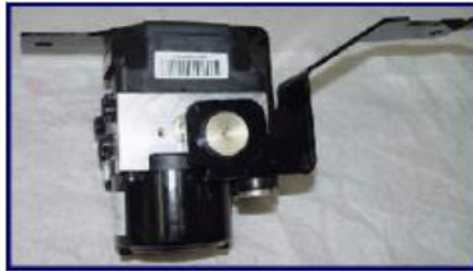
During the installation to vehicle body:

- ☐ Attach the components of brake hose and bracket to the HECU and install to the vehicle body with the body fixing bolts.
- ☐ Confirm if the body fixing bolts are tightened to 190~260 kgf·cm with special tool or torque wrench.
- ☐ Again confirm if the pipeline installation of general pump and wheel branch pump is correct.

(General pump: MCP, MCS; Wheel branch pump: FR, FL, RR, RL)

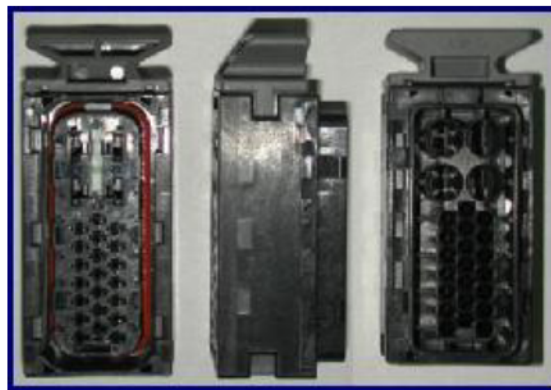
- ① When the vehicle is stopped, remove the 25-pin connector and harness wiring of the HECU located within the engine compartment.

**25-Pin Connector Used in MGH-25 ABS  
(P/No: AMP 368482-1)**

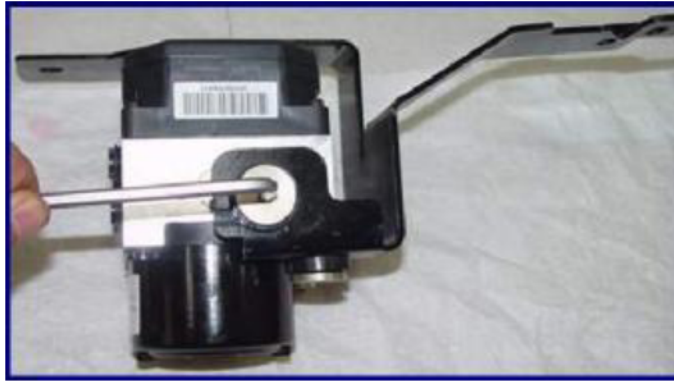
- ② Screw off in counter clockwise direction the 6 bolts (M10x1.0) connected to the HECU brake hose with 11mm tool (wrench) (rotate in clockwise direction during refit). The tightening torque for the brake hose is 120 ~ 160 kgf cm.
- ③ Screw off in counter clockwise direction the 3 bolts or nuts connected to the bracket with 12mm tool (wrench) (rotate in clockwise direction during refit). The tightening torque for the fixing bolts or nuts of the bracket is 190 ~ 260 kgf cm.
- ④ After the removal of the product, screw off in counter clockwise direction the 3 embedded bolts (M6x1.0) attached to the HECU with 5mm tool (hex wrench) (see the figure in next page).

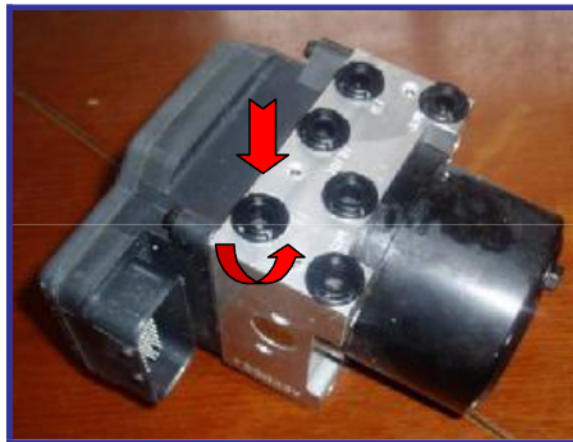
⑤ Screw off in counter clockwise direction the 6 bolts from the after-service HECU with 6mm tool (hex wrench).

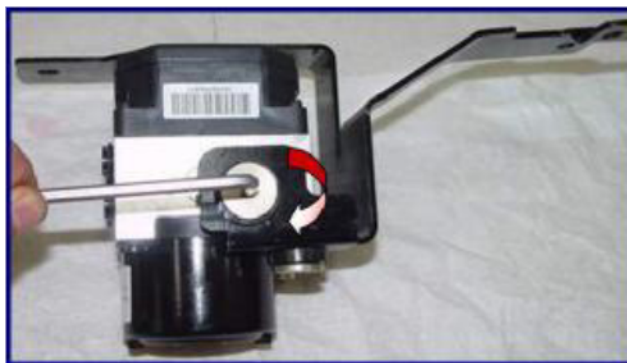
⑥ Screw on in clockwise direction 3 embedded bolts to assemble the after-service HECU and the bracket with 5mm tool (hex wrench). The tightening torque for the embedded bolts is 80 ~ 100 kgf·cm.
