**2017 ACCESSORIES & EQUIPMENT**  
**Floor Coverings and Headlinings - Impala**

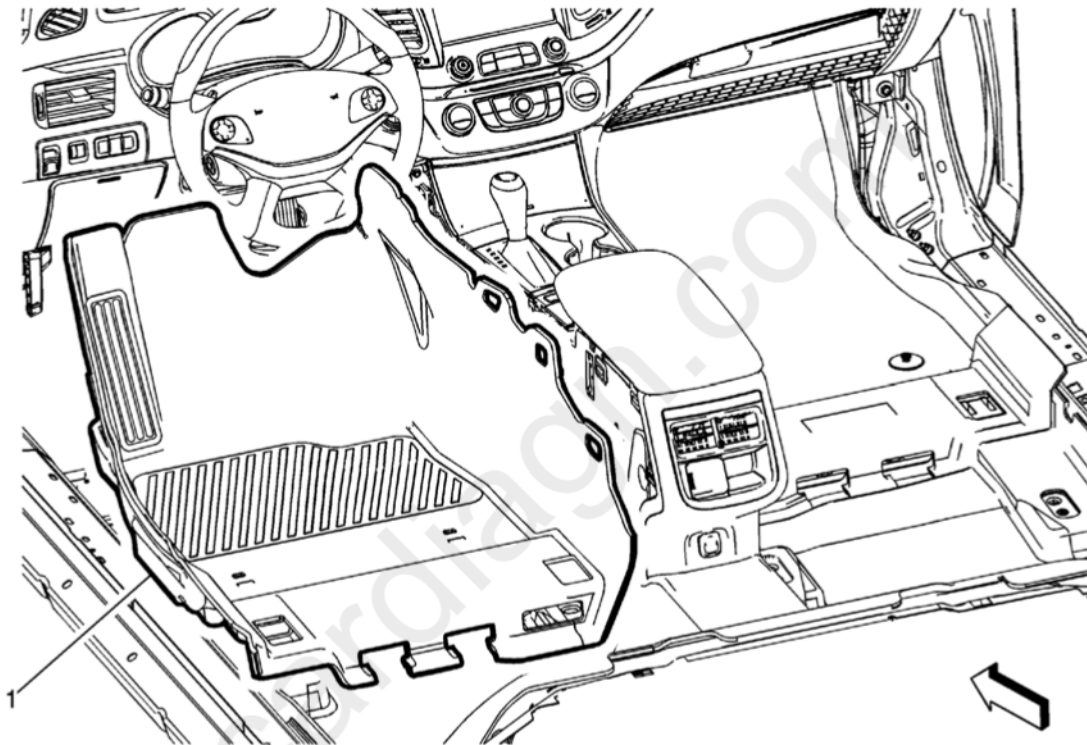
**Fig. 1: Front Floor Panel Carpet - Left Side**

| Callout | Component Name |
|---|---|
| <ol style="list-style-type: none"> <li>1. Remove the driver seat. Refer to <a href="#">Driver or Passenger Seat Removal and Installation</a> .</li> <li>2. Remove the driver side door sill garnish molding. Refer to <a href="#">Front Side Door Sill Garnish Molding Replacement</a> .</li> <li>3. Remove the front floor console extension - left side. Refer to <a href="#">Front Floor Console Extension Replacement - Left Side</a> .</li> </ol> | |

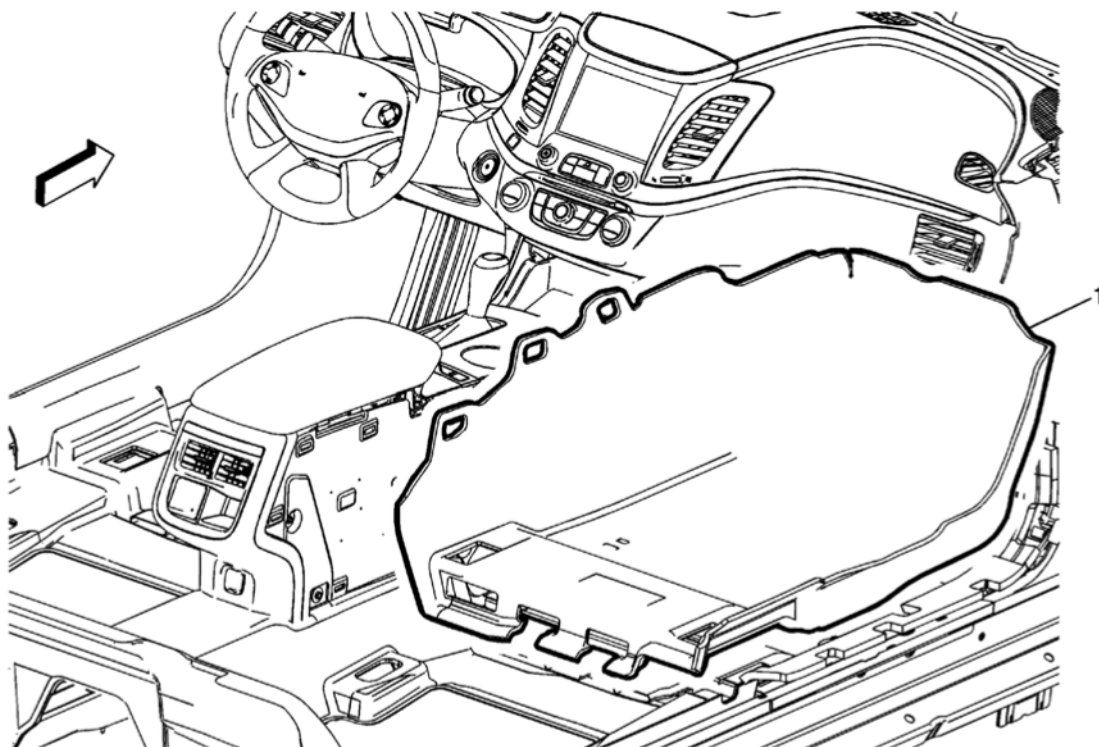
**Fig. 2: Front Floor Panel Carpet - Right Side**  
Courtesy of GENERAL MOTORS COMPANY

| Callout | Component Name |
|---|---|
| <ol style="list-style-type: none"> <li>1. Remove the passenger seat. Refer to <a href="#">Driver or Passenger Seat Removal and Installation</a> .</li> <li>2. Remove the passenger side door sill garnish molding. Refer to <a href="#">Front Side Door Sill Garnish Molding Replacement</a> .</li> <li>3. Remove the front floor console extension - right side. Refer to <a href="#">Front Floor Console Extension Replacement - Right Side</a> .</li> </ol> | |

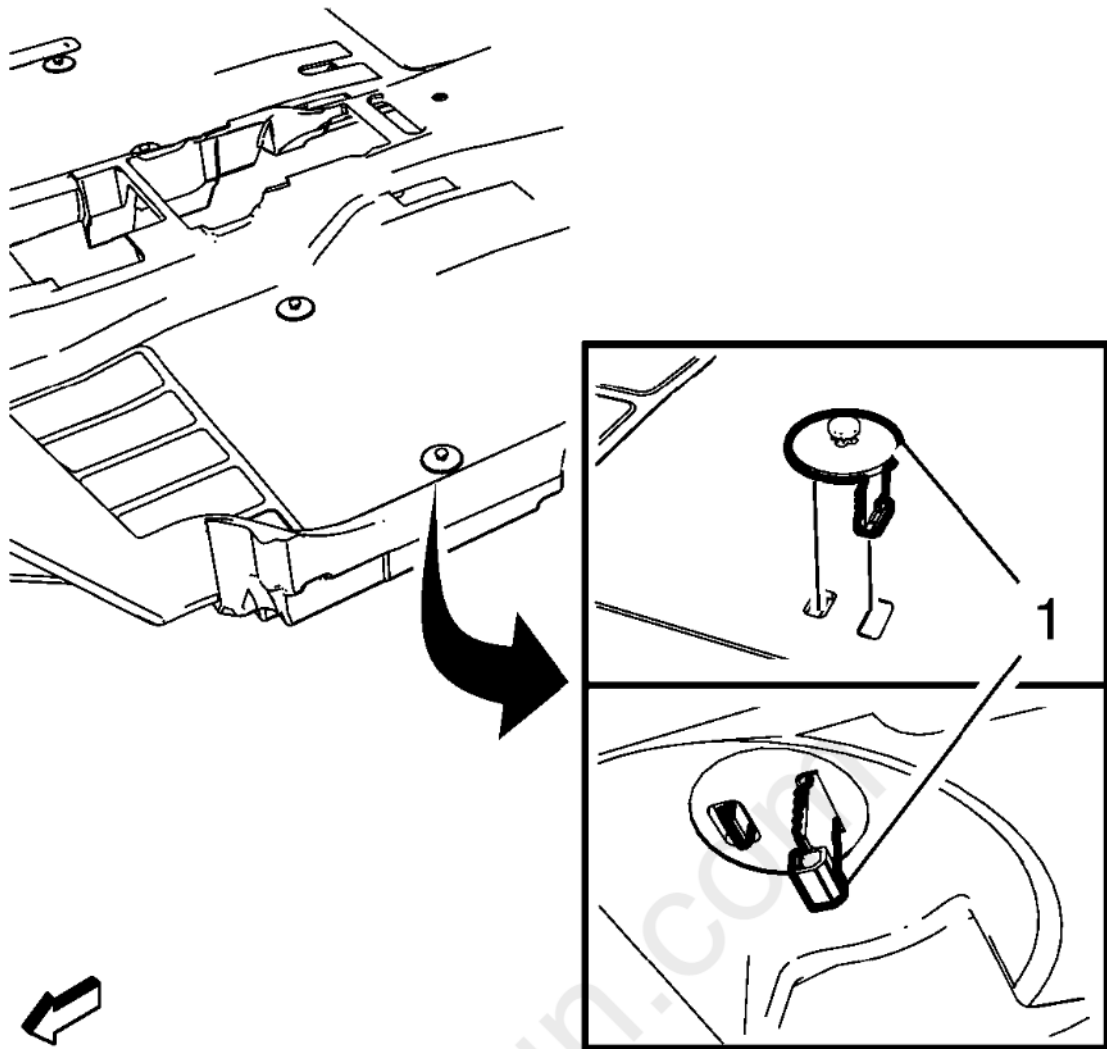
**Fig. 3: Floor Panel Carpet Retainer**

1. Align the front floor panel carpet retainer (1) to the cutout in the carpet.
2. Engage the front floor panel carpet retainer (1) on the rear side of the front floor panel carpet.
3. Reposition the front floor panel carpet as needed. Refer to [Front Floor Panel Carpet Replacement - Left Side](#), and [Front Floor Panel Carpet Replacement - Right Side](#).
4. Install the front side door sill garnish molding. Refer to [Front Side Door Sill Garnish Molding Replacement](#).

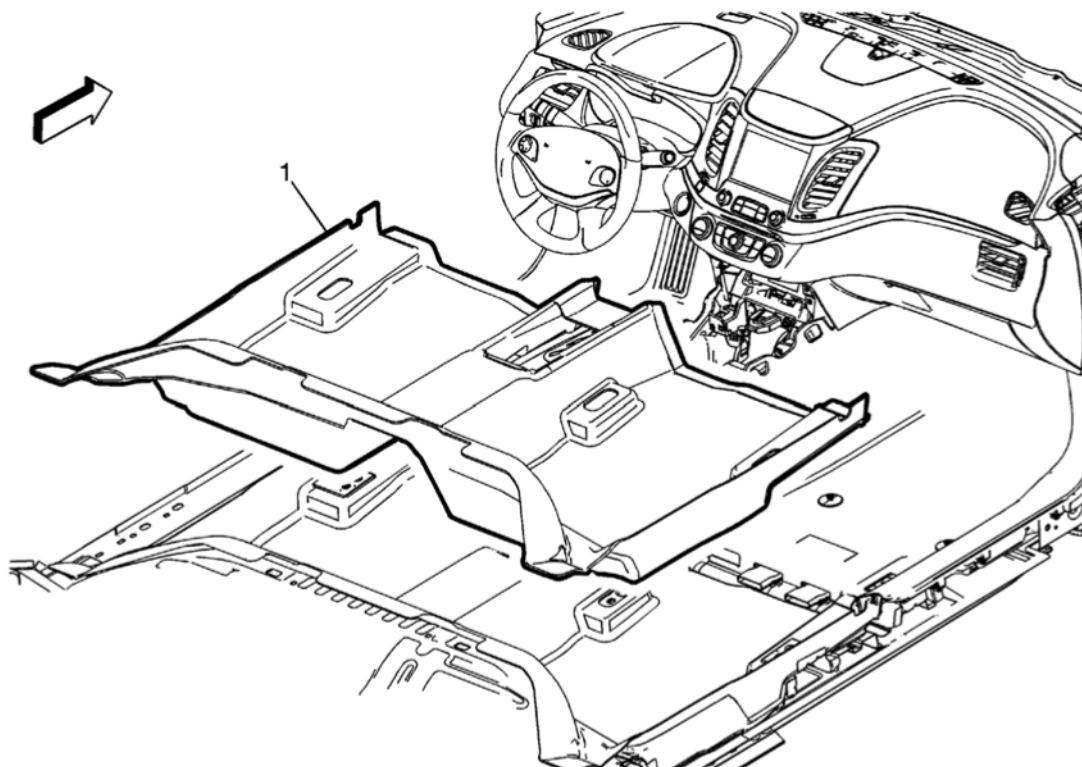
**Fig. 5: Rear Floor Panel Carpet**

| Callout | Component Name |
|---|---|
| <b>Preliminary Procedures</b> <ol style="list-style-type: none"> <li>1. Remove both the driver and passenger seat. Refer to <a href="#">Driver or Passenger Seat Removal and Installation</a> .</li> <li>2. Remove the rear seat cushions. Refer to <a href="#">Rear Seat Cushion Removal and Installation</a> .</li> <li>3. Remove the front floor console. Refer to <a href="#">Front Floor Console Replacement</a> .</li> <li>4. Remove the center pillar lower trim panel. Refer to <a href="#">Center Pillar Lower Trim Panel Replacement</a> .</li> </ol> | |

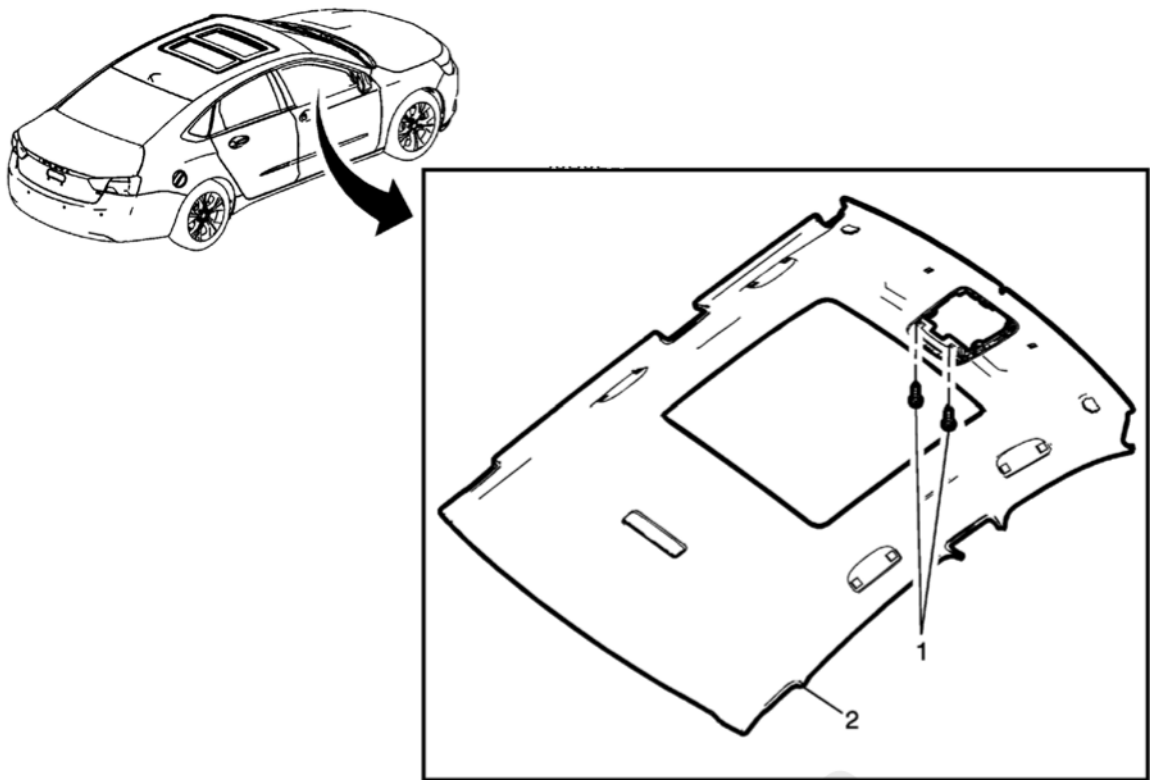
**Fig. 22: Headliner & Mounting Screws**  
Courtesy of GENERAL MOTORS COMPANY

1. With the aid of an assistant, position the headliner trim panel assembly (2) into the vehicle through the front passenger door opening.
2. Install the two screws (1) to the front portion of the headliner at the roof console backing plate.
3. Connect the electrical connectors to the headliner trim panel assembly (2).
4. If replacing the headliner assembly, transfer all necessary components.
5. If transferring or replacing the wiring harness, refer to [Headliner Harness Replacement](#).
6. Tape any unused connectors to the headliner with a high adhesive tape.

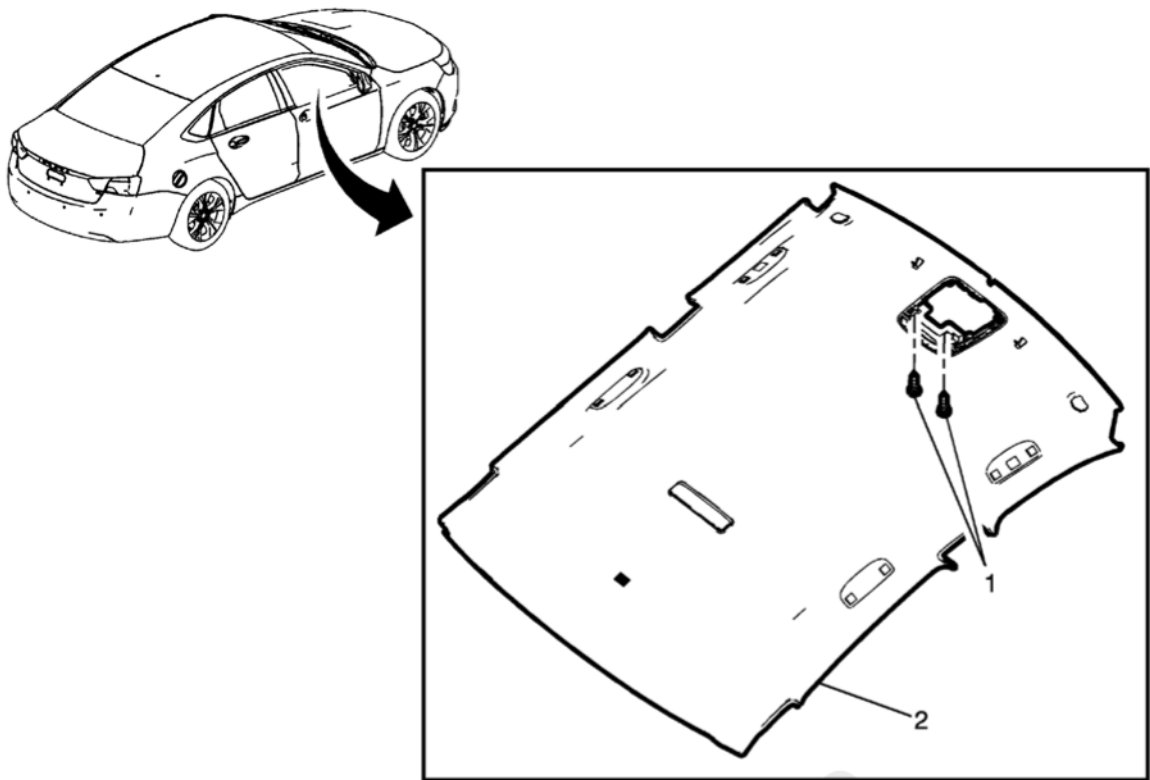
**Fig. 56: Headliner & Mounting Screws**  
 Courtesy of GENERAL MOTORS COMPANY

1. With the aid of an assistant, position the headliner trim panel assembly (2) into the vehicle through the front passenger door opening.
2. Install the two screws (1) to the front portion of the headliner at the roof console backing plate.
3. Connect the electrical connectors to the headliner trim panel assembly (2).
4. If replacing the headliner assembly, transfer all necessary components.
5. If transferring or replacing the wiring harness, refer to [Headliner Harness Replacement](#).
6. Tape any unused connectors to the headliner with a high adhesive tape.

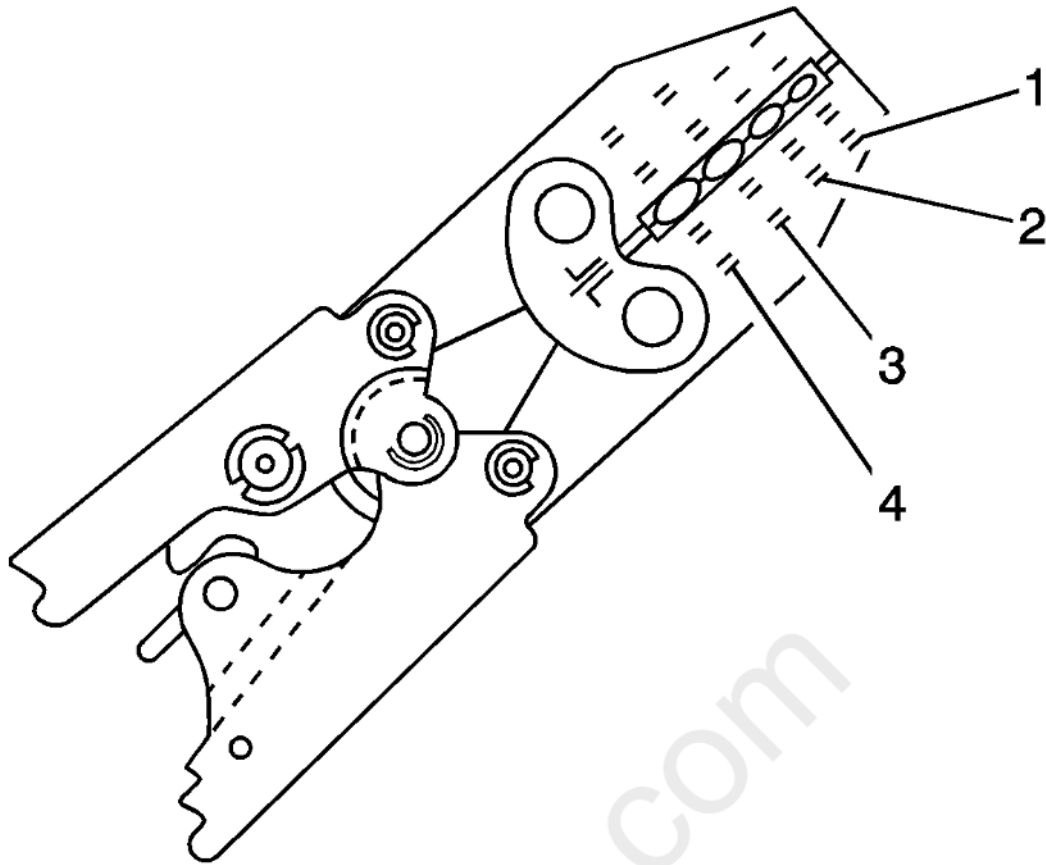
**Fig. 74: Splice Sleeve Crimping Tool With 4 Crimp Nests**

5. Select the proper DuraSeal splice sleeve according to the wire size. Refer to the above table at the beginning of the repair procedure for the color coding of the DuraSeal splice sleeves and the crimp tool nests.

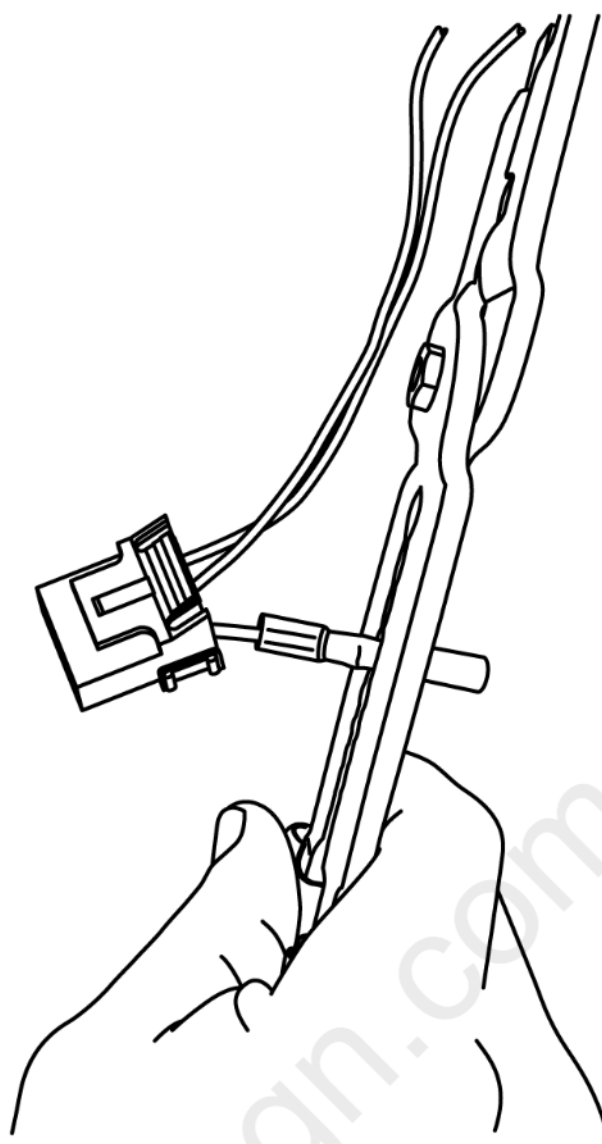
**Fig. 79: Tightly Close Handles Of Crimp Tool**  
**Courtesy of GENERAL MOTORS COMPANY**

1. Insert the wire into the splice sleeve barrel until the wire hits the barrel stop. Refer to **Folded-Over Wire Repair** for splicing wires of 0.35 mm or less (22, 24, 26 gauge sizes) and for splicing wires of different gauges.
