## 2008 Chevrolet Silverado 1500

2008 DRIVELINE/AXLE Wheel Drive Shafts - Cab & Chassis Sierra, Cab & Chassis Silverado, Sierra & Silverado

### WHEEL DRIVE SHAFT REPLACEMENT (2500)

## WHEEL DRIVE SHAFT REPLACEMENT (1500)

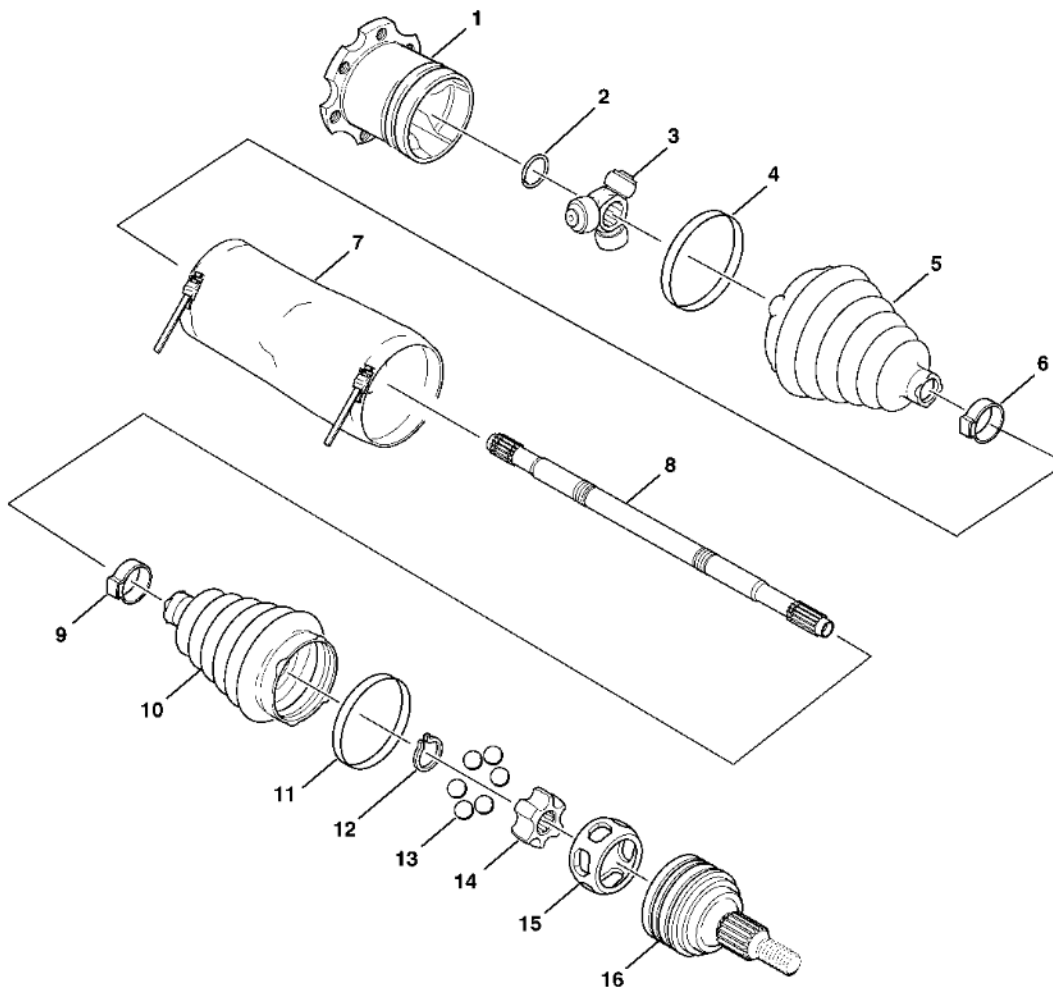
**Fig. 1: Wheel Drive Shaft Components, Disassembled View**  
**Courtesy of GENERAL MOTORS CORP.**

| Callout | Component Name |
| 1 | Tripot Housing Assembly |
| 2 | Spacer Ring |
| 3 | Tripot Joint Spider Assembly |
| 4 | Swage Ring |
| 5 | Tripot Joint Boot |
| 6 | Small Boot Retaining Clamp |
| 7 | Halfshaft Boot Cover (Optional) |
| 8 | Halfshaft Bar |

| 9 | Small Boot Retaining Clamp |
| 10 | CV Joint Boot |
| 11 | Swage Ring |
| 12 | Race Retaining Ring |
| 13 | Ball |
| 14 | CV Joint Inner Race |
| 15 | CV Joint Cage |
| 16 | CV Joint Outer Race |

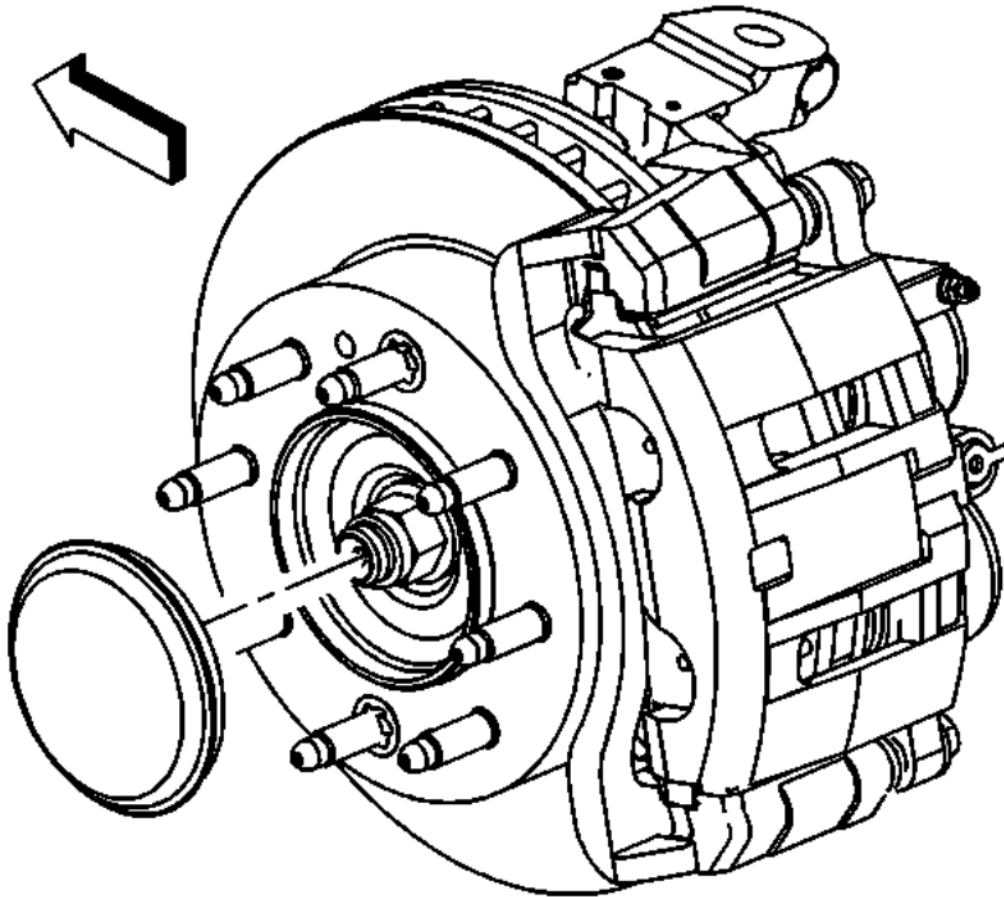
**Fig. 2: Drive Axle Center Cap**  
**Courtesy of GENERAL MOTORS CORP.**

1. Raise the vehicle. Refer to **Lifting and Jacking the Vehicle** .
2. Remove the wheel and tire assembly. Refer to **Tire and Wheel Removal and Installation** .
3. Remove the drive axle center cap, if equipped.

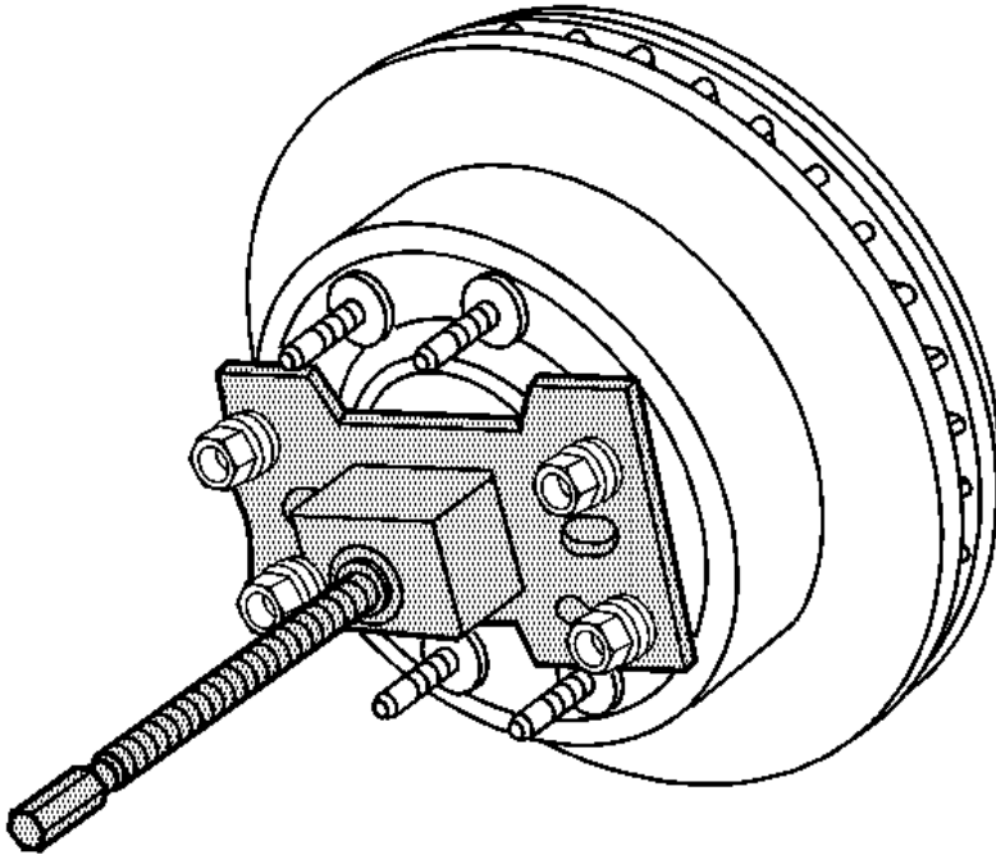
**Fig. 3: Pressing Wheel Drive Shaft From Hub**  
Courtesy of GENERAL MOTORS CORP.

4. Insert a drift or a large screwdriver through the brake caliper into one of the brake rotor vanes in order to prevent the drive axle wheel drive shaft from turning.
5. Remove the nut and the washer from the hub. Do not reuse the nut. A new nut must be used when installing the wheel drive shaft.
6. Using the **J 45859** or equivalent, press the wheel drive shaft from the hub. See **Special Tools**.

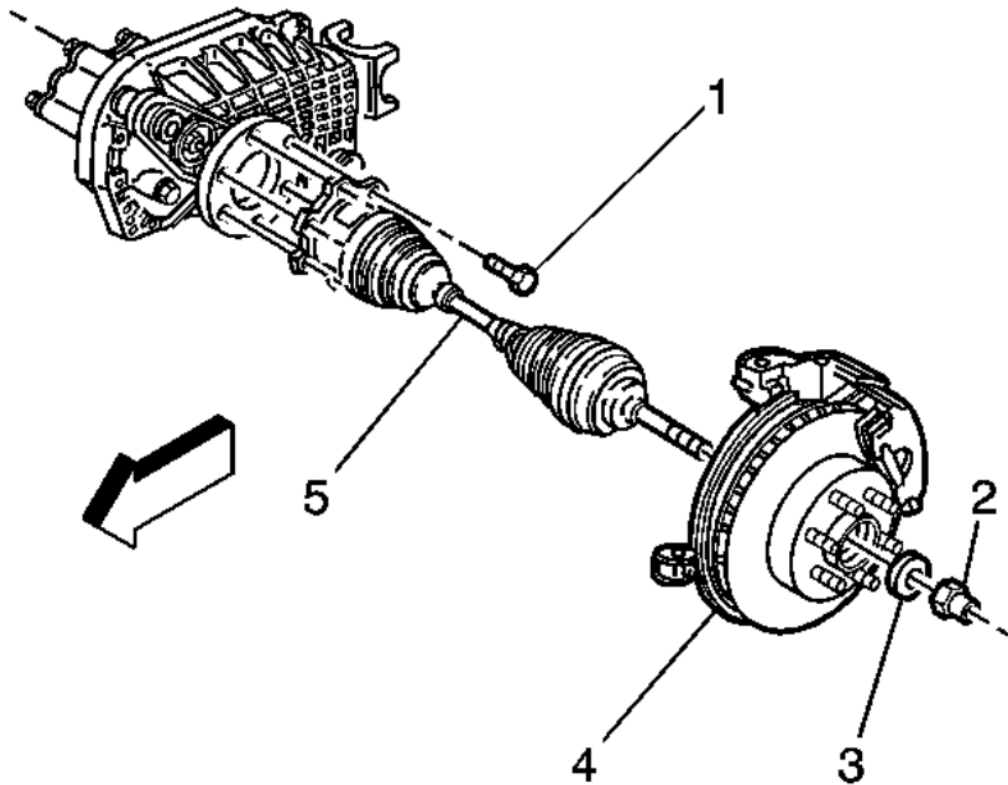
**Fig. 4: Wheel Drive Shaft & Hub**  
**Courtesy of GENERAL MOTORS CORP.**

7. Remove the 6 bolts (1) securing the wheel drive shaft inboard flange to the output shaft flange.
8. Remove the drift from the rotor.
9. Remove the stabilizer shaft link from the lower control arm. Refer to **Stabilizer Shaft Replacement (2500, 3500)** or **Stabilizer Shaft Replacement (1500)** .
10. Wrap shop towels around both the inner and the outer wheel drive shaft boots in order to avoid damage to the boots during removal and installation.
11. Pull the wheel drive shaft through the lower control arm opening.

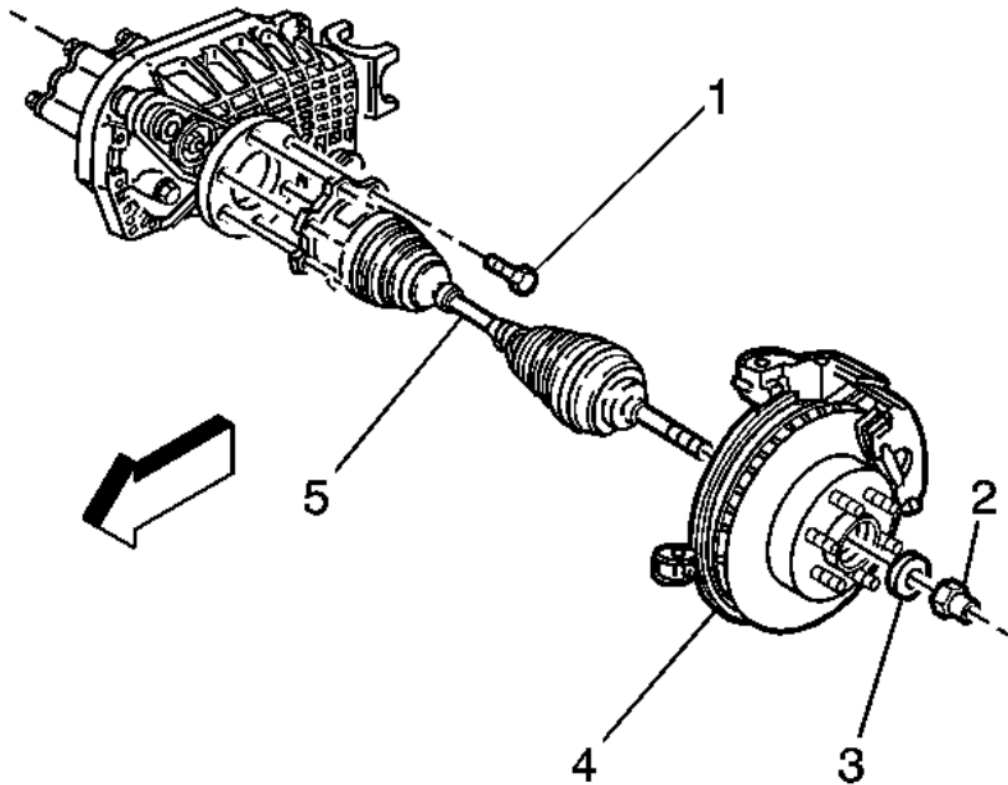
**Fig. 5: Wheel Drive Shaft & Hub**

3. Install the washer (3) and the new hub nut (2) to the wheel drive shaft.

4. Attach the wheel drive shaft inboard flange to the output shaft flange using the inboard flange bolts (1).

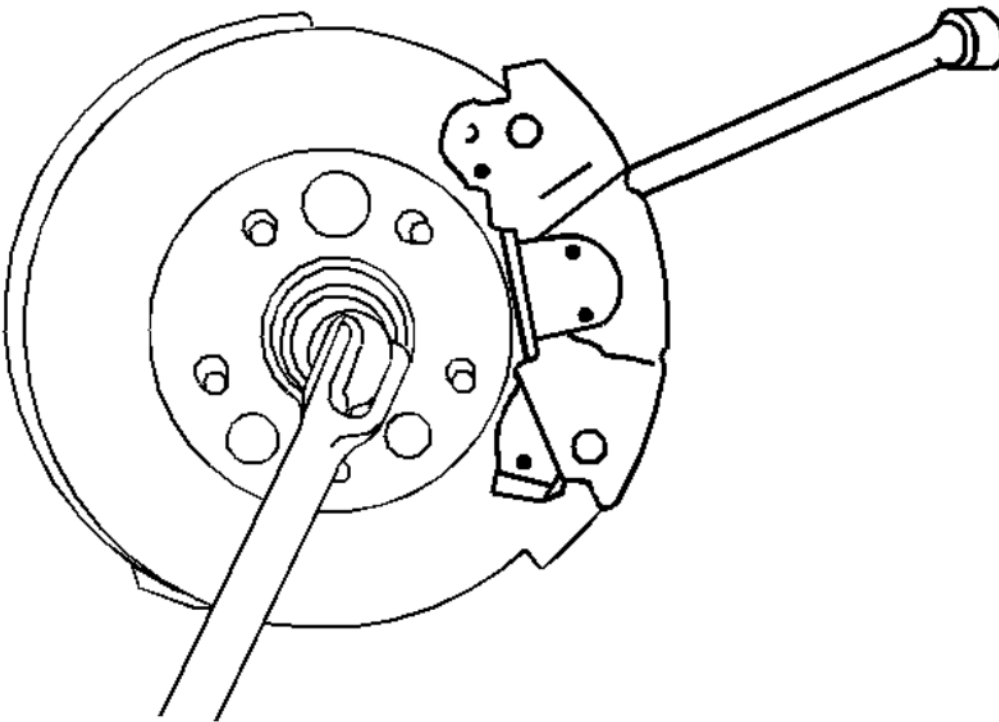
**Fig. 6: Inserting Drift Or Screwdriver To Prevent Wheel Drive Shaft From Turning**  
Courtesy of GENERAL MOTORS CORP.

5. Insert a drift or a large screwdriver through the brake caliper into 1 of the brake rotor vanes in order to prevent the wheel drive shaft from turning.

- Tighten the inboard flange bolts to 79 N.m (58 lb ft).

- Tighten the hub nut to 240 N.m (177 lb ft).

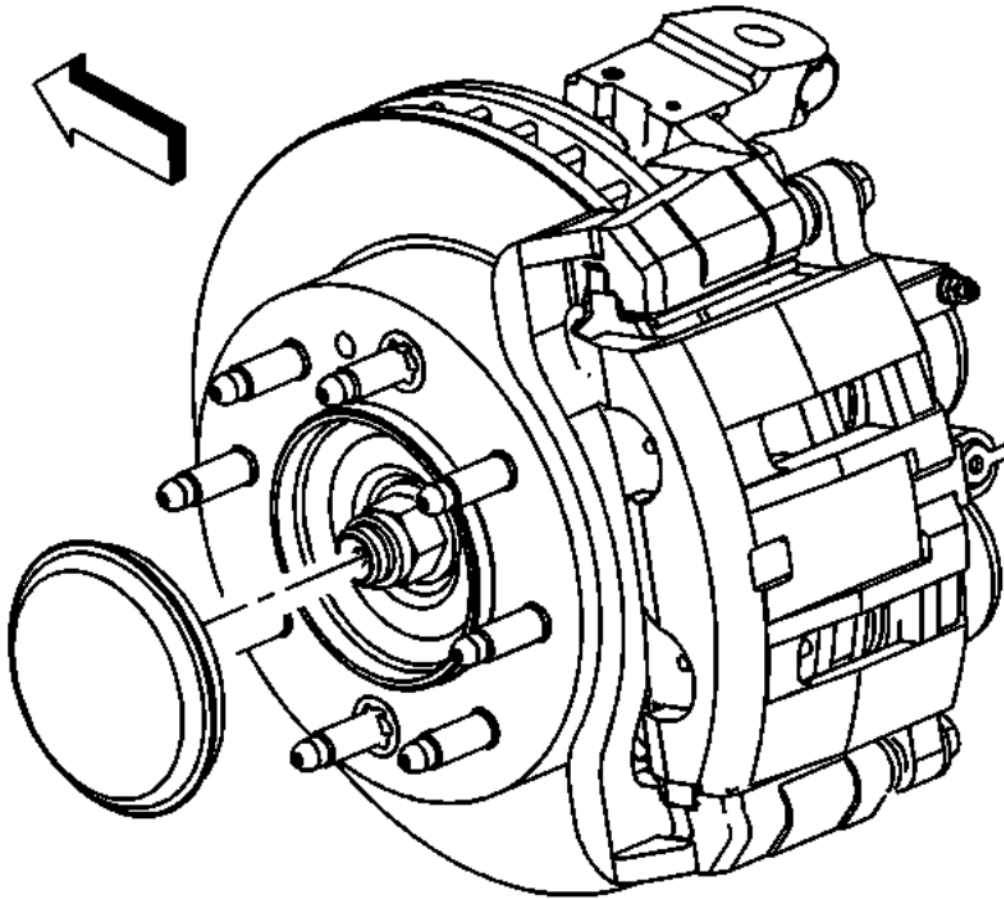
**Fig. 7: Drive Axle Center Cap**  
Courtesy of GENERAL MOTORS CORP.

7. Install the drive axle center cap, if equipped.
8. Install the stabilizer shaft link. Refer to **Stabilizer Shaft Replacement (2500, 3500)** or **Stabilizer Shaft Replacement (1500)** .
9. Install the wheel and tire assembly. Refer to **Tire and Wheel Removal and Installation** .
10. Lower the vehicle.

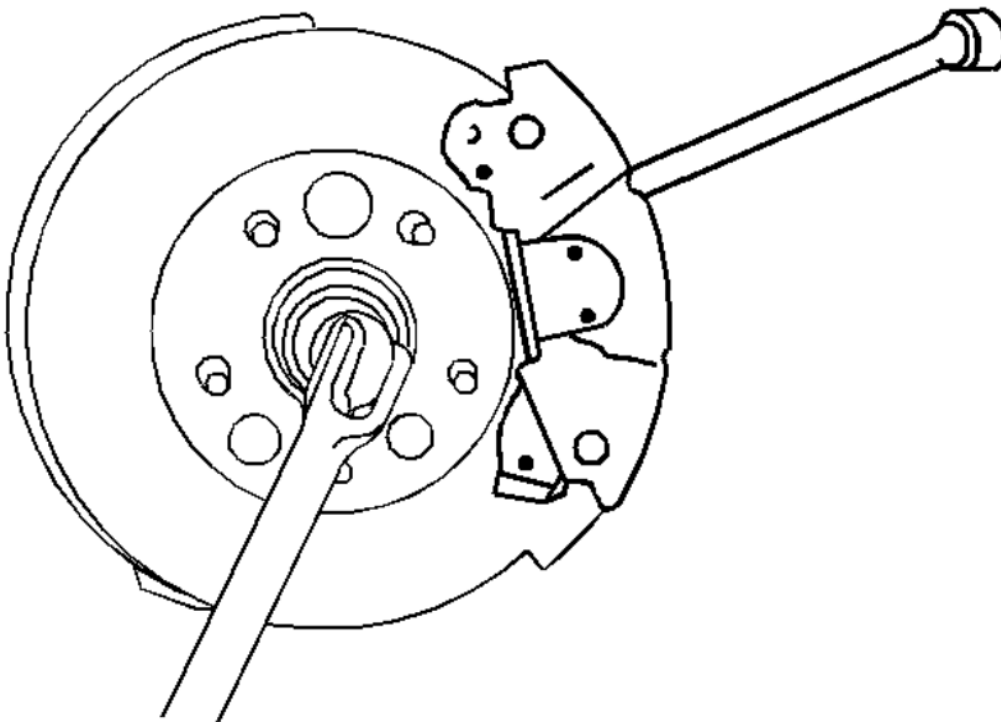
**Fig. 8: Inserting Drift Or Screwdriver To Prevent Wheel Drive Shaft From Turning**

3. Insert a drift or large screwdriver through the brake caliper into one of the brake rotor vanes in order to prevent the wheel drive shaft from turning.

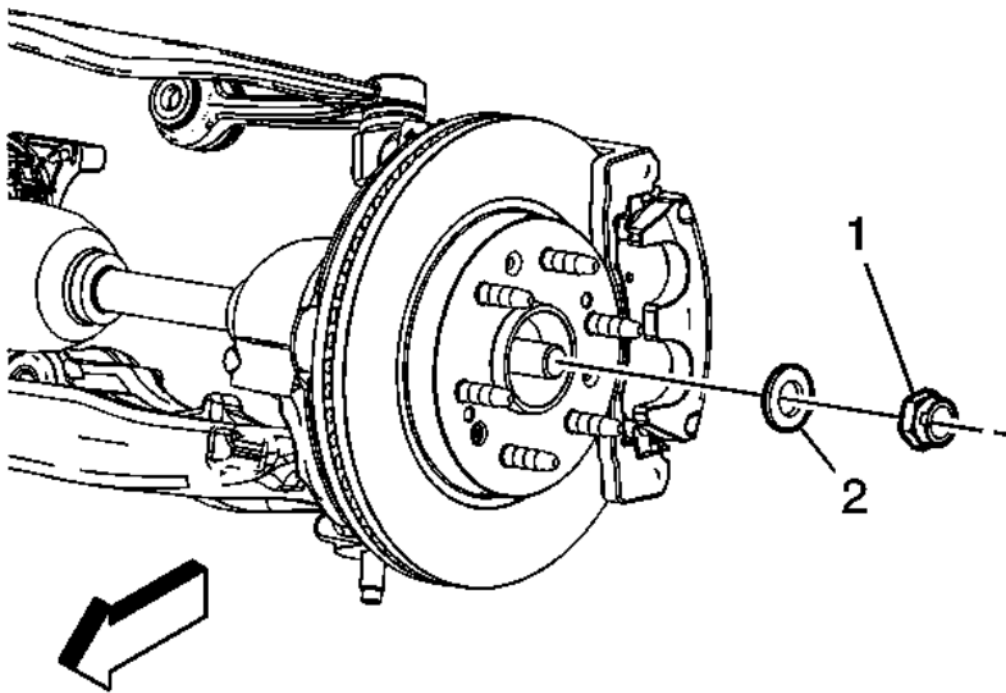
**Fig. 9: View Of Hub Nut & Washer**

**IMPORTANT: DO NOT** reuse the wheel drive shaft nut, use a **NEW** nut only.

4. Remove the nut (1) and washer (2) from the hub.

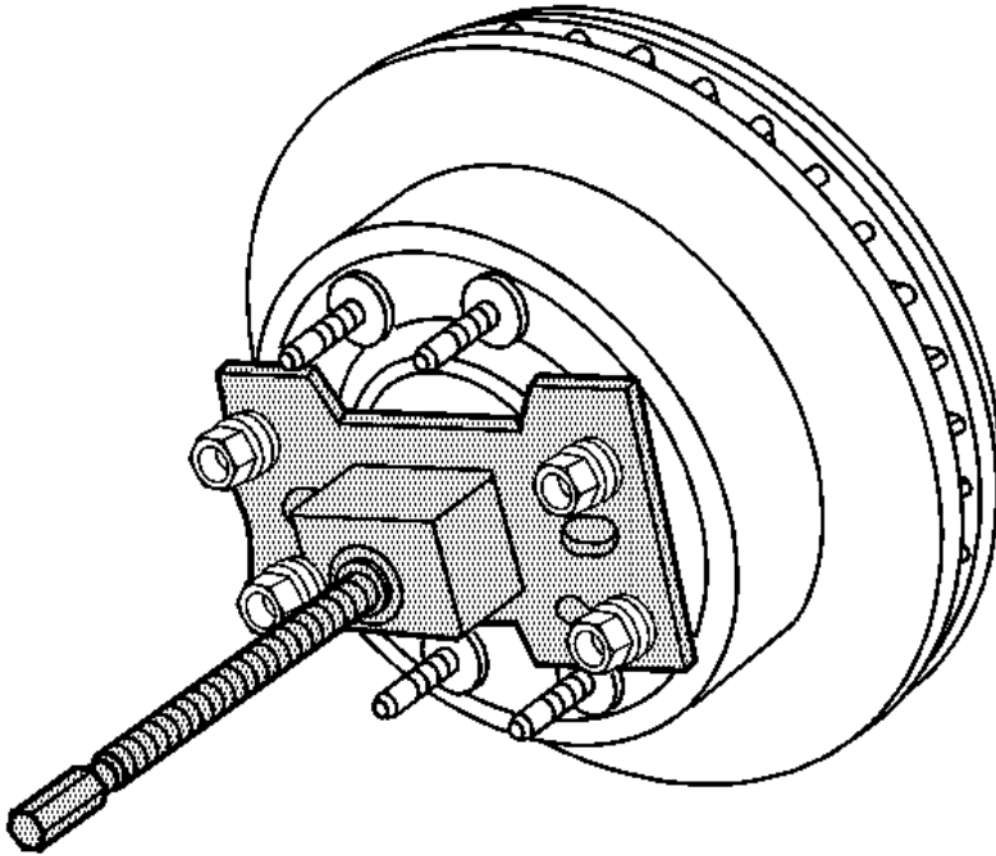
**Fig. 10: Pressing Wheel Drive Shaft From Hub**  
Courtesy of GENERAL MOTORS CORP.

5. Using the **J 45859** or equivalent, remove the wheel drive shaft from the hub. See **Special Tools**.
6. Remove the special tool.

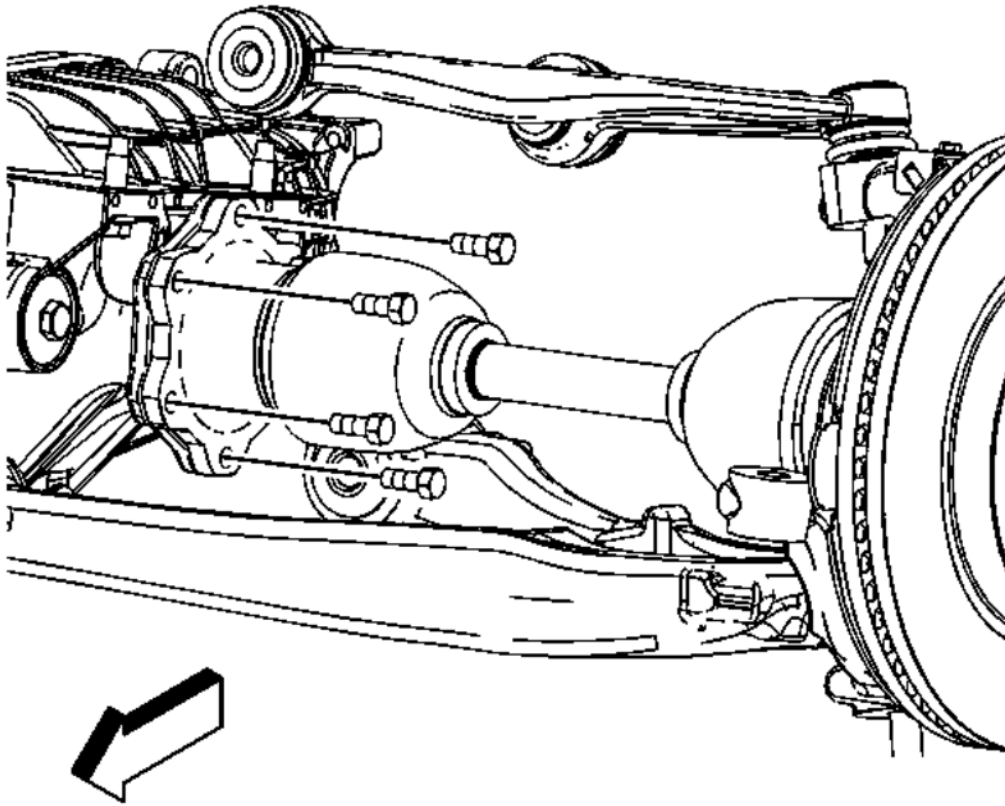
**Fig. 11: View Of Drive Flange & Retaining Bolts**  
Courtesy of GENERAL MOTORS CORP.

7. Remove the retaining bolts from the drive flange.
8. Remove the drift or large screwdriver from the brake rotor.
9. Remove the stabilizer shaft link from the lower control arm. Refer to **Stabilizer Shaft Replacement (2500, 3500)** or **Stabilizer Shaft Replacement (1500)** .
10. Remove the shock module. Refer to **Shock Absorber and Spring Assembly Replacement** .

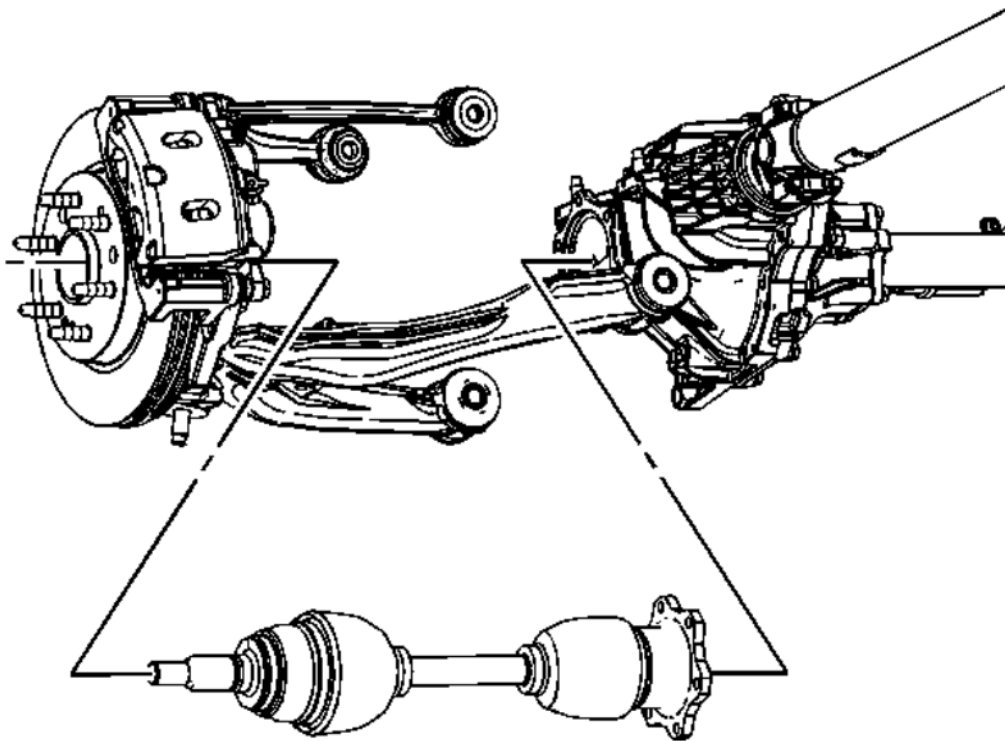
**Fig. 12: View Of Wheel Drive Shaft**  
**Courtesy of GENERAL MOTORS CORP.**

11. Remove the wheel drive shaft through the lower control arm opening.
12. Remove all dirt and debris from the splines on the wheel hub/bearing.

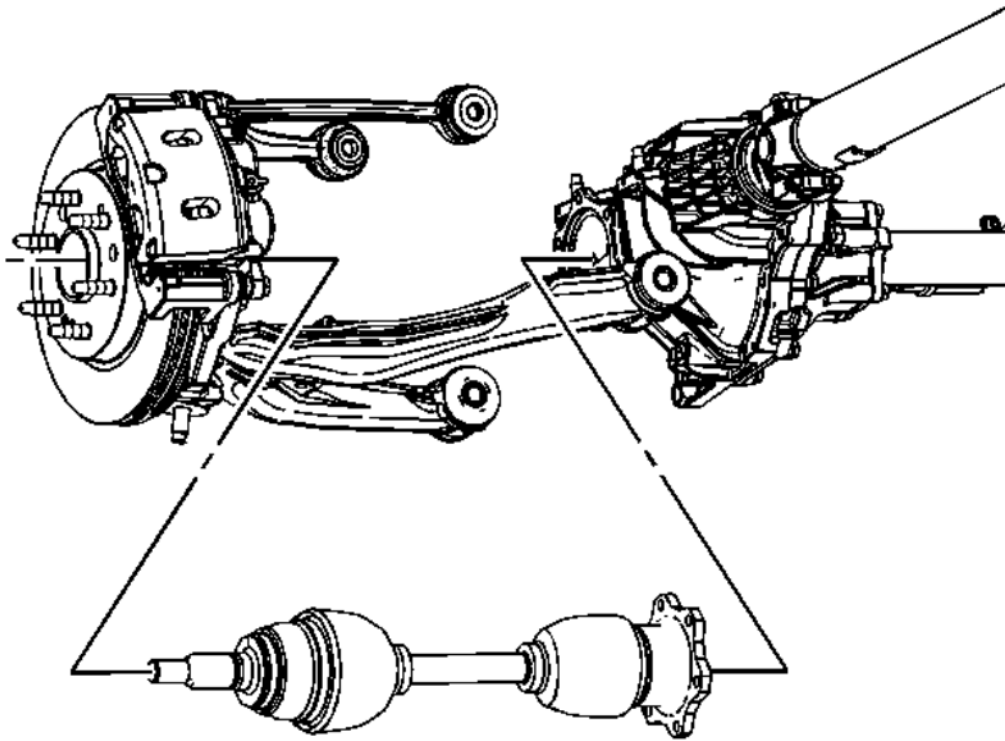
**Fig. 13: View Of Wheel Drive Shaft**  
**Courtesy of GENERAL MOTORS CORP.**

1. Install the wheel drive shaft in the steering knuckle.

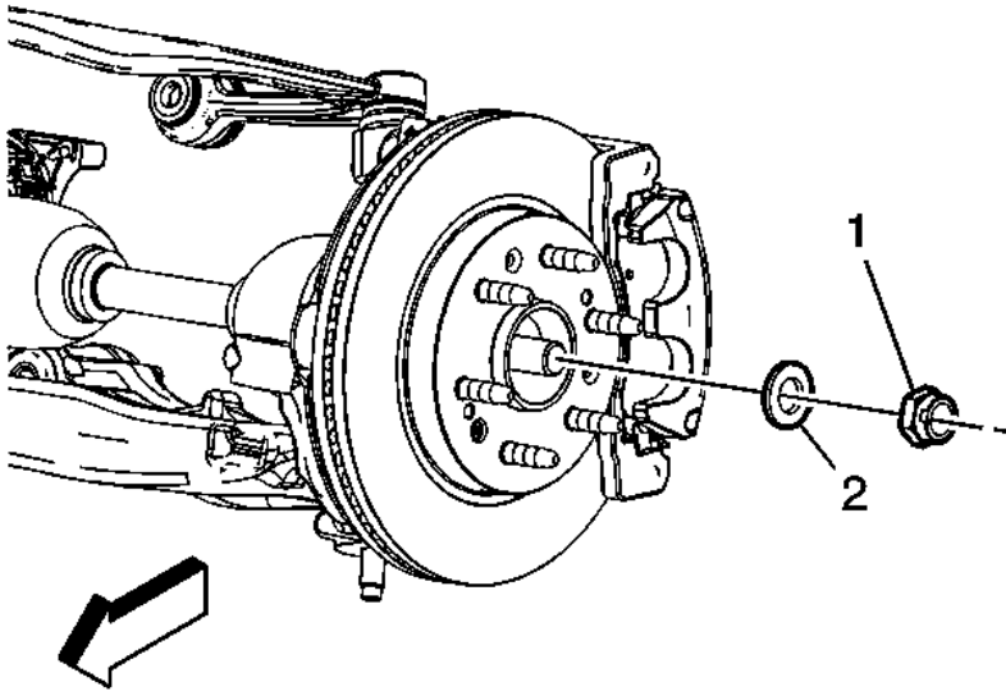
**Fig. 14: View Of Hub Nut & Washer**  
Courtesy of GENERAL MOTORS CORP.

**IMPORTANT:** Install the NEW nut and washer, but DO NOT tighten at this time.

2. Install the NEW nut (1) and washer (2).

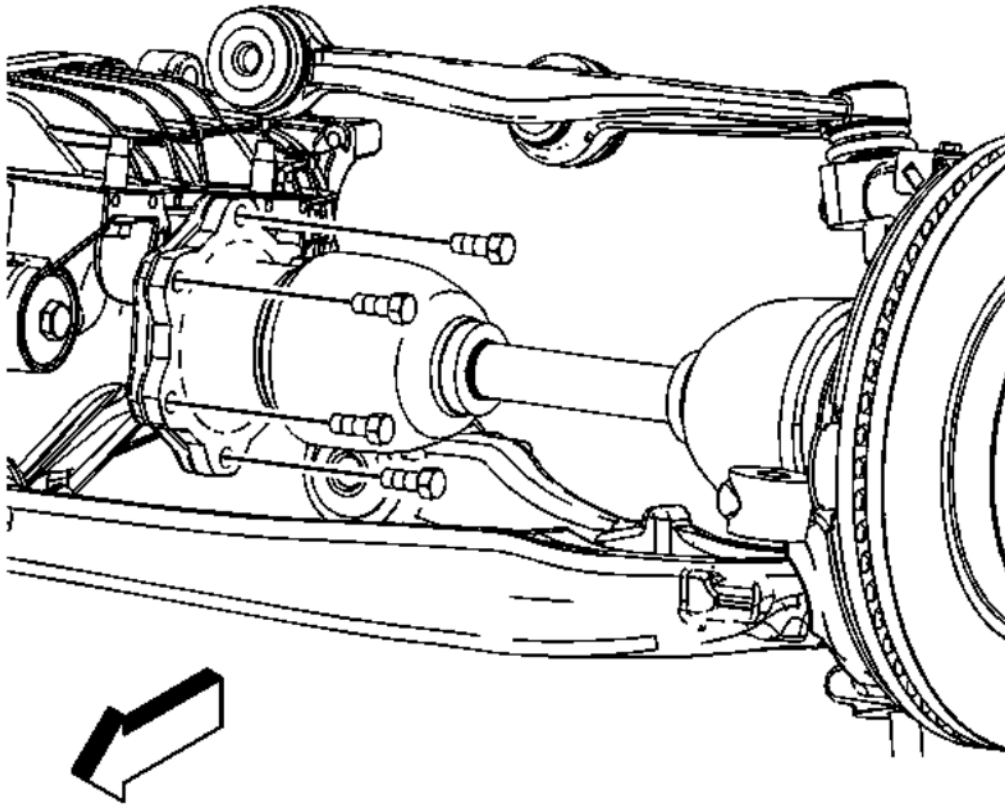
**Fig. 15: View Of Drive Flange & Retaining Bolts**  
Courtesy of GENERAL MOTORS CORP.

3. Install the retaining bolts and finger tighten.

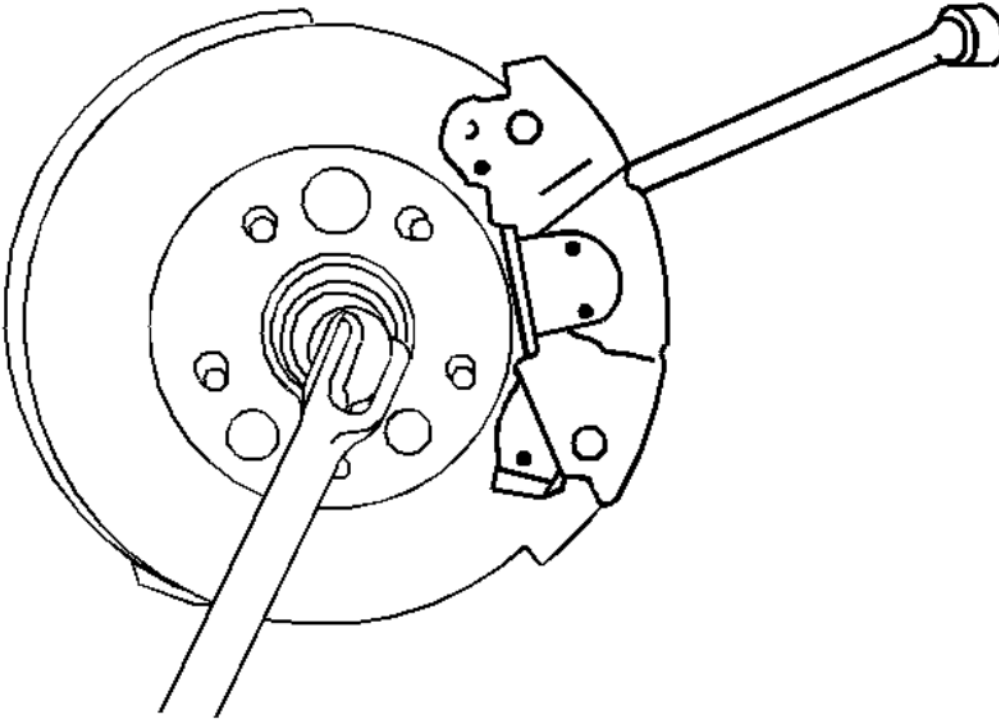
**Fig. 16: Inserting Drift Or Screwdriver To Prevent Wheel Drive Shaft From Turning**

5. Tighten the wheel driver shaft retaining bolts.

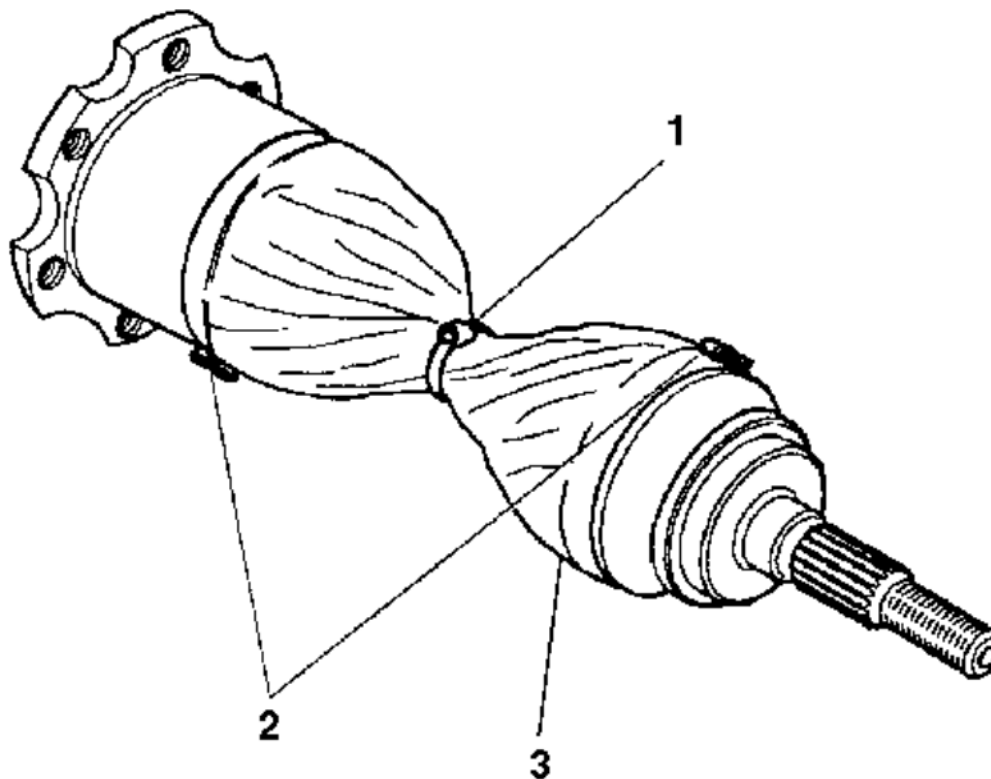
**Fig. 17: Seal Cover, Clamps & Nylon Strap**  
Courtesy of GENERAL MOTORS CORP.

1. Use side cutters to cut the halfshaft seal cover clamps (2) and the nylon strap (1).

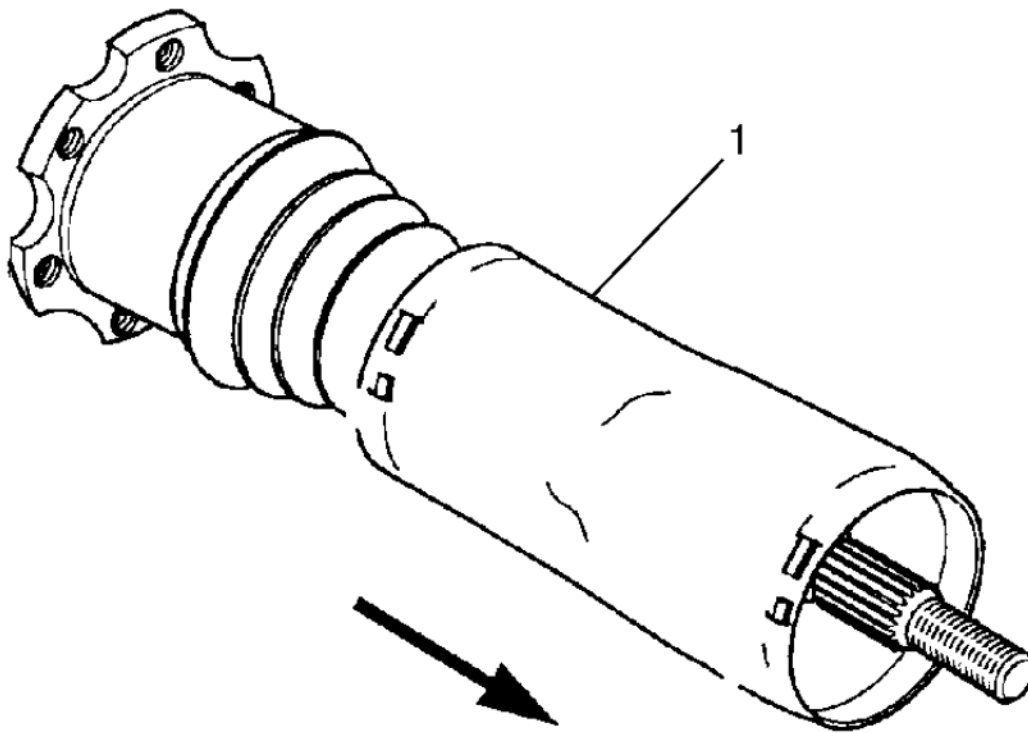
**Fig. 18: Seal Cover**  
Courtesy of GENERAL MOTORS CORP.

2. Slide the halfshaft seal cover (1) off of the halfshaft, over the CV joint end.
3. Check the halfshaft seal cover (1) for rips, tears, worn spots or other damage. Reuse the halfshaft seal cover (1) if there is no damage visible.

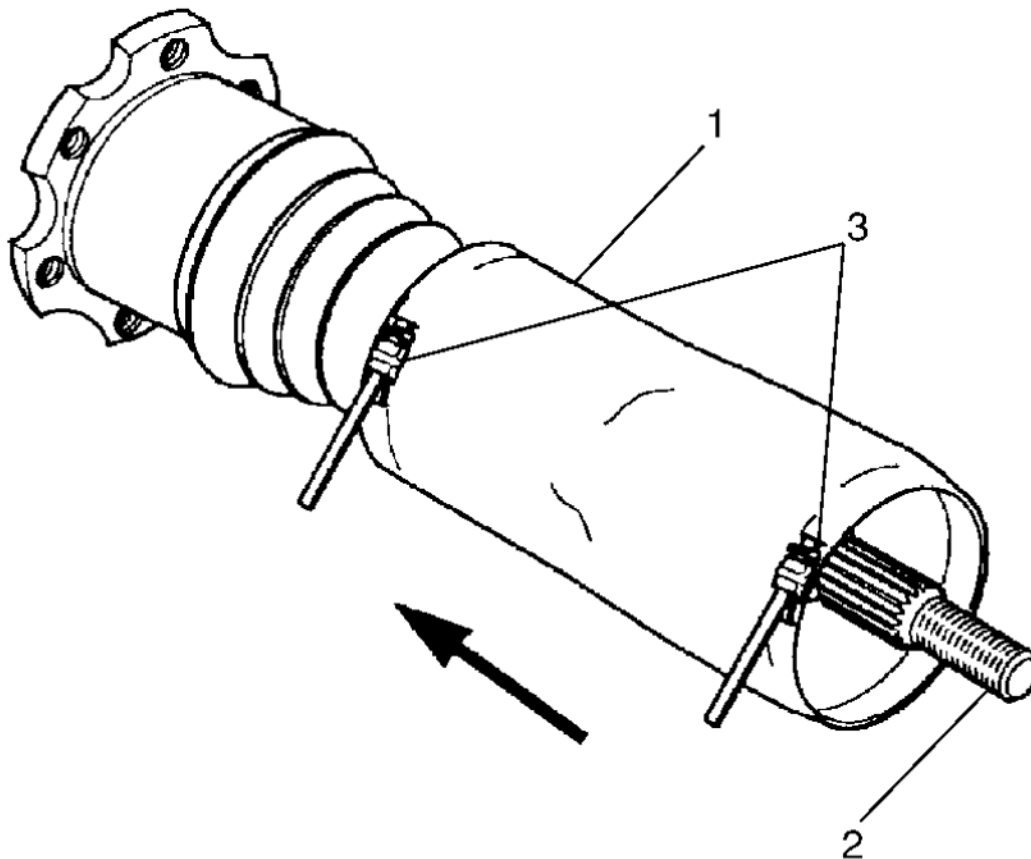
**Fig. 19: Seal Cover, Halfshaft Assembly & New Clamps**  
**Courtesy of GENERAL MOTORS CORP.**

1. Insert new clamps (3) into the original halfshaft seal cover (1) (if you are reusing the original halfshaft seal cover).
2. Slide the halfshaft seal cover (1) onto the halfshaft assembly (2), starting at the outboard (CV joint) end.

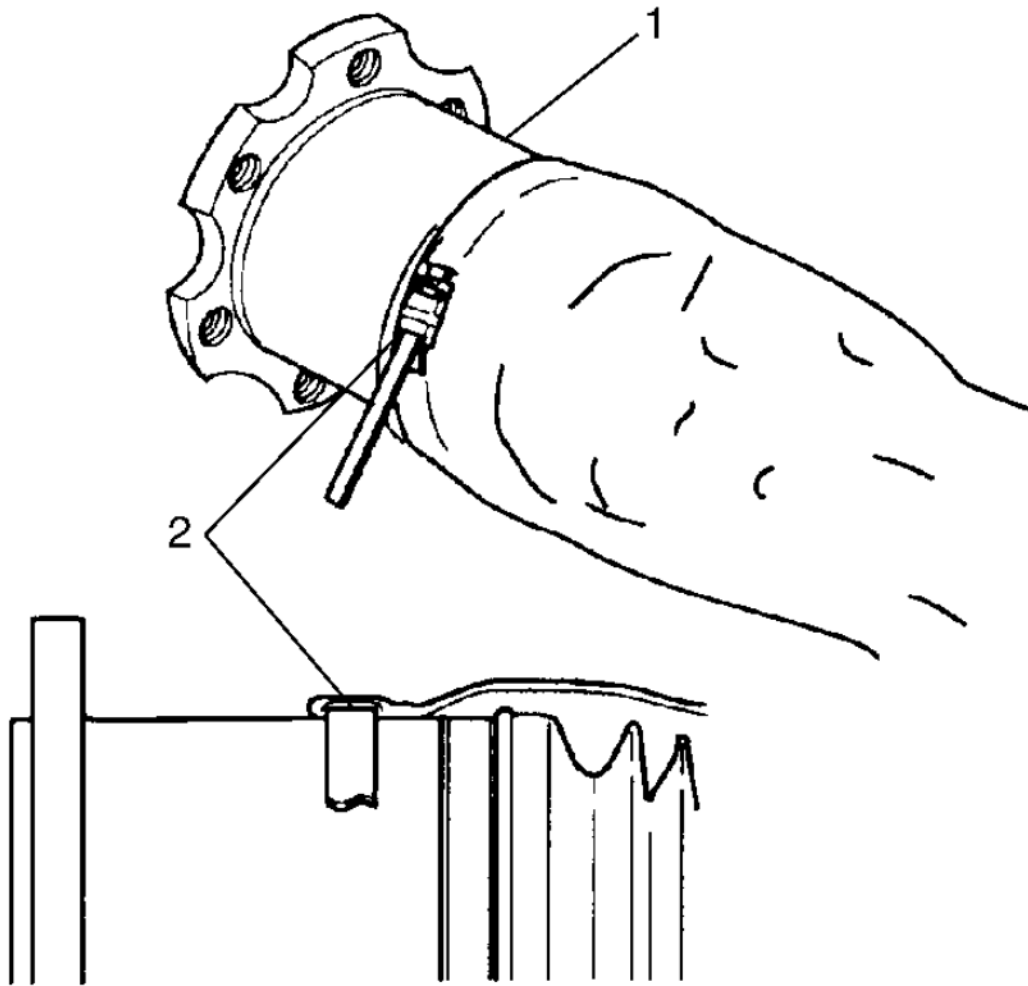
**Fig. 20: Installing Seal Cover**  
**Courtesy of GENERAL MOTORS CORP.**

3. Align the inboard clamp (2) on the inboard joint (1). Align the seal cover seam so the seam is straight.

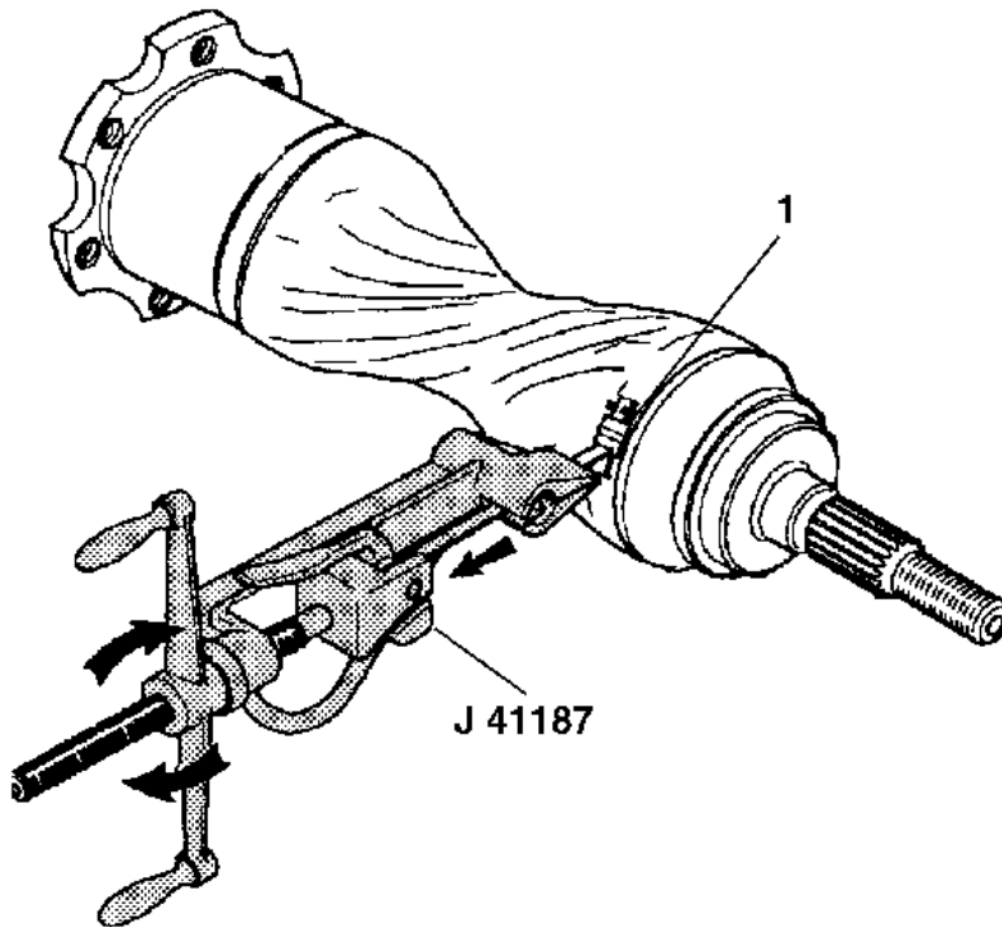
**Fig. 21: Tightening Seal Cover Clamp**  
Courtesy of GENERAL MOTORS CORP.

**IMPORTANT:** Tighten the seal cover clamp (1) as tight as possible without deforming the retaining clip. Clamps that are not tight enough allow the cover to slide upon the joint. This causes shortened service life.

4. Use **J 41187** in order to tighten the inboard seal cover clamp (1). See **Special Tools**.

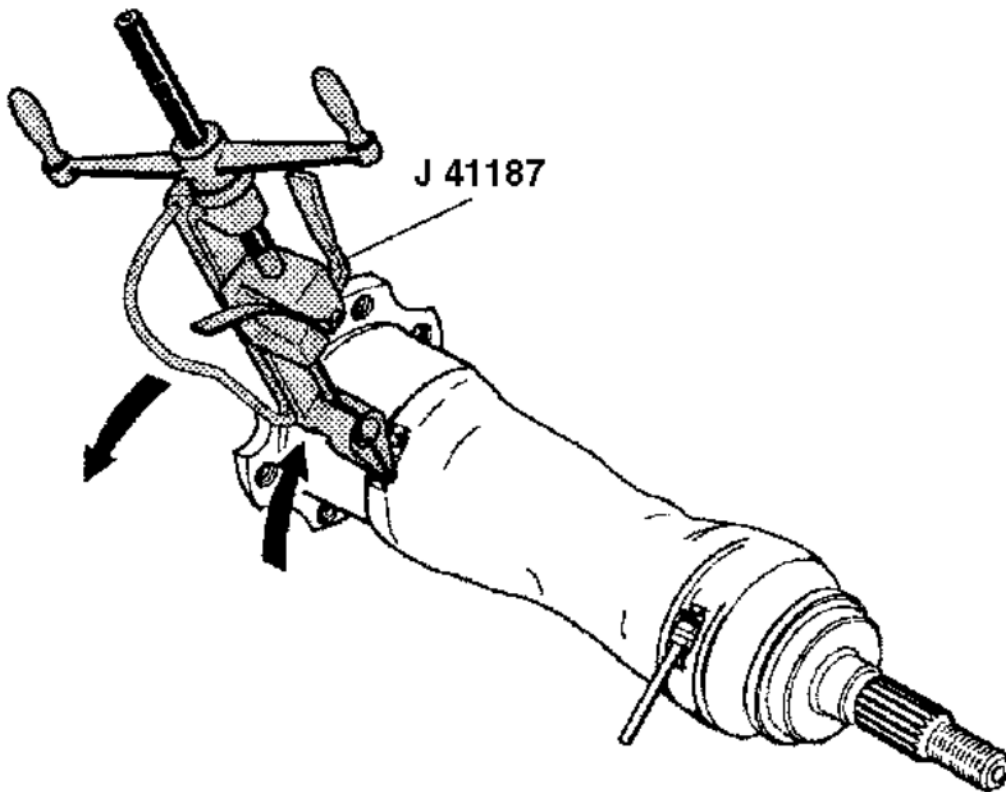
**Fig. 22: Bending Inboard Band Onto Clip**  
Courtesy of GENERAL MOTORS CORP.

5. Rotate **J 41187** toward the clip in order to bend the band onto the clip. See **Special Tools**.
6. Pull on the tool's cutting handle in order to cut off the excess band.

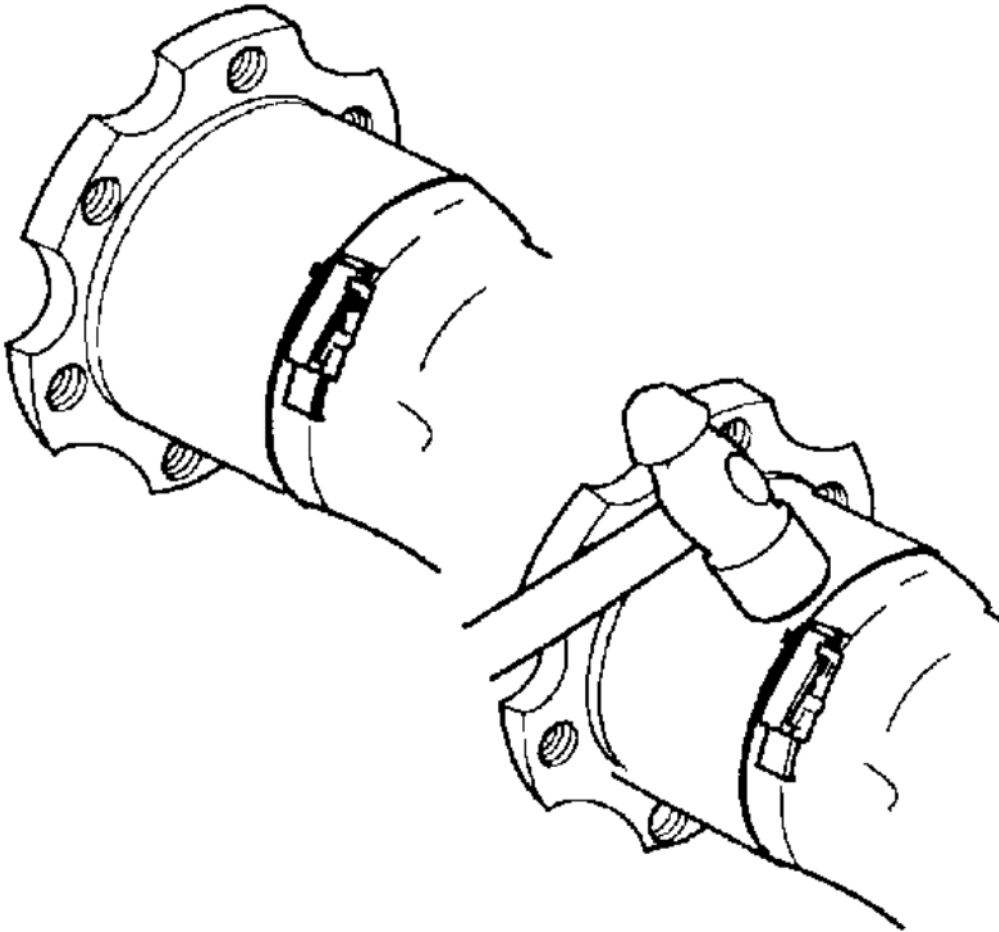
**Fig. 23: Pounding Inboard Band Flat**  
**Courtesy of GENERAL MOTORS CORP.**

7. Pound the band flat between the latch tabs. Peen the latch tabs over in order to lock the band into position.

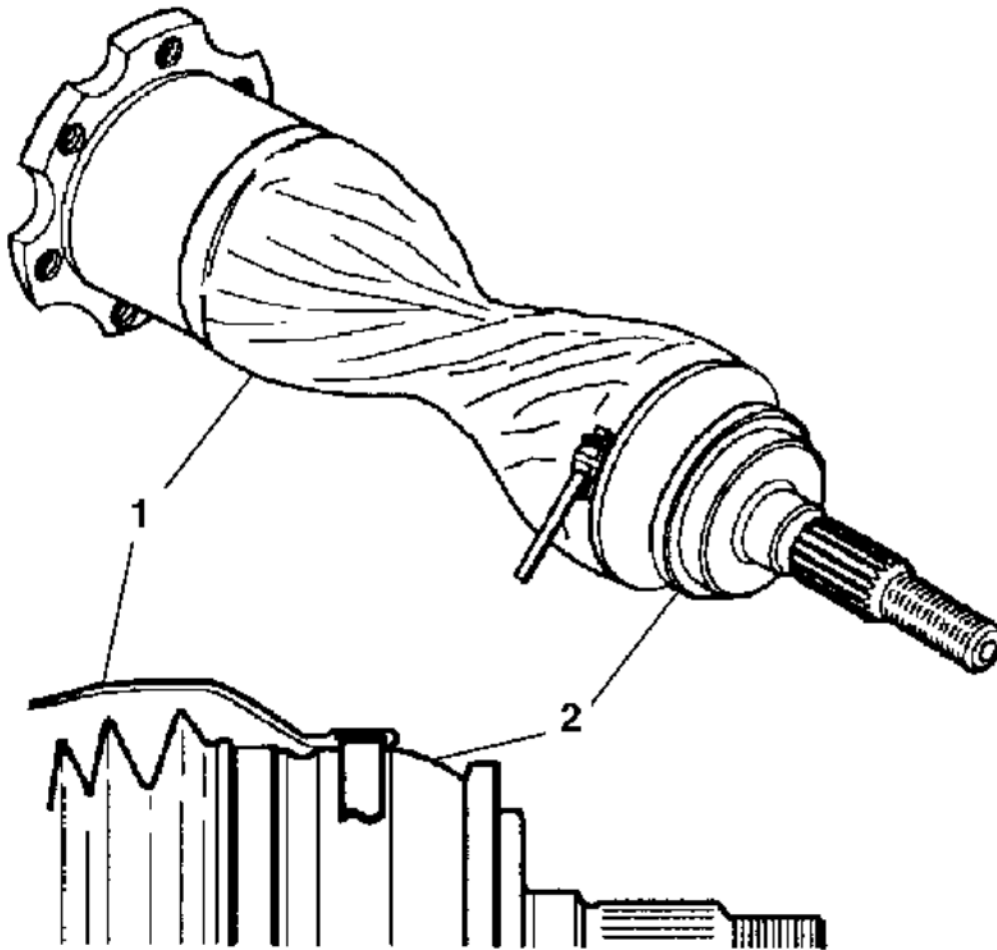
**Fig. 24: Halfshaft Seal Cover & CV Joint**  
**Courtesy of GENERAL MOTORS CORP.**

8. Twist the halfshaft seal cover (1) until the middle of the cover fits loosley against the halfshaft bar.
9. Position the outboard end of the halfshaft seal cover (1) over the CV joint (2) flat.

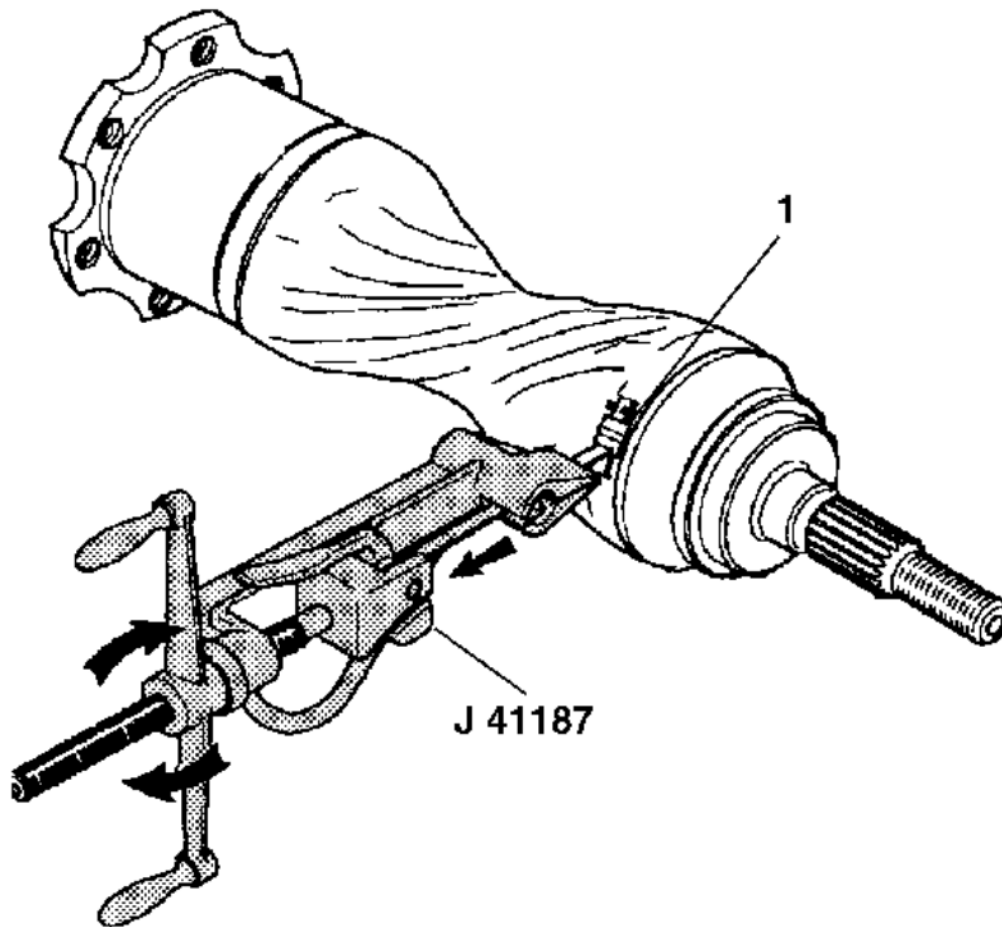
**Fig. 25: Tightening Seal Cover Clamp**  
Courtesy of GENERAL MOTORS CORP.

**IMPORTANT:** Tighten the seal cover clamp (1) as tight as possible without deforming the retaining clip. Clamps that are not tight enough allow the cover to slide upon the joint. This causes shortened service life.

10. Use **J 41187** in order to tighten the outboard cover clamp (1). See Special Tools.
