## 2008 Chevrolet Silverado 1500

2008 DRIVELINE/AXLE Wheel Drive Shafts - Cab & Chassis Sierra, Cab & Chassis Silverado, Sierra & Silverado

### WHEEL DRIVE SHAFT REPLACEMENT (2500)

## WHEEL DRIVE SHAFT REPLACEMENT (1500)

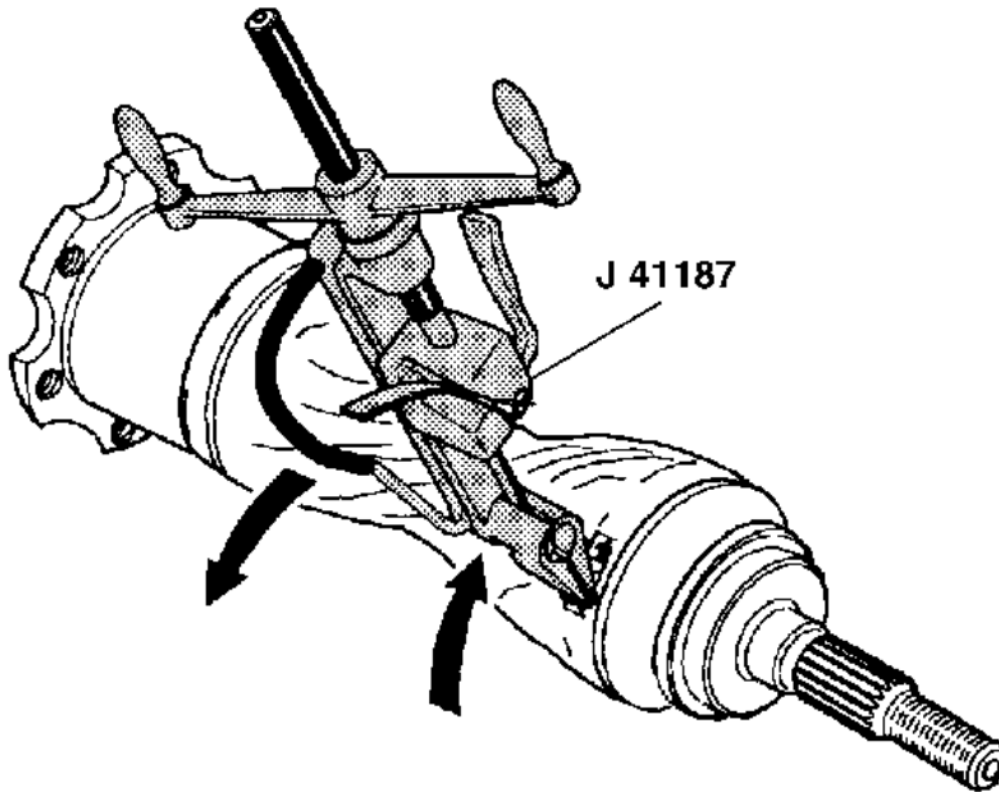
**Fig. 26: Bending Outboard Band Onto Clip**  
**Courtesy of GENERAL MOTORS CORP.**

11. Rotate **J 41187** toward the clip in order to bend the band onto the clip. See **Special Tools**.
12. Pull the tool's cutting handle in order to cut off the excess band.

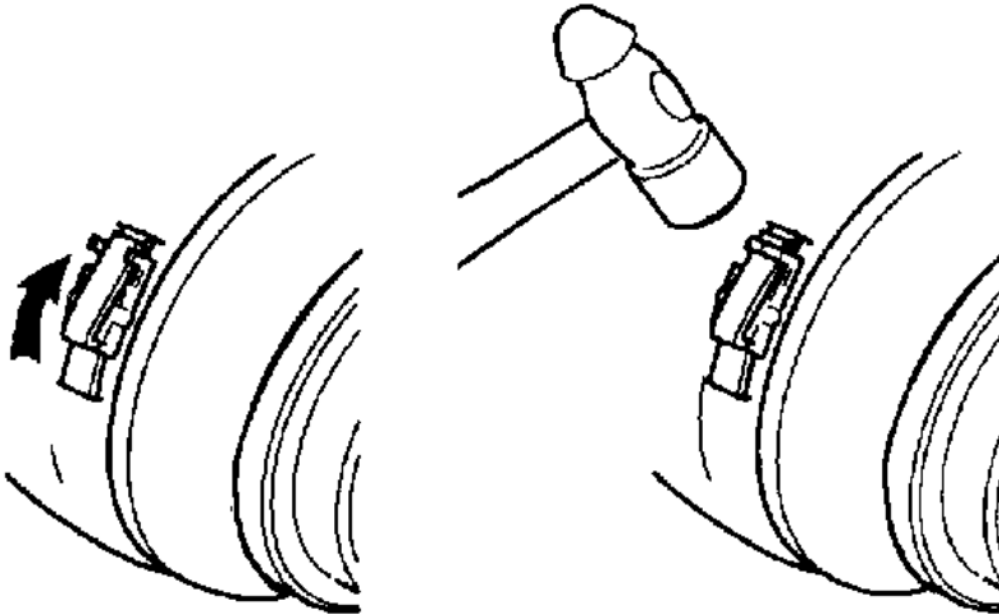
**Fig. 27: Pounding Outboard Band Flat**  
**Courtesy of GENERAL MOTORS CORP.**

13. Pound the band flat between the latch tabs. Peen the latch tabs over in order to lock the band into position.

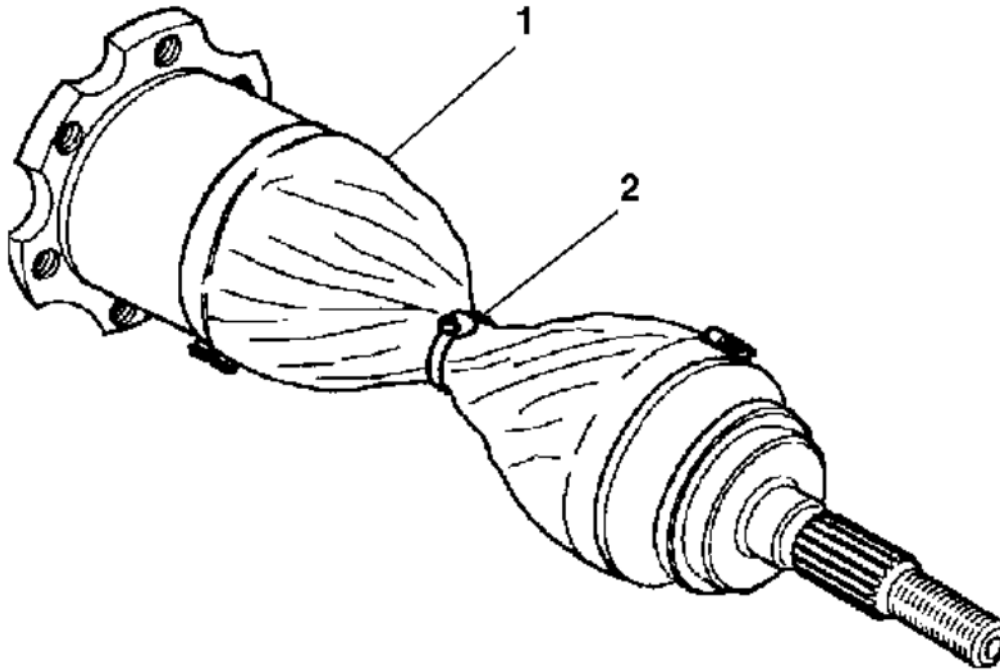
**Fig. 28: Halfshaft Seal Cover & Nylon Strap**  
**Courtesy of GENERAL MOTORS CORP.**

14. Gather the halfshaft seal cover material at the center. Wrap the halfshaft seal cover (1) tightly with the nylon strap (2) provided in the kit.

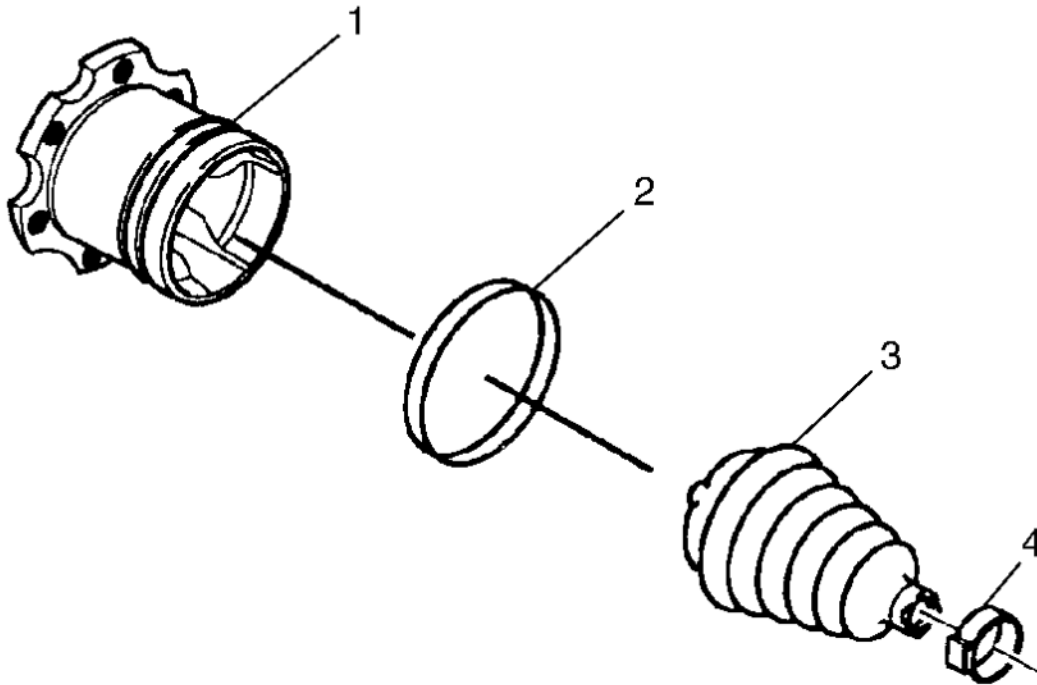
**Fig. 29: Tripot Housing & Swage Ring**  
Courtesy of GENERAL MOTORS CORP.

3. Use a hand grinder in order to cut through the swage ring (2).
4. Remove the tripot housing (1) from the halfshaft.
5. Wipe the grease off of the housing (1).
6. Thoroughly degrease the tripot housing (1).
7. Allow the tripot housing (1) to dry prior to assembly.

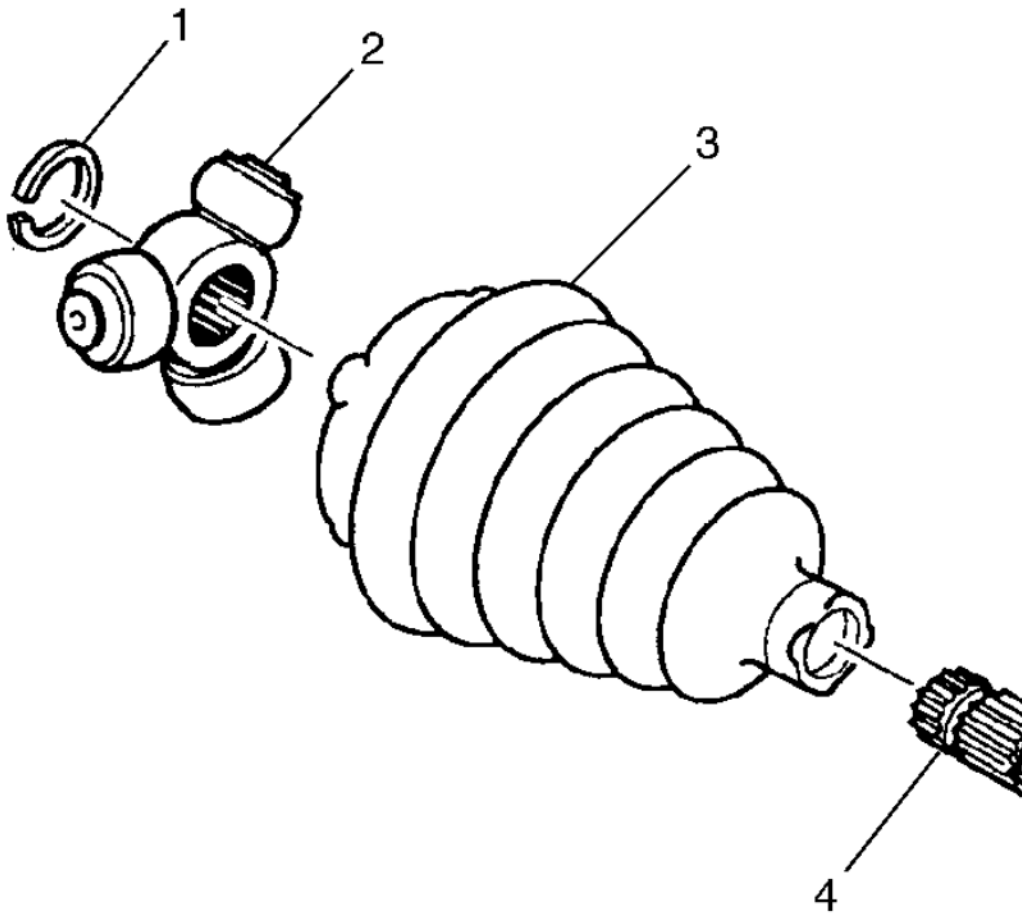
**Fig. 30: Spacer Ring, Tripot Spider Assembly, Tripot Boot & Halfshaft Bar**  
Courtesy of GENERAL MOTORS CORP.

8. Using side cutters, remove the small boot retaining clamp.
9. Remove the following items from the halfshaft bar:
  1. The spacer ring (1)
  2. The tripot spider assembly (2)
  3. The tripot boot (3)
10. Clean the halfshaft bar (4). Use a wire brush in order to remove any rust in the seal mounting area (grooves).
11. Inspect the needle rollers, needle bearings, and trunnion. Inspect the tripot housing for unusual wear, cracks, or other damage. Replace any damaged parts with the appropriate

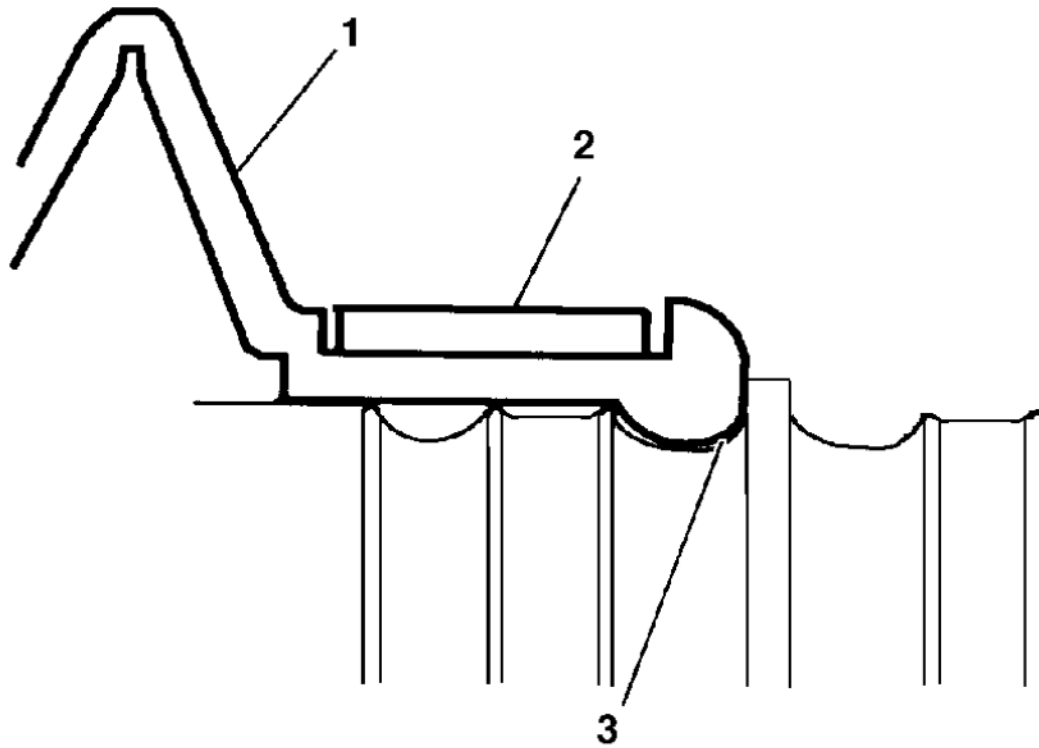
**Fig. 31: Positionng Small End Of Joint Seal Into Joint Seal Groove**  
**Courtesy of GENERAL MOTORS CORP.**

1. Place the new small seal clamp (2) onto the small end of the joint seal (1). Compress the joint seal (1) and small seal clamp (2) onto the halfshaft bar.
2. Position the small end of the joint seal (1) into the joint seal groove (3) on the halfshaft bar.

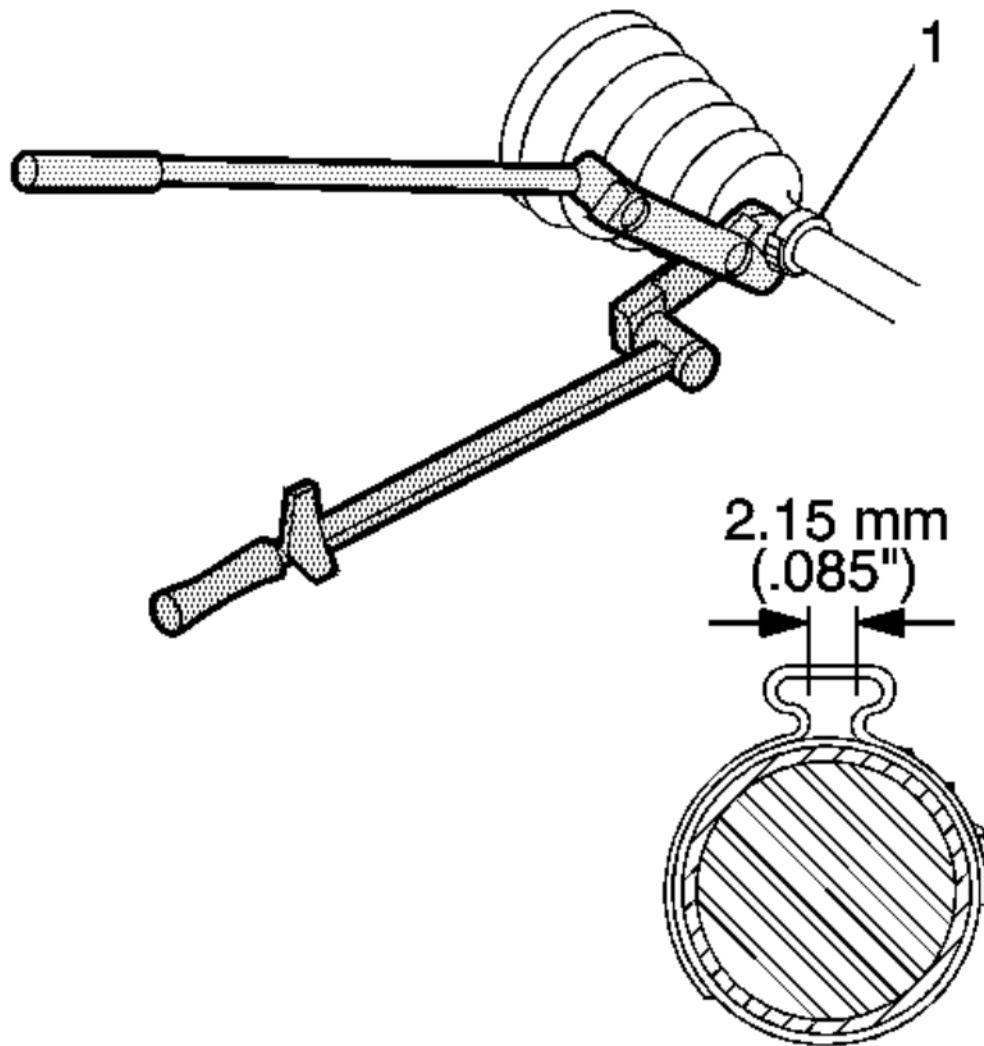
**Fig. 32: View Of CV Joint Seal Retaining Clamp**  
Courtesy of GENERAL MOTORS CORP.

4. Inspect the gap dimension on the clamp ear. Continue tightening until the gap dimension is reached.

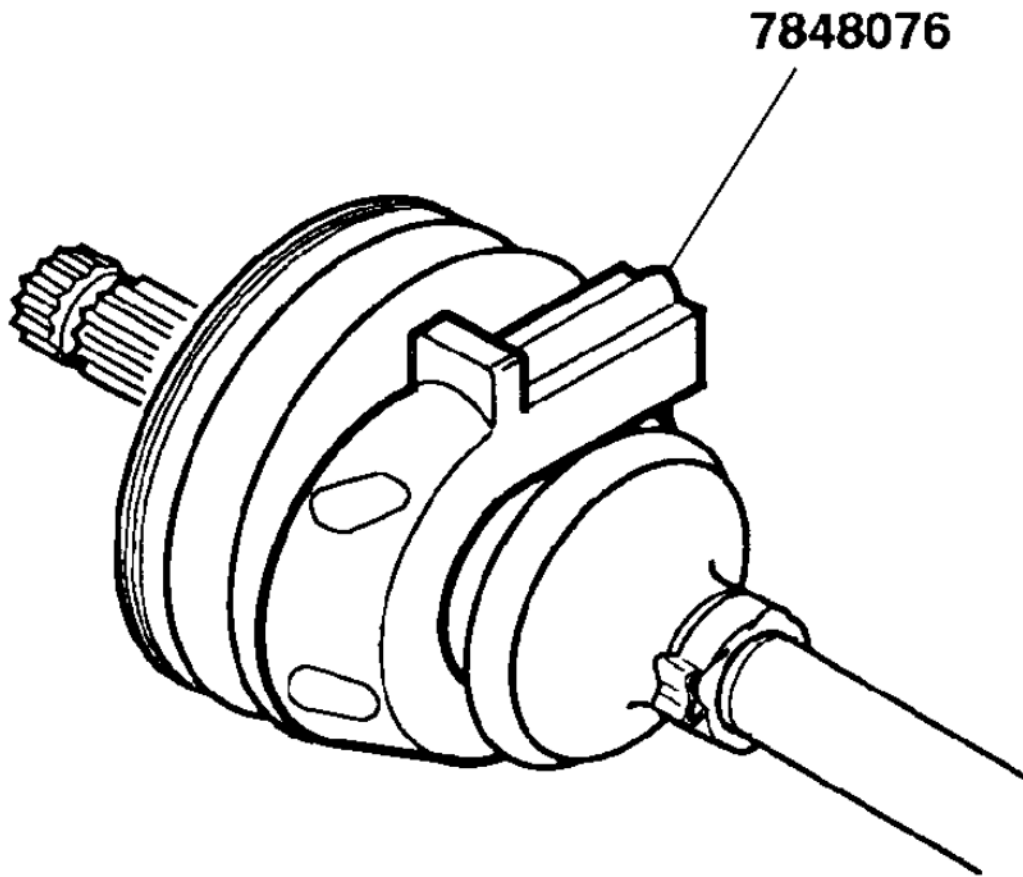
**Fig. 33: Tripot Joint W/Convolute Retainer**  
Courtesy of GENERAL MOTORS CORP.

**IMPORTANT:** Assemble the tripot joint with the convolute retainer in the correct position, as illustrated.

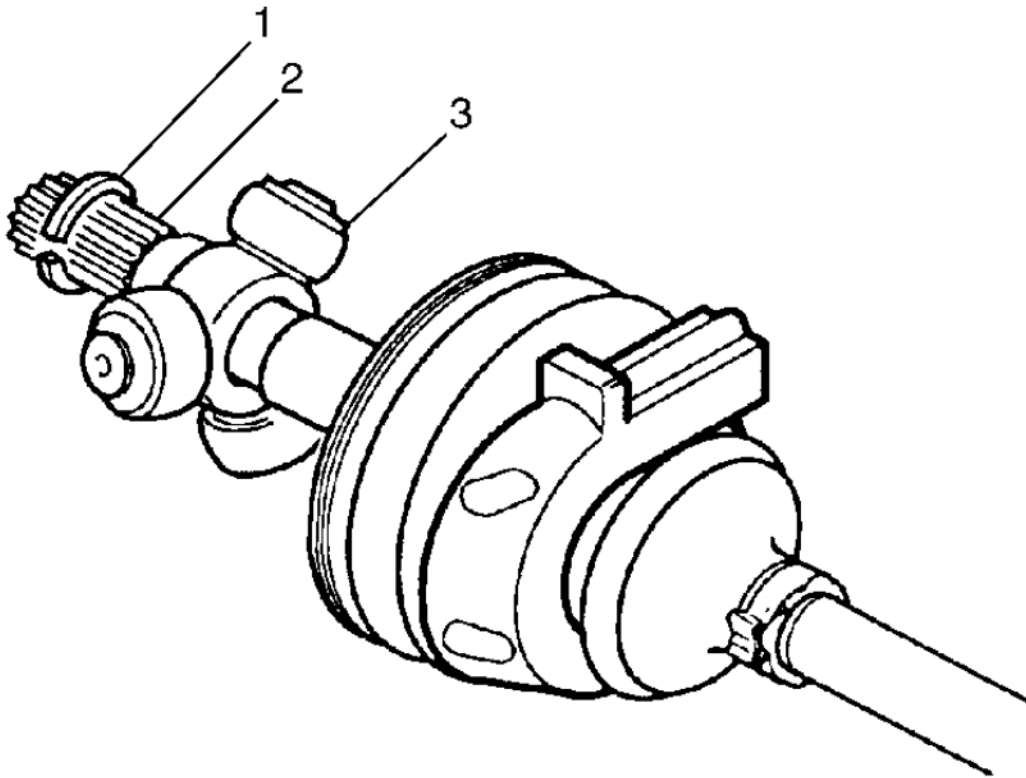
**Fig. 34: Spacer Ring, Halfshaft Bar & Tripot Spider Assembly**  
**Courtesy of GENERAL MOTORS CORP.**

6. Install the tripot spider assembly (3) onto the halfshaft bar (2).
7. Install the spacer ring (1) in the groove at the end of the halfshaft bar (2).

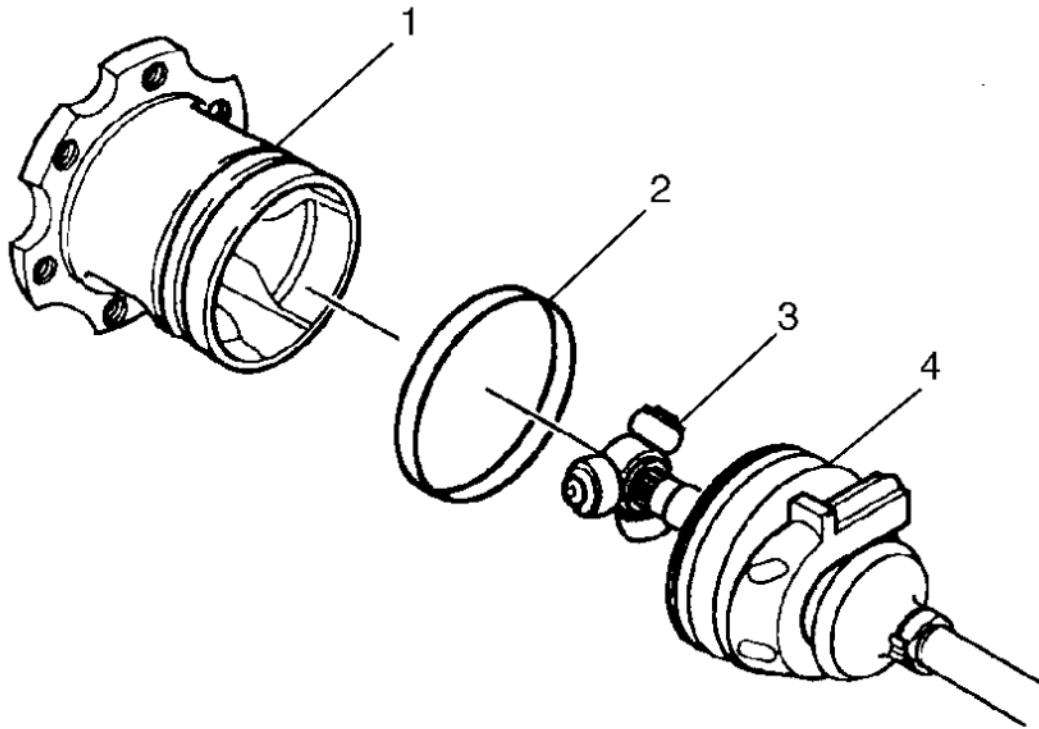
**Fig. 35: Tripot Housing, Tripot & Seal**  
Courtesy of GENERAL MOTORS CORP.

8. Pack the tripot seal (4) and the tripot housing (1) with the grease supplied in the kit.

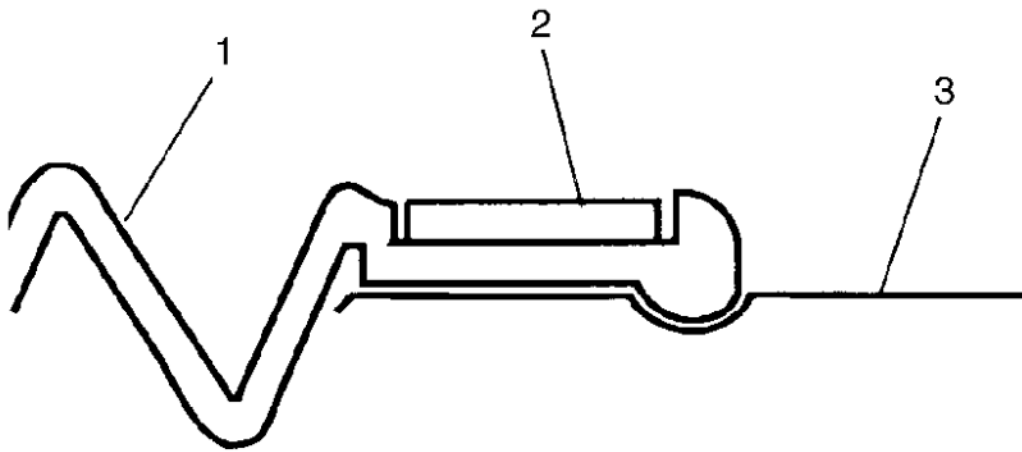
**Fig. 36: Assembling Tripot Housing And Tripot Seal**  
**Courtesy of GENERAL MOTORS CORP.**

9. Assemble the tripot housing and the tripot seal using the following procedure:
  1. Pinch the swage ring (2) slightly by hand in order to distort it into an oval shape.
  2. Slide the distorted swage ring (2) over the large diameter of the seal.
  3. Place the tripot housing over the spider assembly.
  4. Install the seal onto the tripot housing.
  5. Align the tripot seal (1), with the swage ring (2) in place, over the flat area on the tripot housing (3).

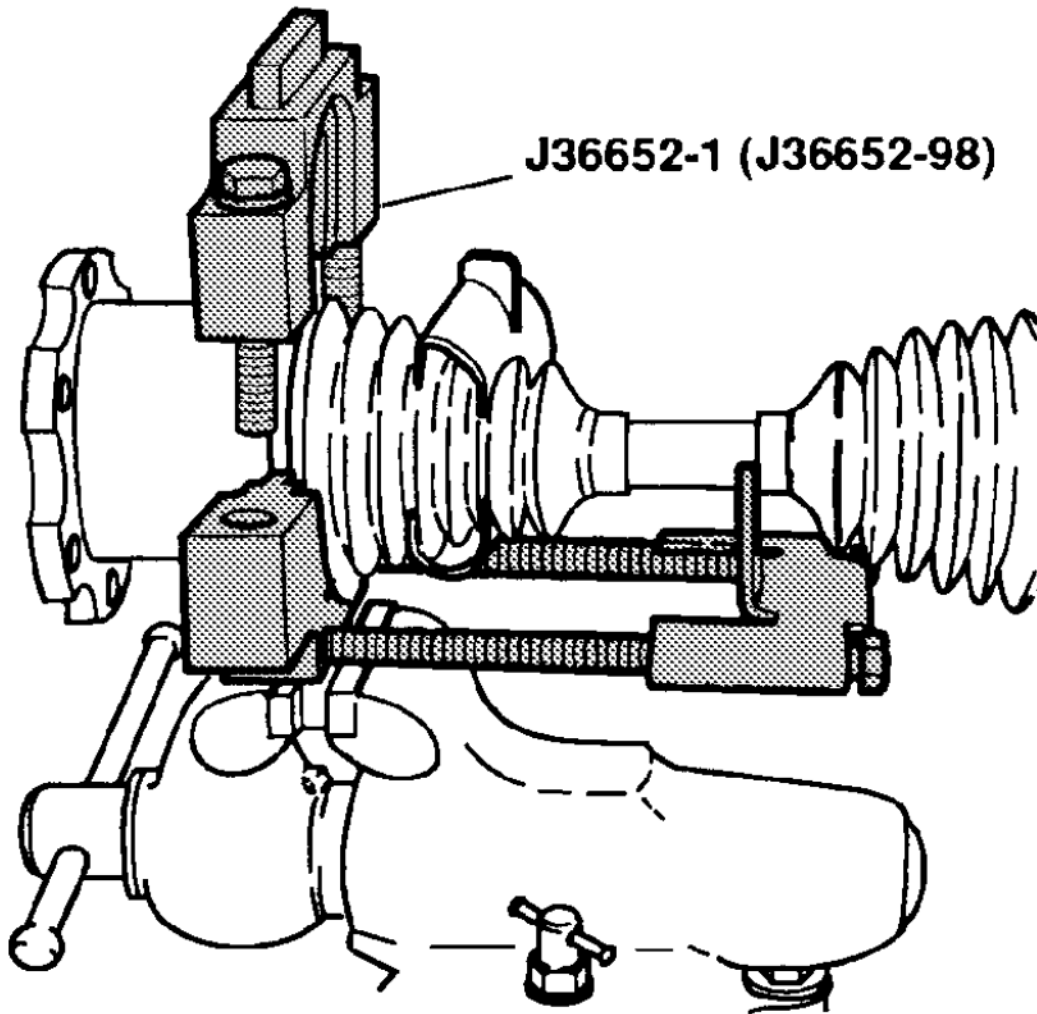
**Fig. 37: Assembling Bolts And Support Plate To Base Of J 36652-98**  
**Courtesy of GENERAL MOTORS CORP.**

10. For the 1500 models, assemble the bolts and the support plate to the base of the **J 36652-98** and secure the base in a vise. See **Special Tools**.
11. For the 2500 and 3500 models, assemble the bolts and the support plate to the base of the **J 36652-1** and secure the base in a vise. See **Special Tools**.

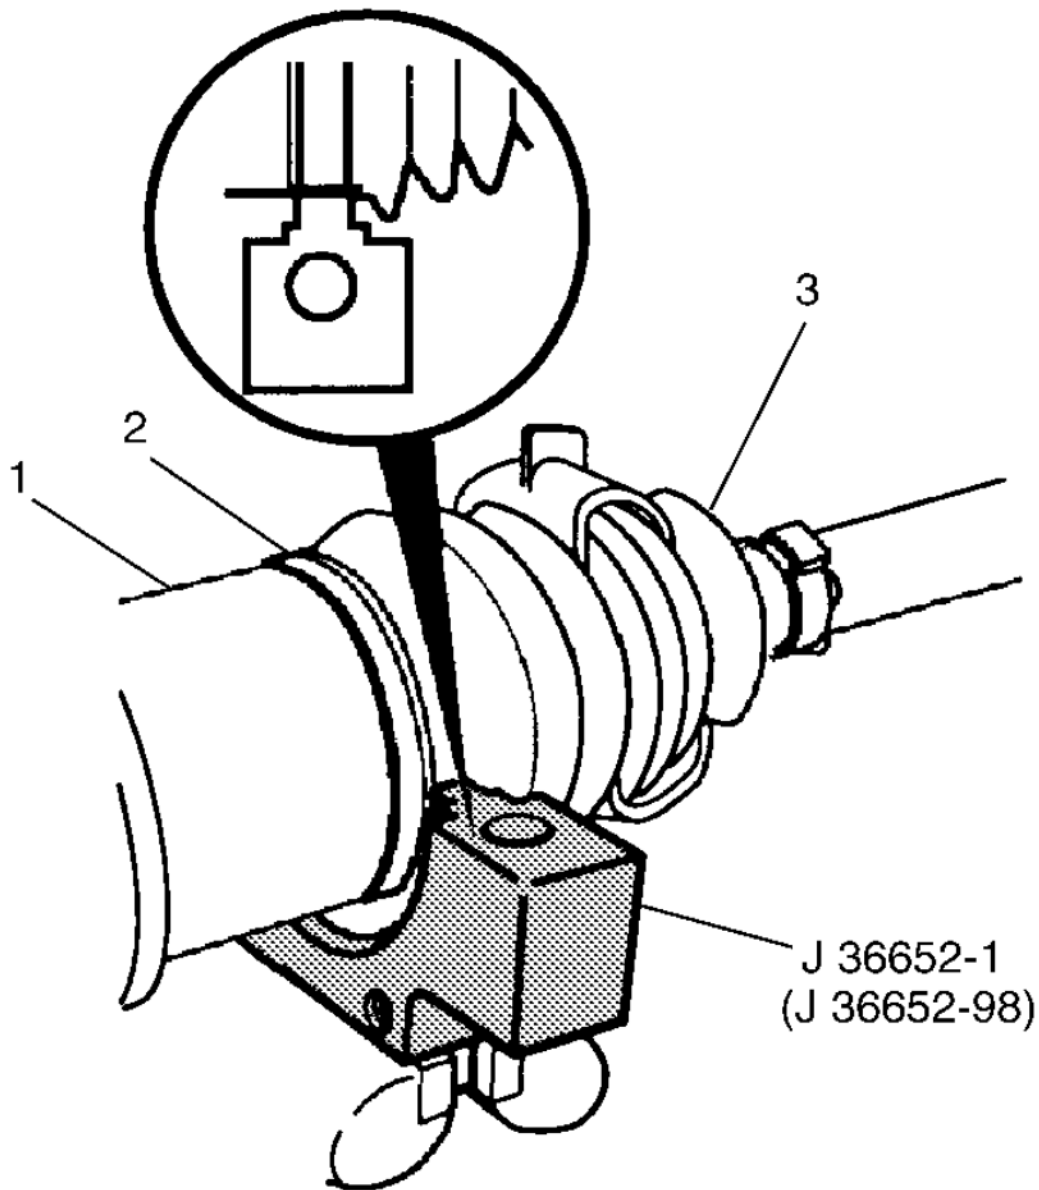
**Fig. 38: Installing Swage Ring**  
Courtesy of GENERAL MOTORS CORP.

12. Position the inboard end (tripot end) of the halfshaft assembly into the base of the **J 36652-98** for the 1500 models or **J 36652-1** for the 2500 and 3500 models. See **Special Tools**.
13. Install the top half of the **J 36652-98** for the 1500 models or **J 36652-1** for the 2500 and

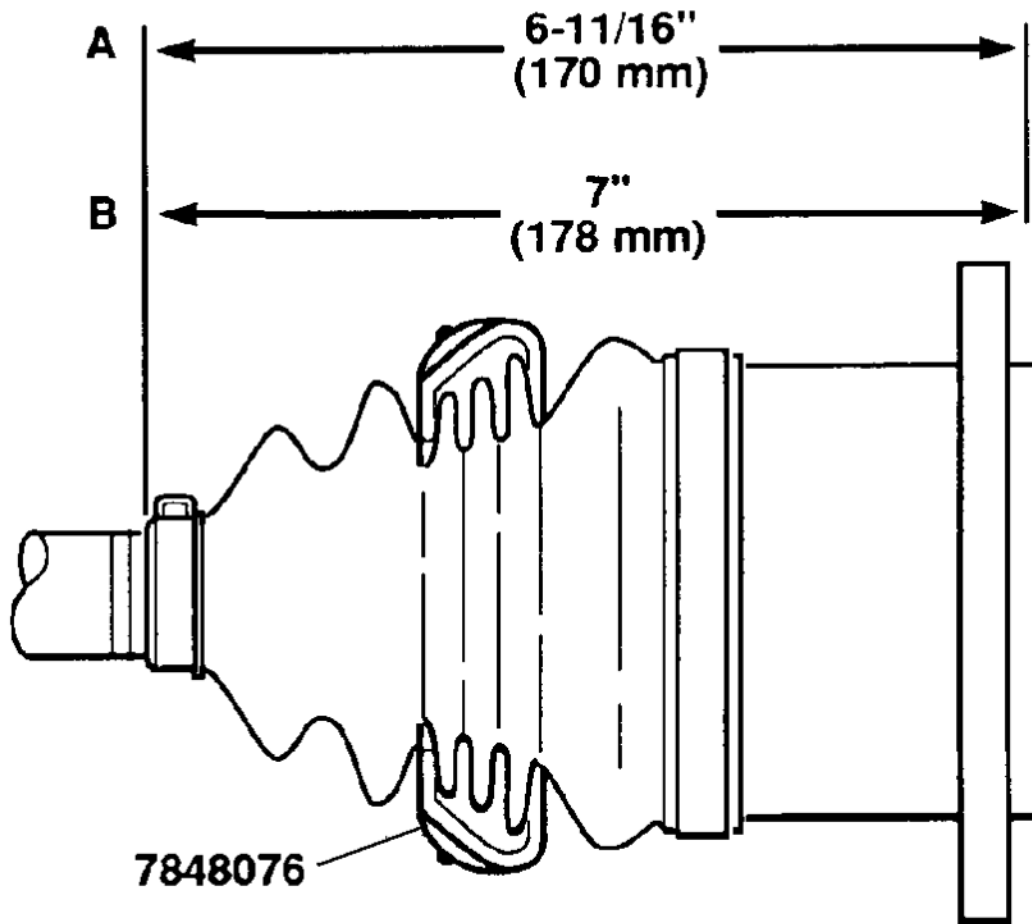
**Fig. 39: Inspecting Inboard Stroke Position**  
**Courtesy of GENERAL MOTORS CORP.**

17. Inspect the inboard stroke position.
  - Use measurement A for the 1500 models.
  - Use measurement B for the 2500 and 3500 models.

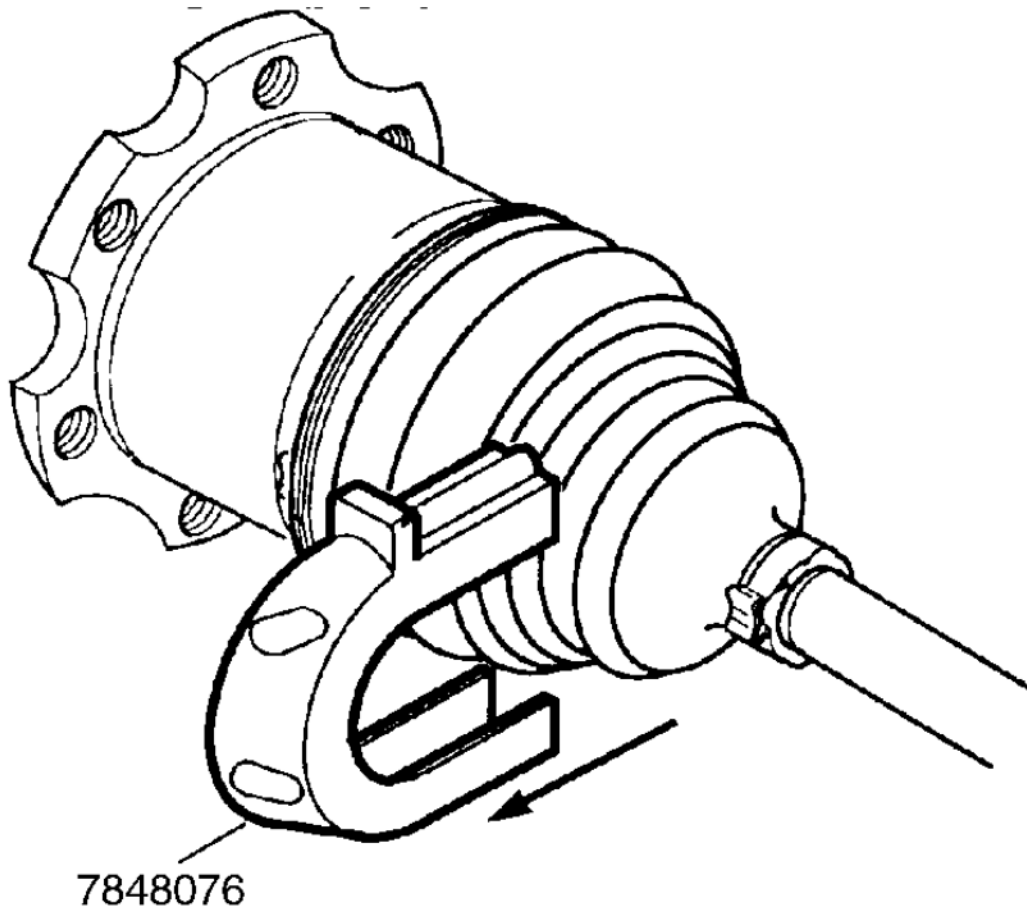
**Fig. 40: View Of Convolute Retainer Tool**  
Courtesy of GENERAL MOTORS CORP.

18. Remove the convolute retainer tool from the boot.
19. Install the wheel drive shaft seal cover, if applicable. Refer to **Wheel Drive Shaft Seal Cover Replacement**.
20. Install the wheel drive shaft. Refer to **Wheel Drive Shaft Replacement (2500)** or **Wheel Drive Shaft Replacement (1500)**.

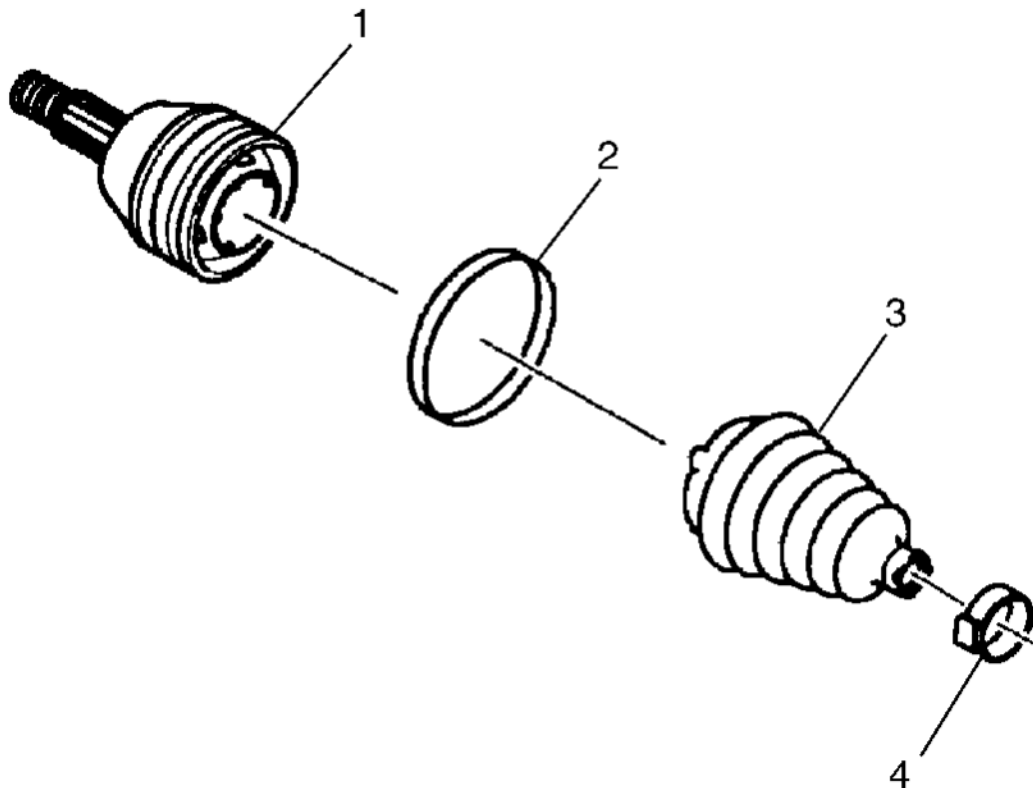
**Fig. 41: CV Joint Outer Race, Swage Ring, Boot & Small Boot Clamp**  
Courtesy of GENERAL MOTORS CORP.

3. Use a hand grinder to cut through the swage ring (2).
4. Use side cutters to cut off the small boot clamp (4).

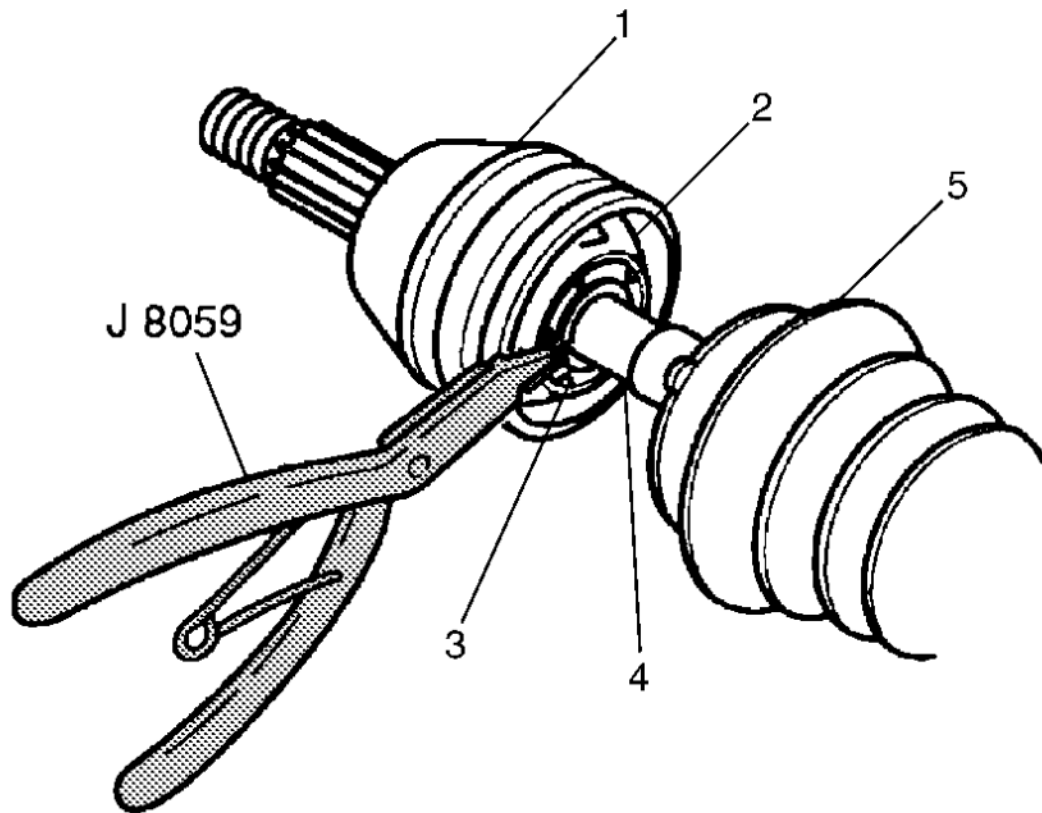
**Fig. 42: Spreading Snap Ring Ears Apart Using J 8059**  
Courtesy of GENERAL MOTORS CORP.

5. Slide the boot (5) down the halfshaft bar (4) and away from the CV joint outer race (1).
6. Wipe all grease away from the face of the CV joint.
7. Find the halfshaft bar retaining snap ring (3), which is located in the inner race (2).
8. Spread the snap ring ears apart using **J 8059** (or equivalent). See **Special Tools**.
9. Pull the CV joint (1) and the CV joint boot (5) from the halfshaft bar (4).
10. Discard the old CV joint boot (5).

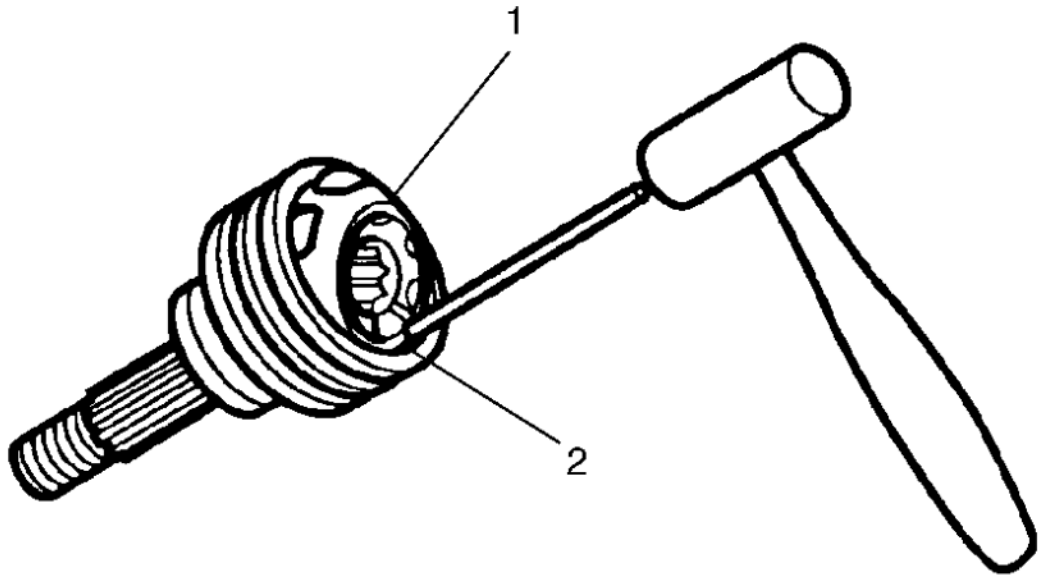
**Fig. 43: Taping Gently On Brass Drift With A Hammer In Order To Tilt Cage**  
**Courtesy of GENERAL MOTORS CORP.**

11. Place a brass drift against the CV joint cage (1).
12. Tap gently on the brass drift with a hammer in order to tilt the cage (1).
13. Remove the first chrome alloy ball (2) when the CV joint cage (1) tilts.
14. Tilt the CV joint cage (1) in the opposite direction to remove the opposing chrome alloy ball (2).
15. Repeat this process to remove all six of the balls.

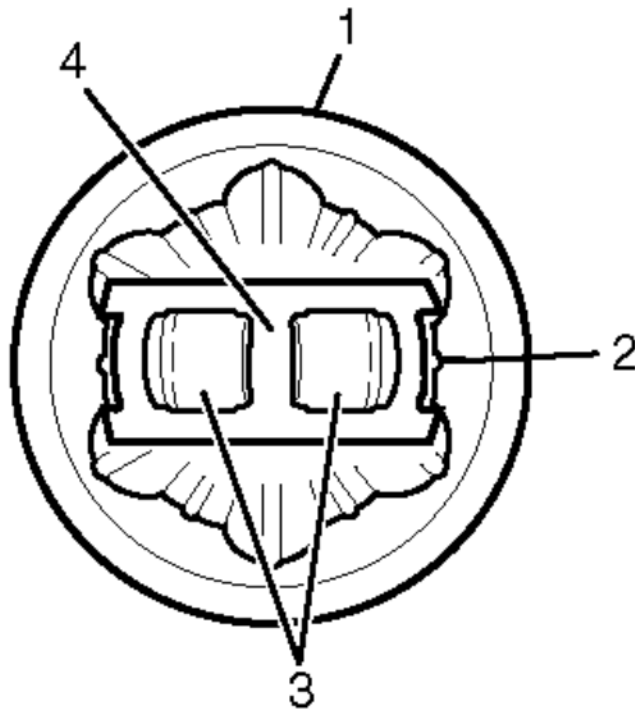
**Fig. 44: View Of Outer Race, Inner Race, Cage Window & CV Joint Cage**  
**Courtesy of GENERAL MOTORS CORP.**

16. Pivot the CV joint cage (4) and the inner race 90 degrees to the center line of the outer race (1). At the same time, align the cage windows (3) with the lands of the outer race (2).
17. Lift out the cage (4) and the inner race.

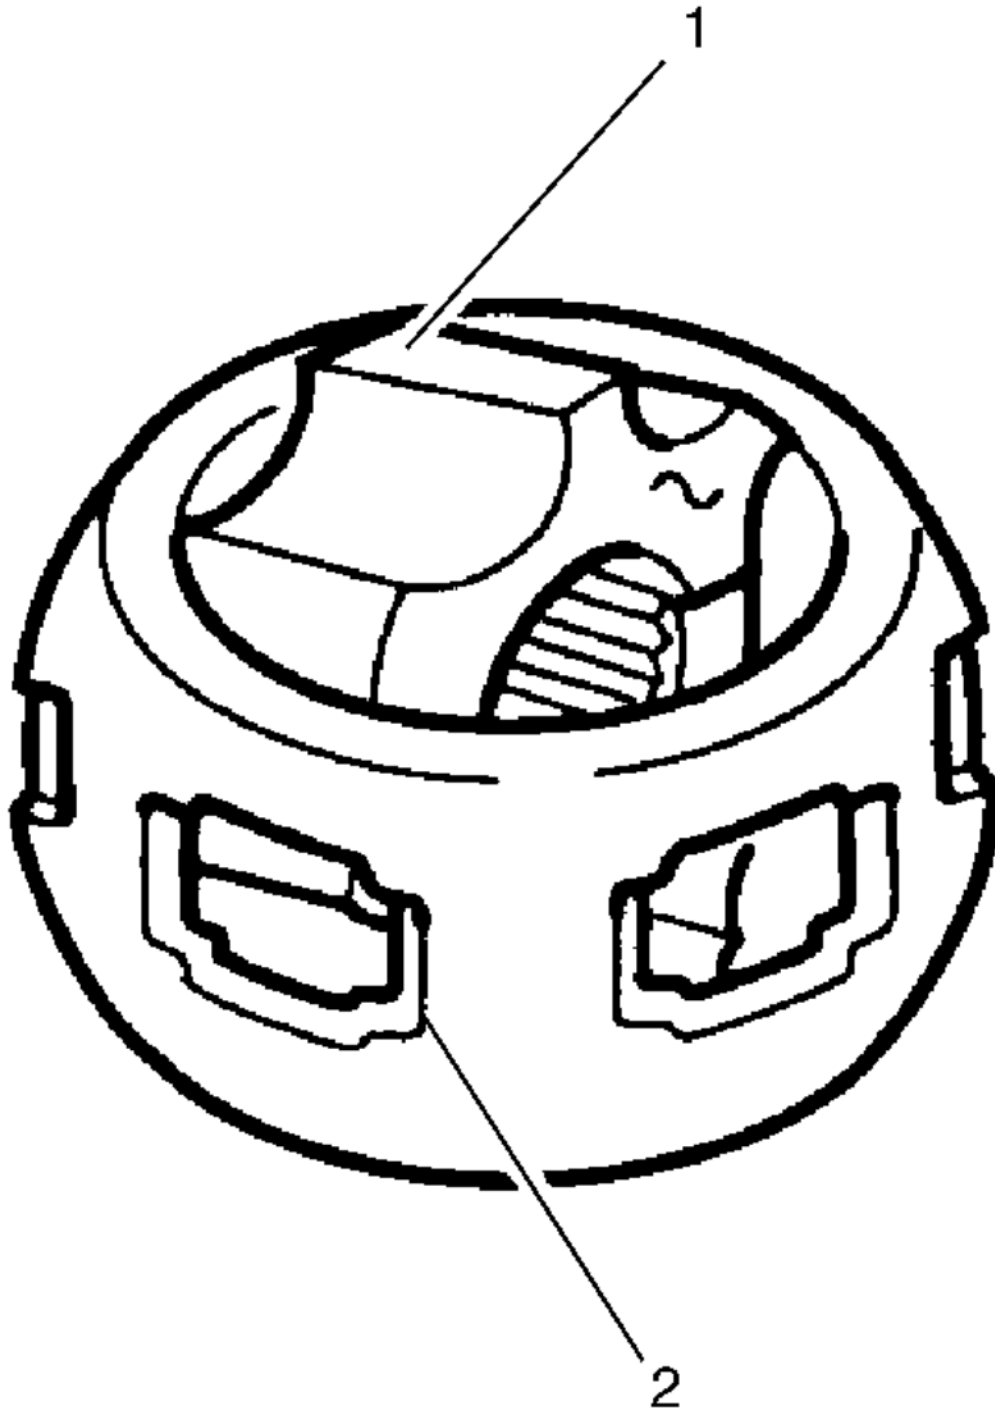
**Fig. 45: View Of Inner Race & Cage**  
**Courtesy of GENERAL MOTORS CORP.**

18. Remove the inner race (1) from the cage (2) by rotating the inner race (1) upward.
19. Clean the following items thoroughly with cleaning solvent. Remove all traces of old grease and any contaminants.
  1. The inner and outer race assemblies
  2. The CV joint cage
  3. The chrome alloy balls
20. Dry all the parts.
21. Check the CV joint assembly for unusual wear, cracks, or other damage.
22. Replace any damaged parts.
23. Clean the halfshaft bar. Use a wire brush to remove any rust in the seal mounting area (grooves).

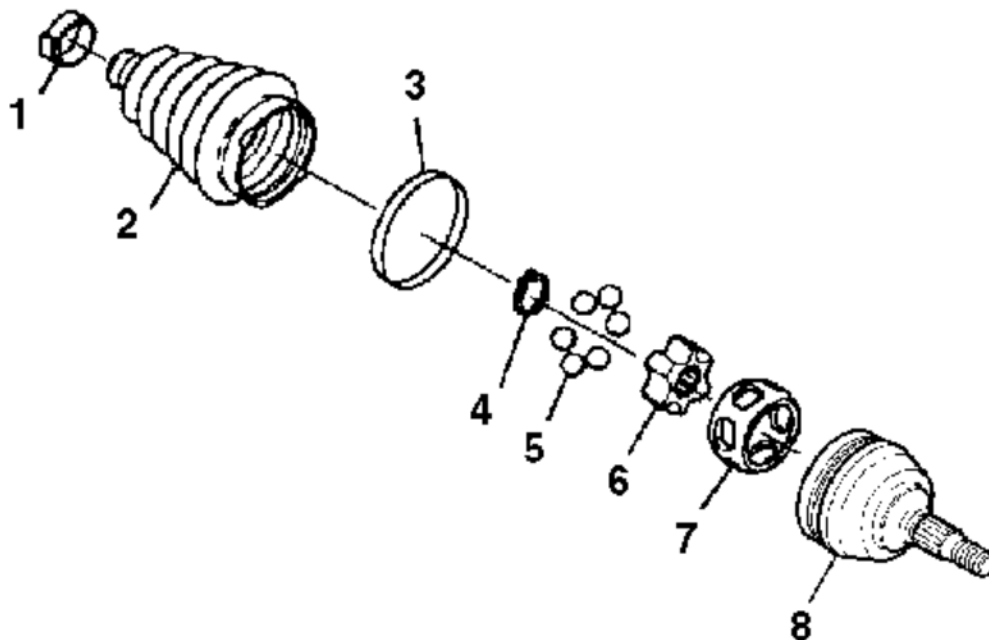
1. Inspect all of the parts for unusual wear, cracks, or other damage. Replace the CV joint assembly if necessary.
2. Put a light coat of the recommended grease on the inner (6) and the outer race (8) grooves.

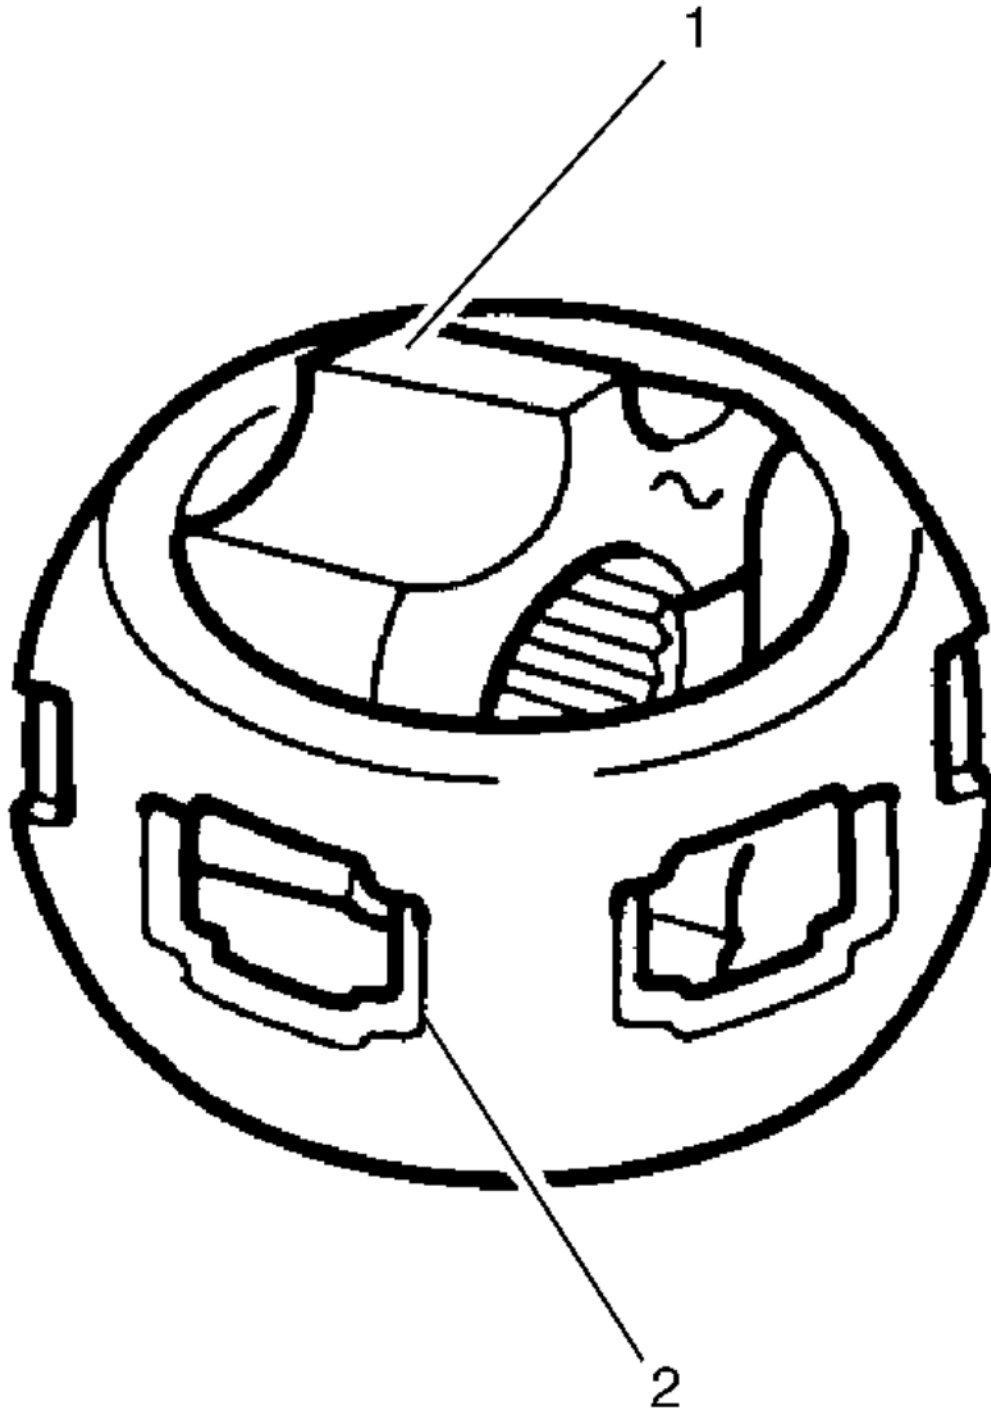
**Fig. 47: View Of Inner Race & Cage**  
**Courtesy of GENERAL MOTORS CORP.**

3. Hold the inner race (1) at 90 degrees to the centerline of the cage (2).
4. Align the lands of the inner race (1) with the windows of the cage (2).
5. Insert the inner race (1) into the cage (2), by rotating the inner race (1) downward.

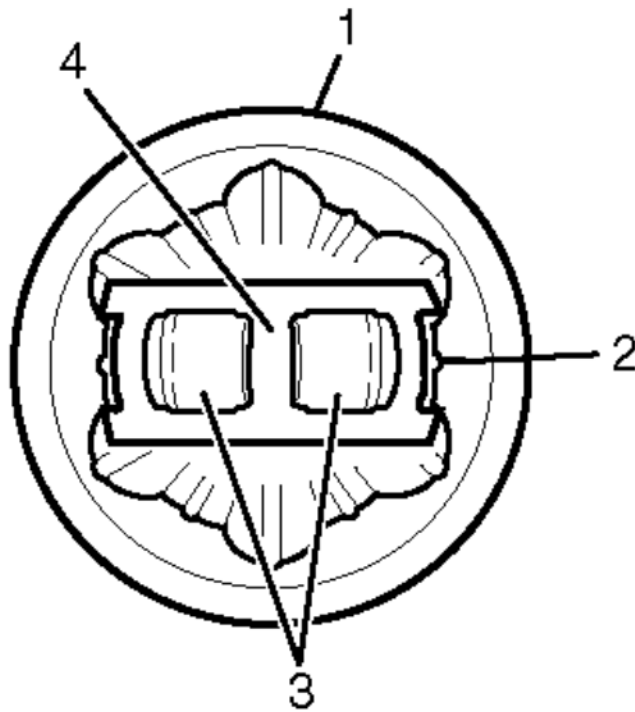
**Fig. 48: View Of Outer Race, Inner Race, Cage Window & CV Joint Cage**  
**Courtesy of GENERAL MOTORS CORP.**

6. Insert the cage (4) and inner race into the outer race (1).

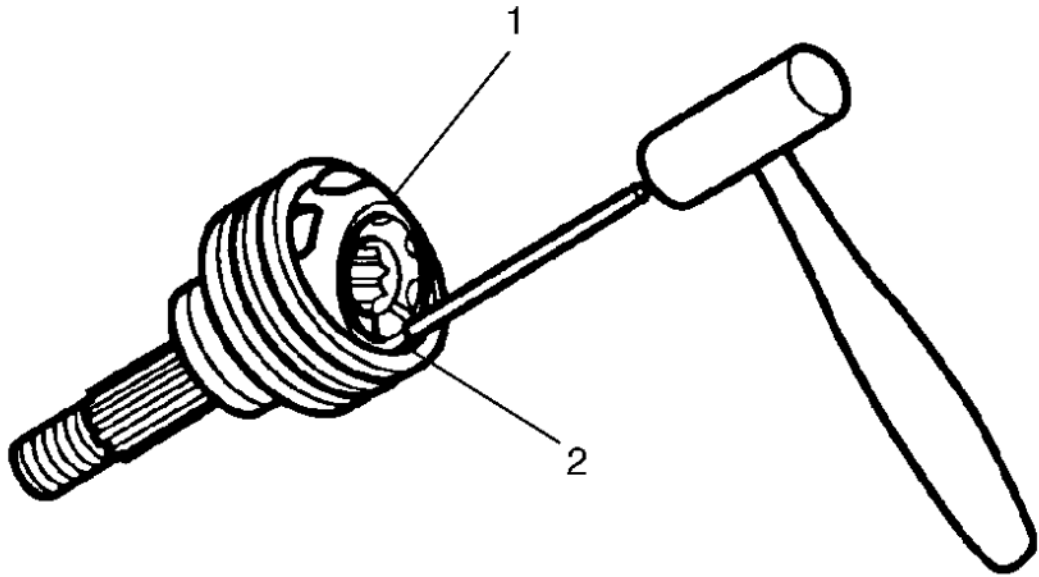
**Fig. 49: Taping Gently On Brass Drift With A Hammer In Order To Tilt Cage**  
**Courtesy of GENERAL MOTORS CORP.**

7. Place a brass drift against the CV joint cage (1).
8. Tap gently on the brass drift with a hammer in order to tilt the cage (1).
9. Install the first chrome alloy ball (2) when the CV joint cage (1) tilts.
10. Tilt the CV joint cage (1) in the opposite direction to install the opposing chrome alloy ball (2).
11. Repeat this process in order to install all six of the balls.

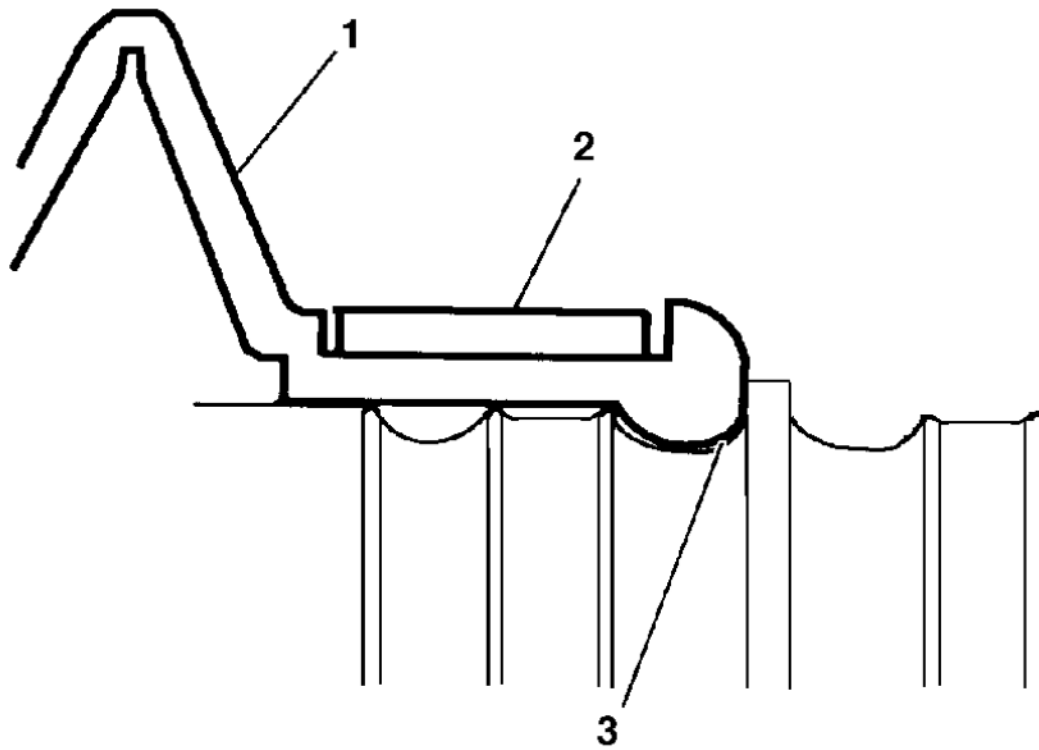
**Fig. 50: Positionng Small End Of Joint Seal Into Joint Seal Groove**  
**Courtesy of GENERAL MOTORS CORP.**

12. Pack the CV joint boot (1) and the CV joint assembly with the grease supplied in the kit. The amount of grease supplied in this kit has been pre-measured for this application.
13. Place the new small boot clamp (2) onto the CV joint seal (1).
14. Slide the CV joint boot (1) onto the halfshaft bar.
15. Position the small end of the CV joint boot (1) into the joint boot groove (3) on the halfshaft bar.
