## 2008 Chevrolet Silverado 1500

2008 DRIVELINE/AXLE Wheel Drive Shafts - Cab & Chassis Sierra, Cab & Chassis Silverado, Sierra & Silverado

### WHEEL DRIVE SHAFT REPLACEMENT (2500)

## WHEEL DRIVE SHAFT REPLACEMENT (1500)

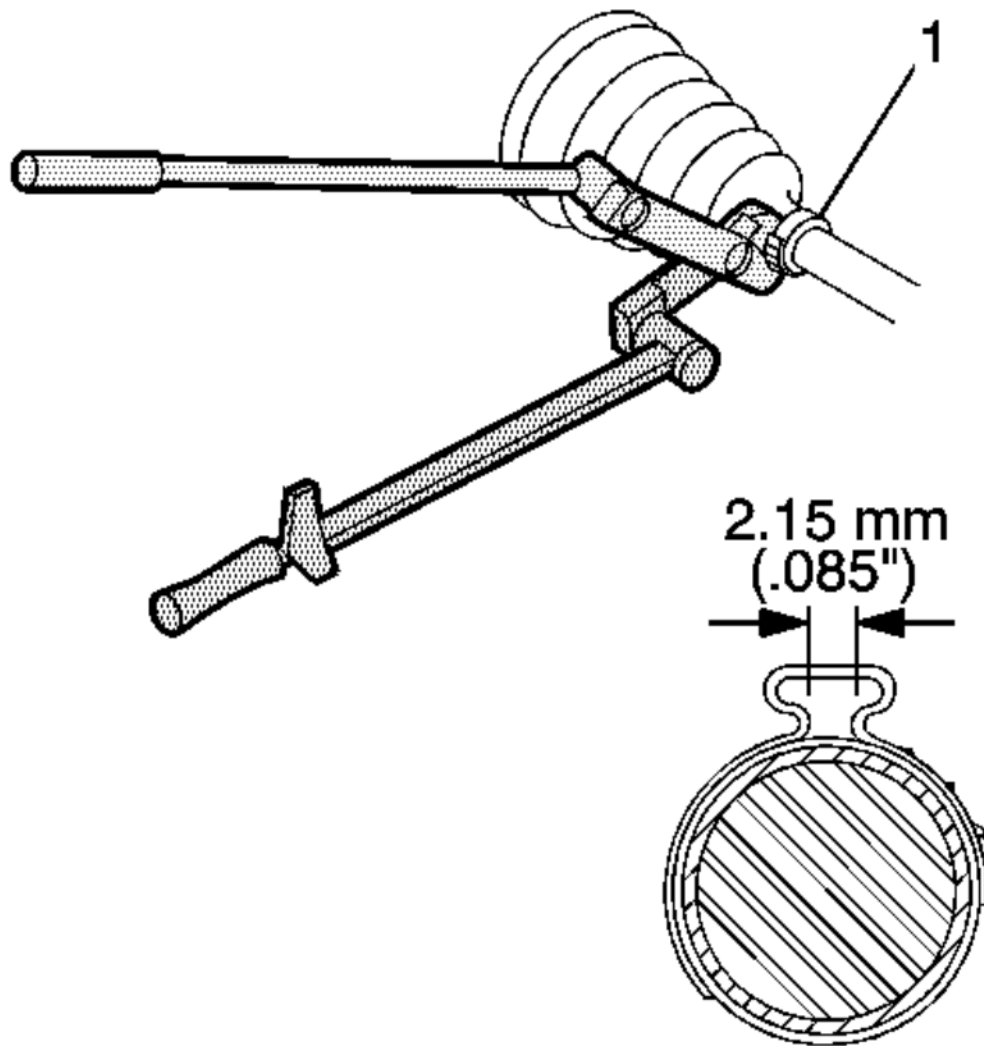
**Fig. 51: View Of CV Joint Seal Retaining Clamp**  
Courtesy of GENERAL MOTORS CORP.

17. Check the gap dimension on the clamp ear. Continue tightening until the gap dimension is reached.

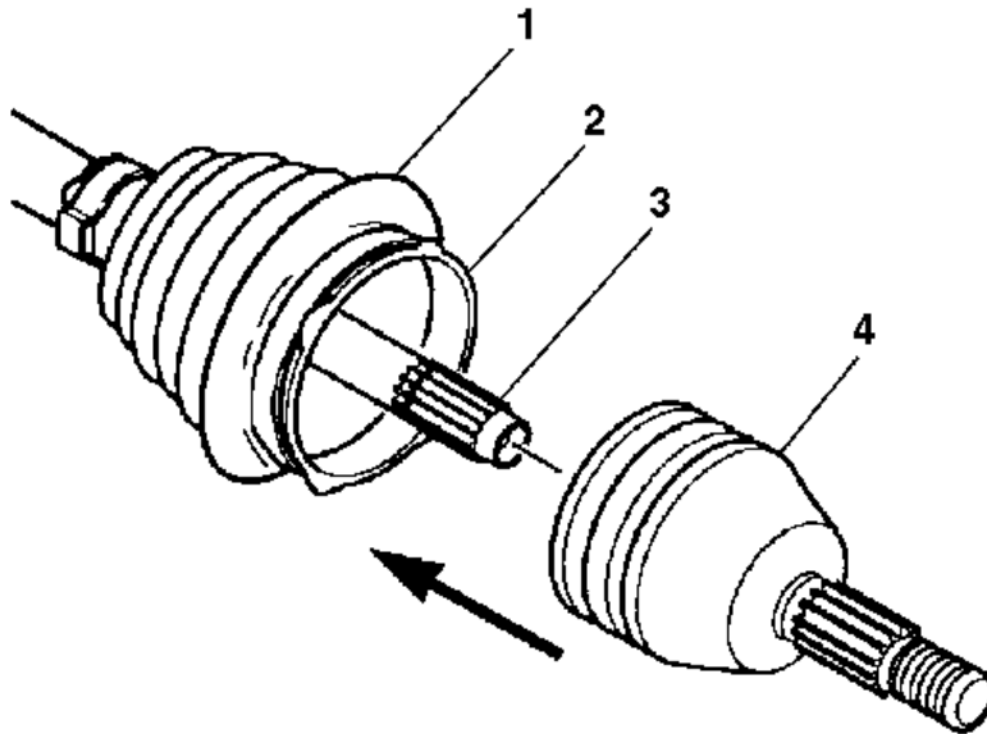
**Fig. 52: CV Boot, Swage Ring, Halfshaft Bar & CV Joint**  
Courtesy of GENERAL MOTORS CORP.

21. Pull on the CV joint (4) to verify engagement.
22. Slide the large diameter of the CV joint boot (1), with the large swage ring (2) in place, over the outside edge of the CV joint outer race (4).

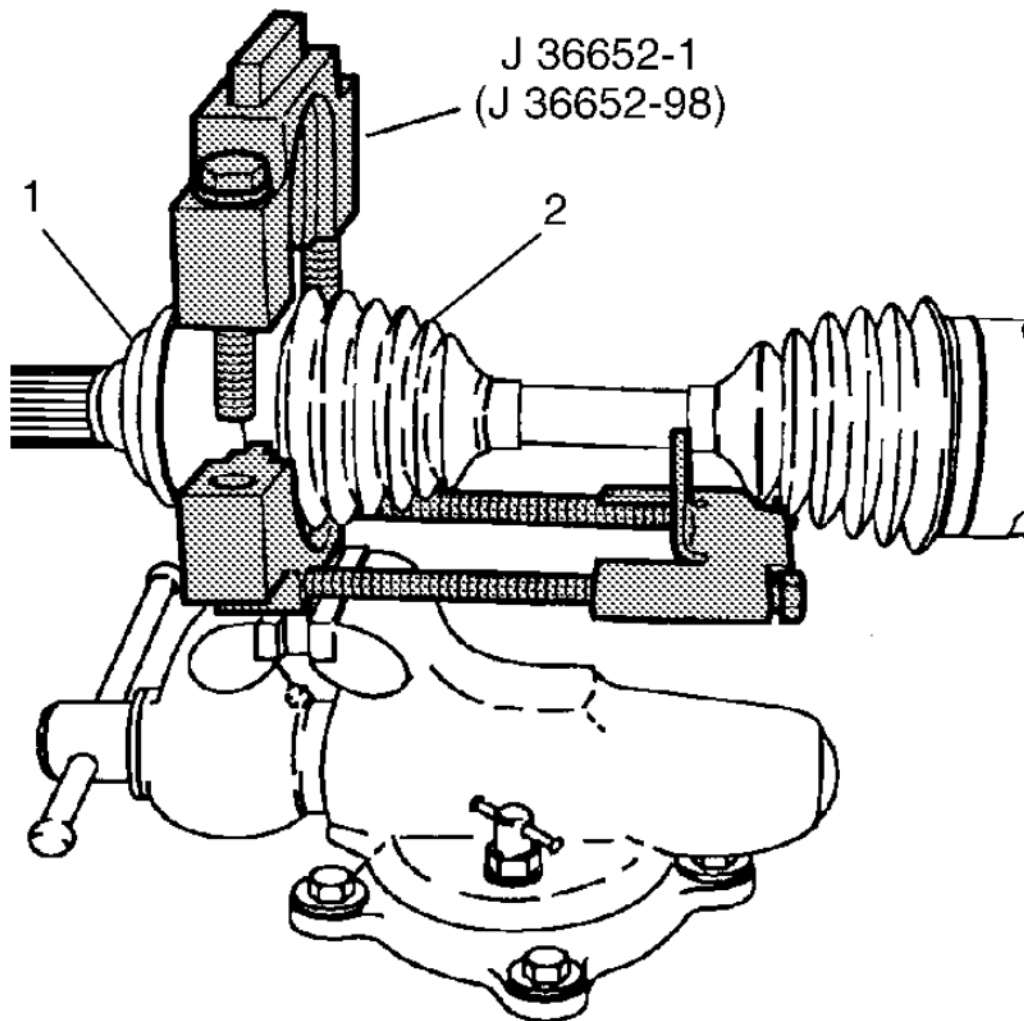
**Fig. 53: Clamping CV Joint Boot**  
 Courtesy of GENERAL MOTORS CORP.

24. For the 1500 models, assemble the bolts and the support plate to the base of the **J 36652-1** and secure the base in a vise. See **Special Tools**. For the 2500 and 3500 models, use the **J 36652-2** . See **Special Tools**.
25. Position the CV joint end (outboard end) of the halfshaft assembly in the bottom half of **J 36652-1** or **J 36652-2** . See **Special Tools**.

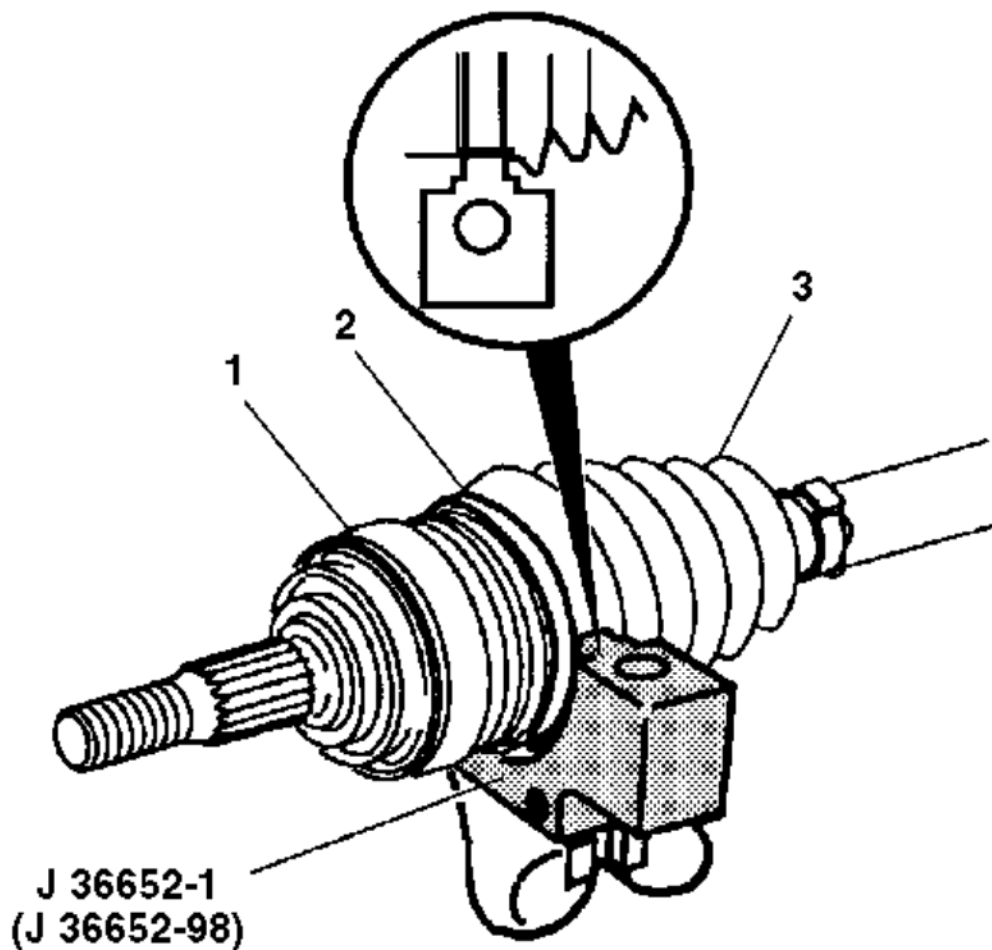
**Fig. 54: Aligning Swage Ring And Swage Ring Clamp**  
Courtesy of GENERAL MOTORS CORP.

**Tighten:** Tighten each bolt 180 degrees at a time. Alternate between the bolts until both sides of the top half of the tool touch the bottom half of the tool.
  30. Loosen the bolts and remove the halfshaft assembly from the tool.
  31. Install the wheel drive shaft seal cover, if applicable. Refer to **Wheel Drive Shaft Seal Cover Replacement**.
  32. Install the wheel drive shaft. Refer to **Wheel Drive Shaft Replacement (2500)** or **Wheel Drive Shaft Replacement (1500)**.
