## ACCESSORIES & EQUIPMENT

### Floor Coverings and Headlinings - Escalade, Suburban, Tahoe, Yukon

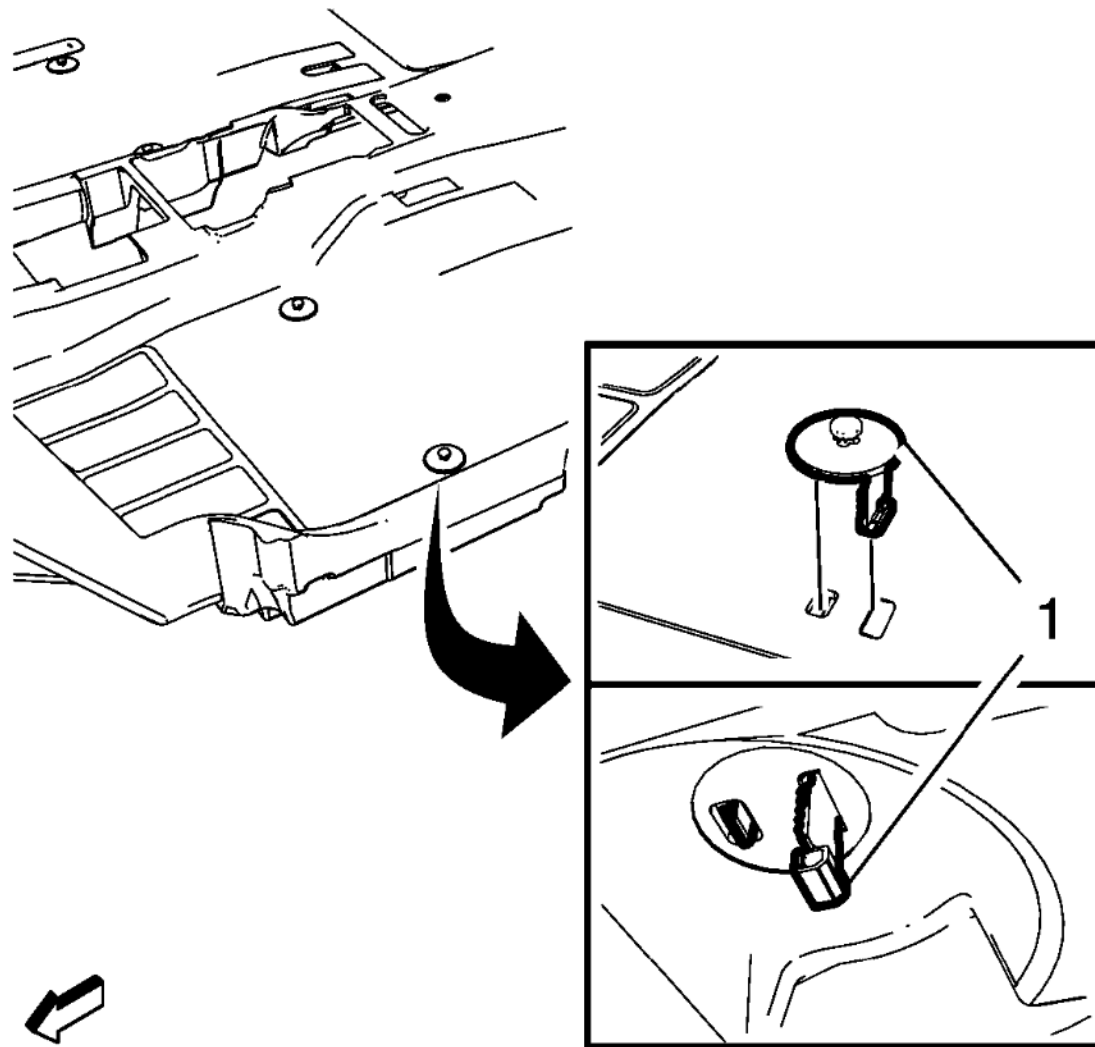
**Fig. 4: Floor Panel Carpet Retainer**

1. Remove the front side door sill garnish molding. Refer to Front Side Door Sill Garnish Molding Replacement .
2. Reposition the front floor panel carpet as needed to access retainers. Refer to Front Floor Panel Carpet Replacement.

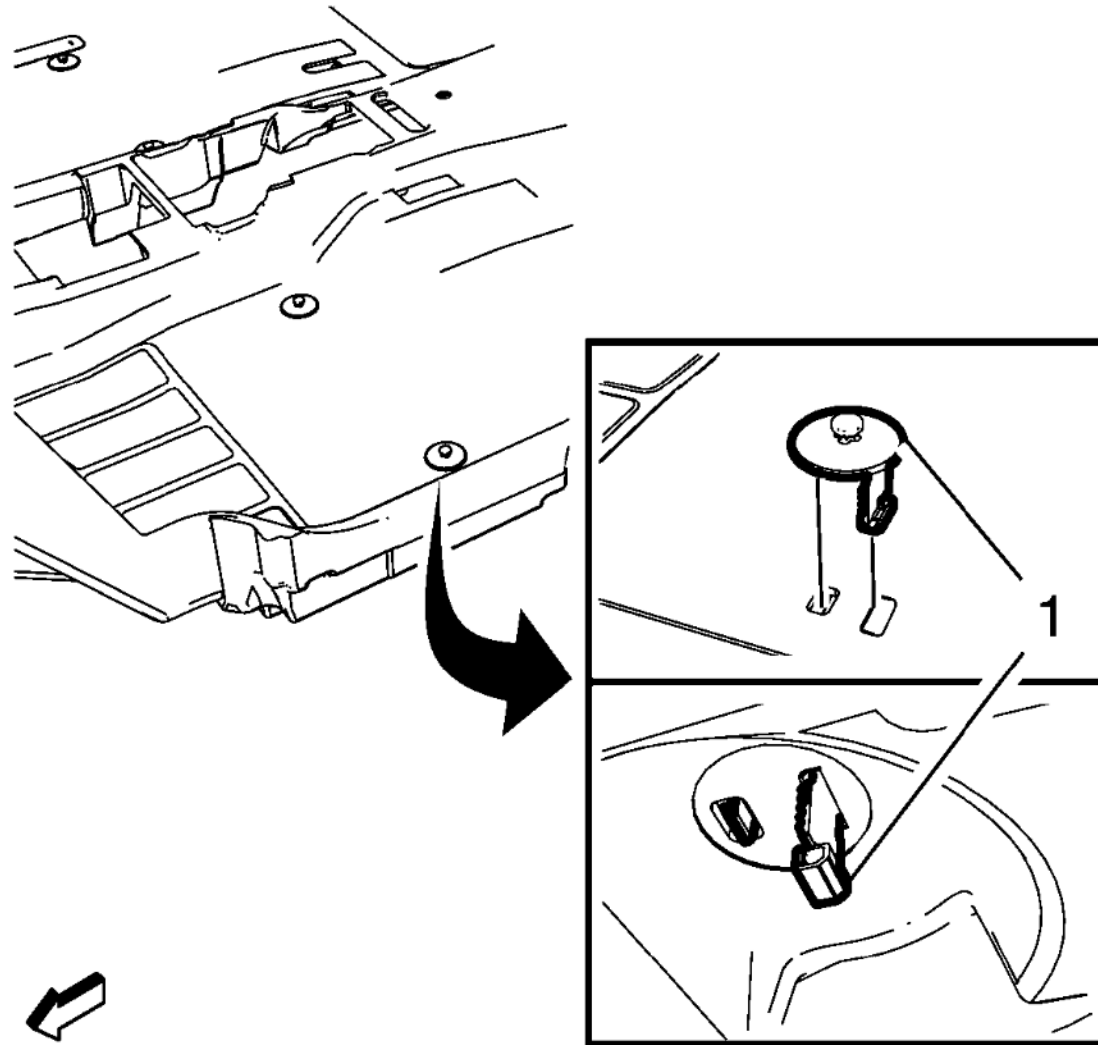
**Fig. 5: Floor Panel Carpet Retainer**

2. Engage the floor carpet auxiliary mat retainer (1) on the rear side of the front floor panel carpet.
3. Reposition the front floor panel carpet as needed. Refer to [Front Floor Panel Carpet Replacement](#).
4. Install the front side door sill garnish molding. Refer to [Front Side Door Sill Garnish Molding Replacement](#).

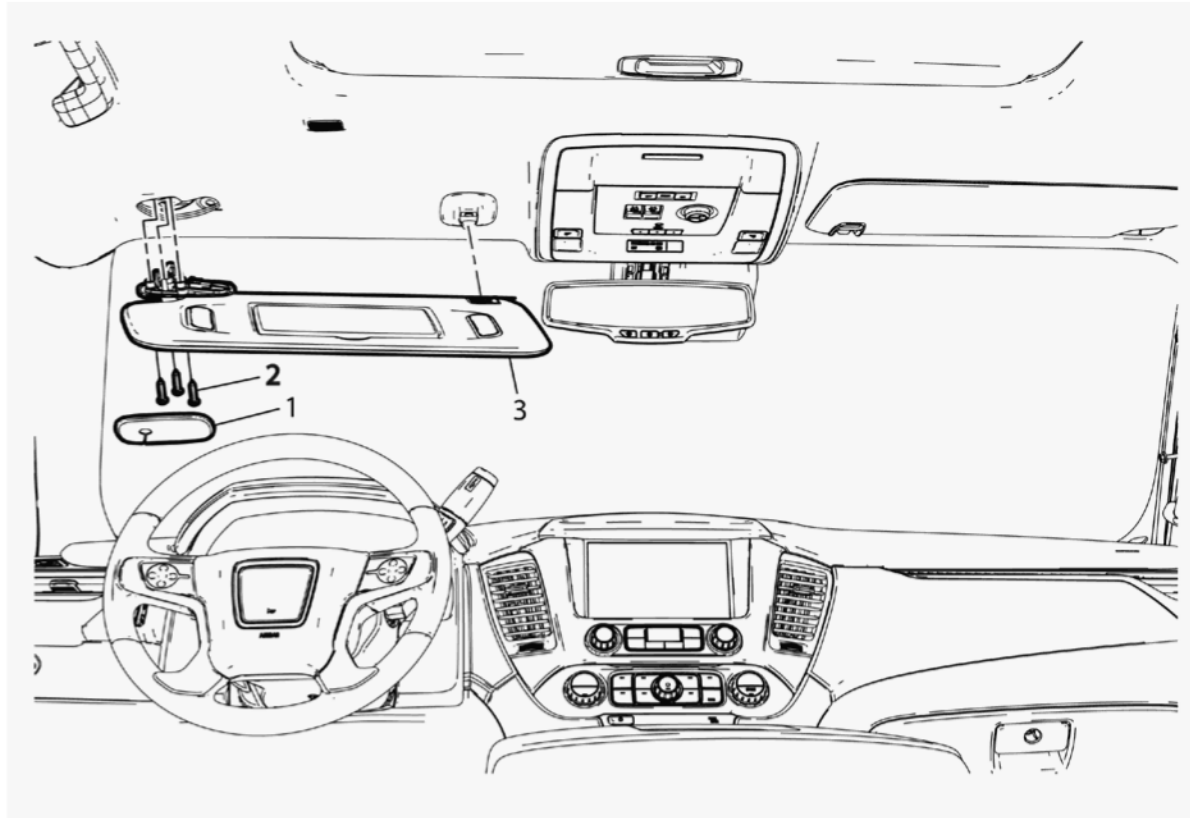
**Fig. 6: Sunshade Assembly**

2. Remove the sunshade assembly (3). Refer to [Sunshade Replacement](#) .

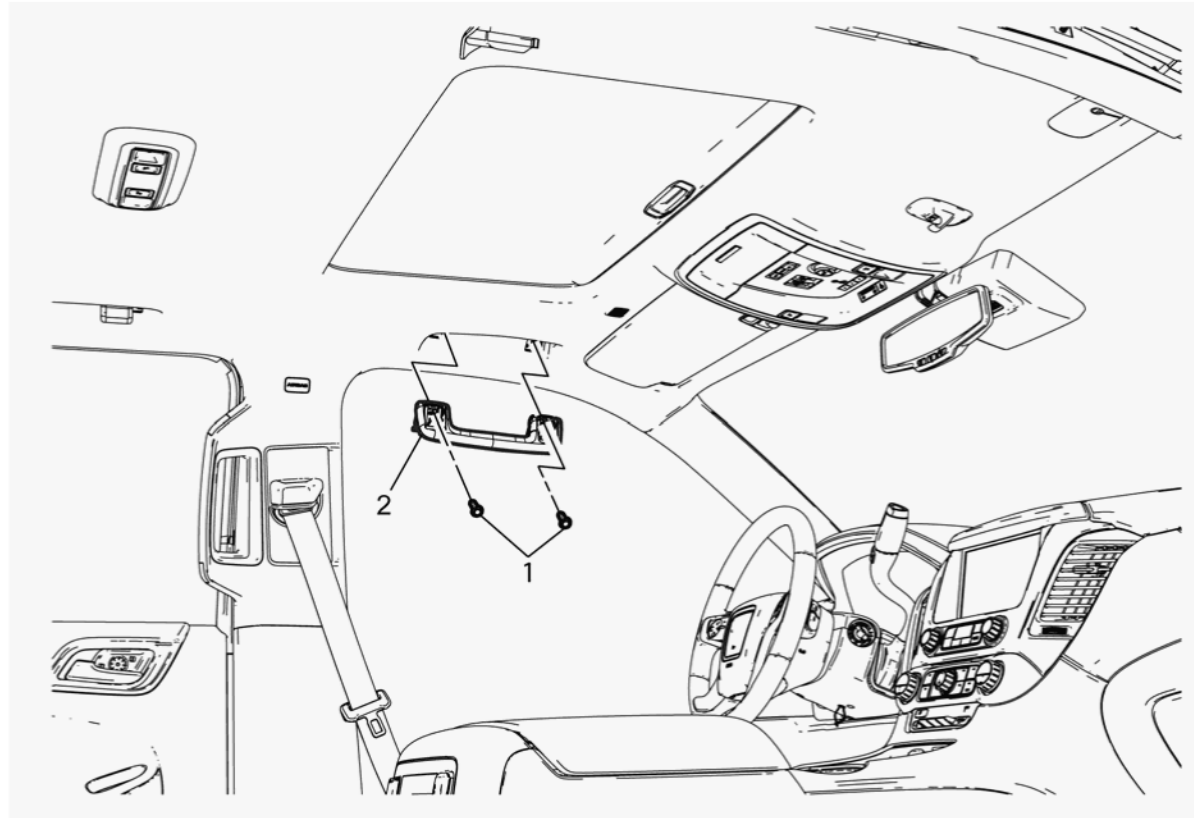
**Fig. 8: Roof Rail Assist Handle Assembly**

4. Remove the roof rail assist handle assembly (2). Refer to [Roof Rail Assist Handle Replacement](#) .

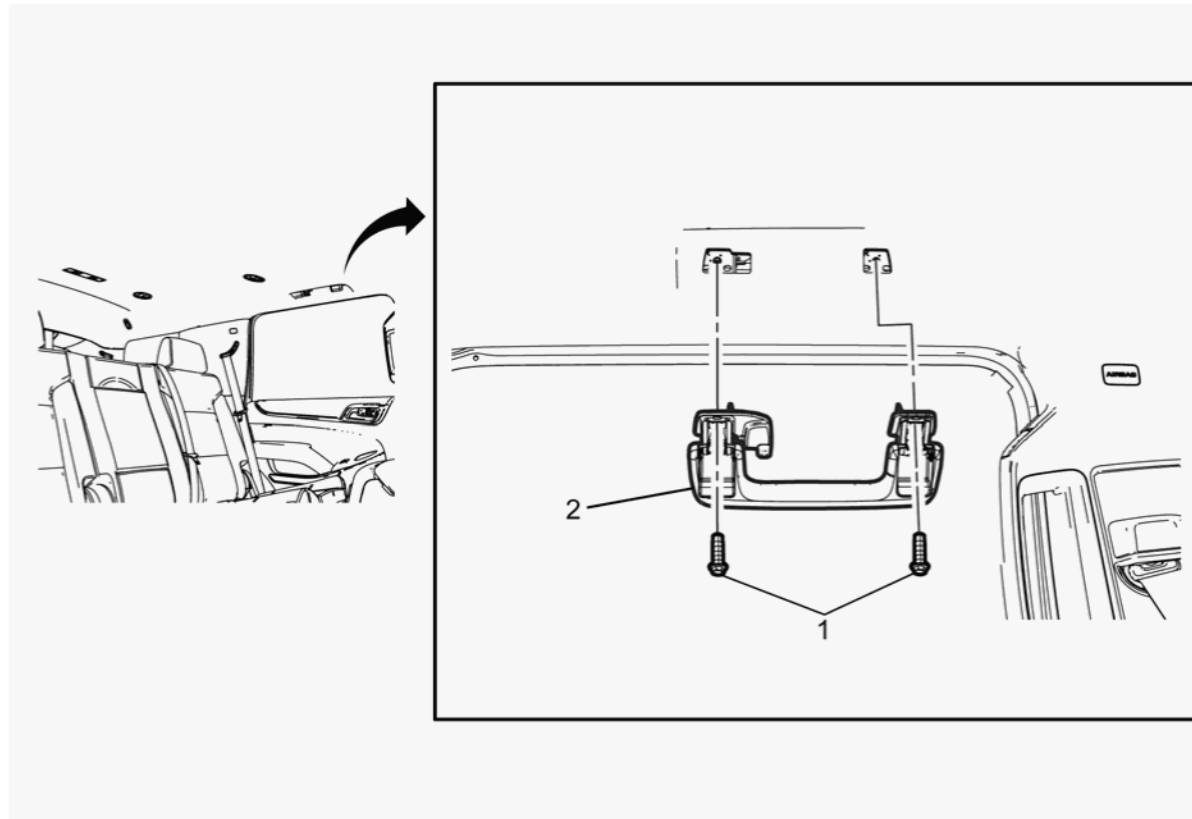
**Fig. 9: Roof Rail Rear Assist Handle**

5. Remove the roof rail rear assist handle (2). Refer to [Roof Rail Rear Assist Handle Replacement](#) .

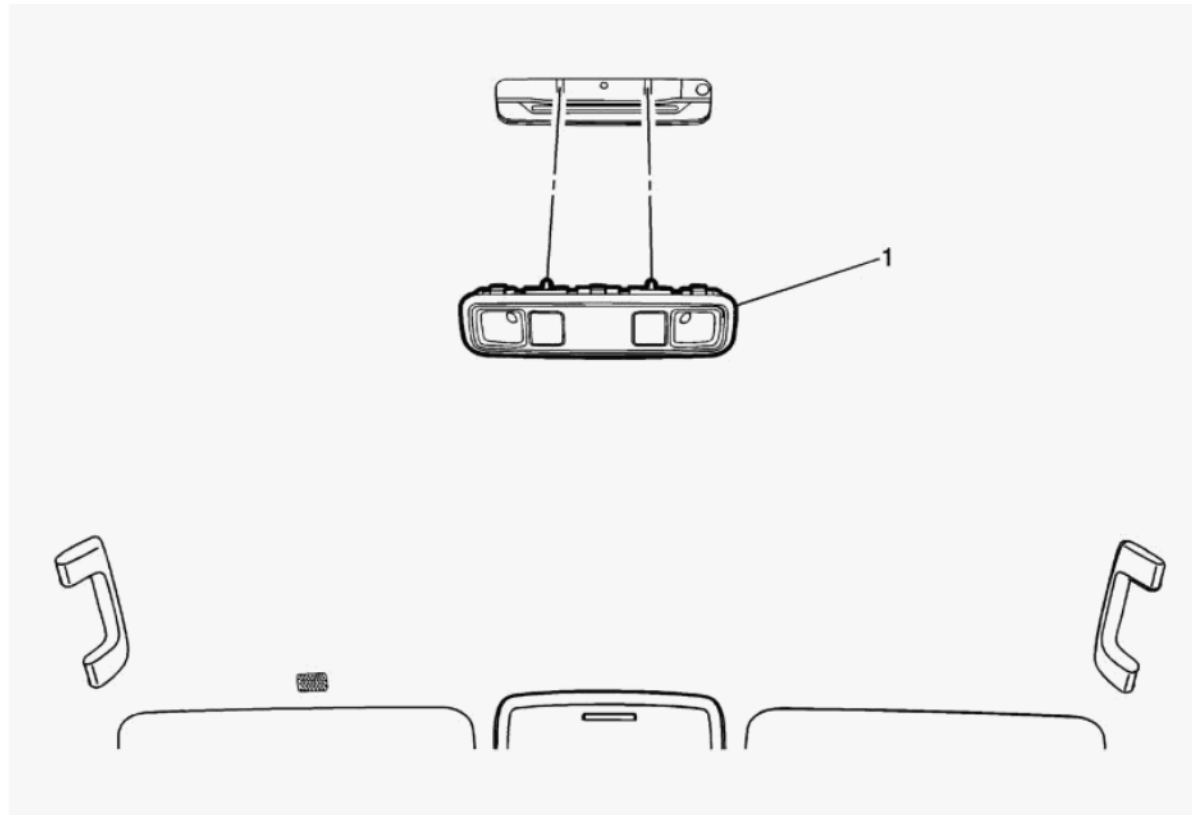
**Fig. 10: Rear Seat Position Center Reading and Courtesy Lamp**

6. Remove the rear seat position center reading and courtesy lamp (1). Refer to [Rear Seat Position Center Reading and Courtesy Lamp Replacement](#) .

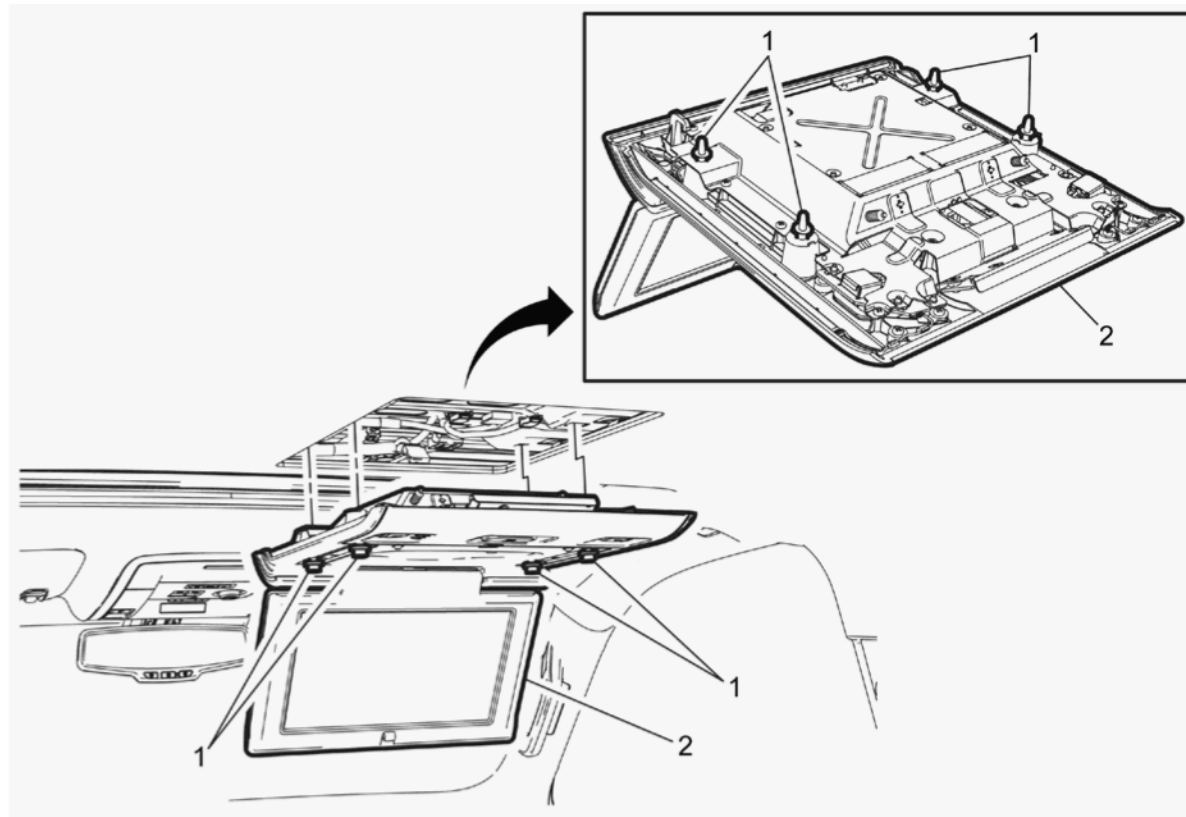
**Fig. 11: Video Display Second Row**

7. Remove the video display second row, if equipped. Refer to [Video Display Replacement \(Second Row\)](#) .

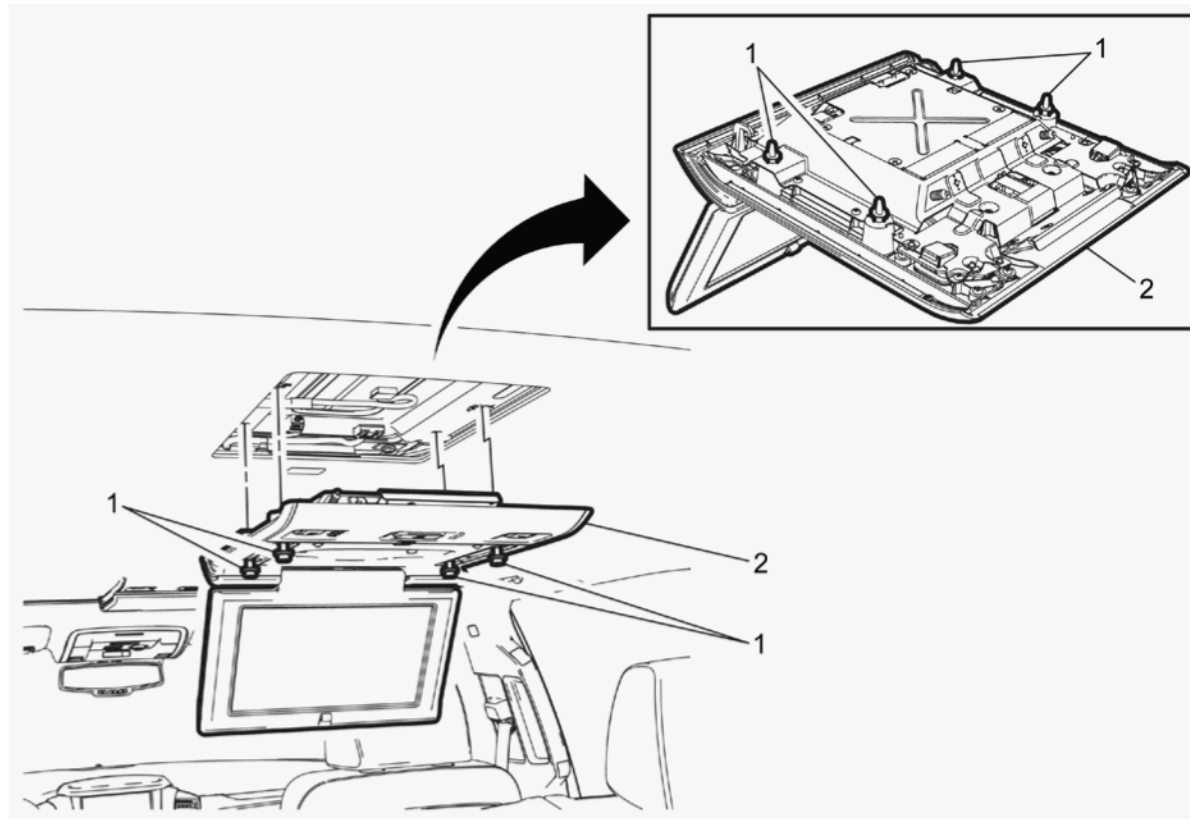
**Fig. 12: Video Auxiliary Display Third Row**  
Courtesy of GENERAL MOTORS COMPANY

8. Remove the video auxiliary display third row, if equipped. Refer to [Video Auxiliary Display Replacement \(Third Row\)](#) .

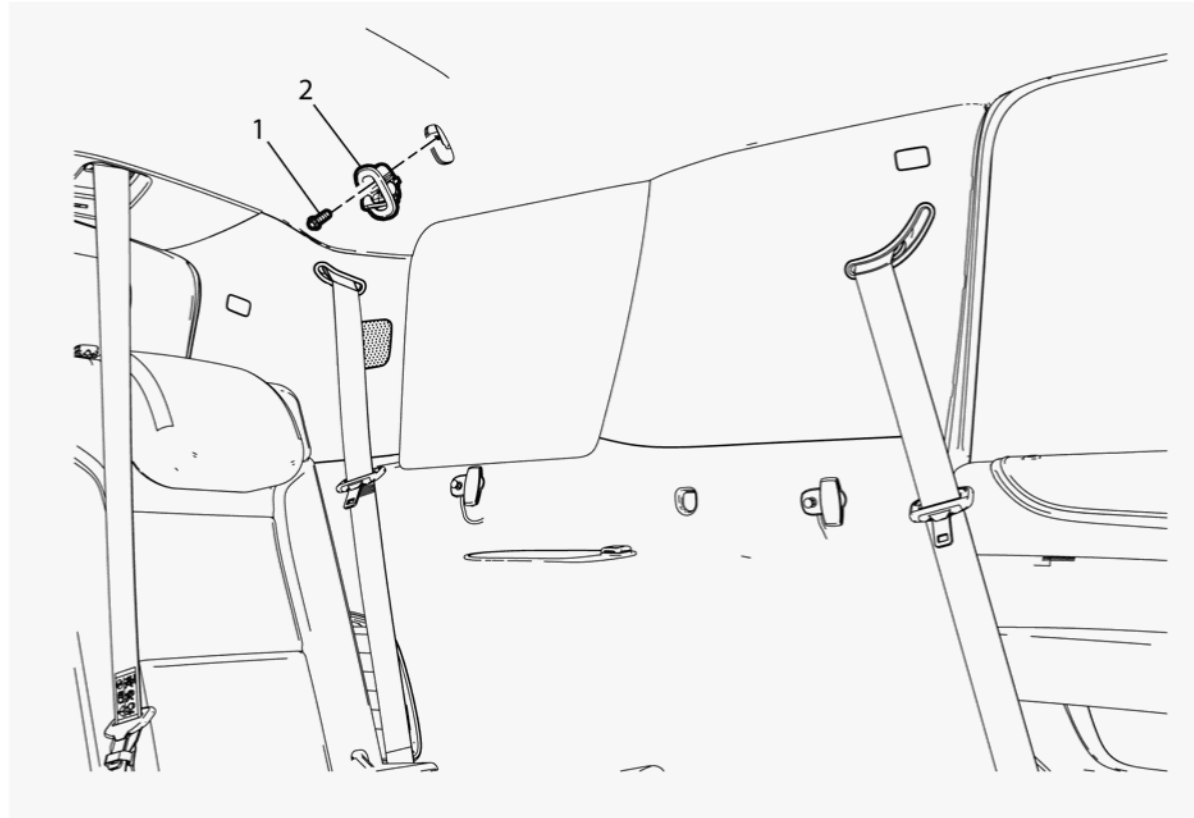
**Fig. 13: Coat Hook**

9. Remove the coat hook (2). Refer to [Coat Hook Replacement](#) .

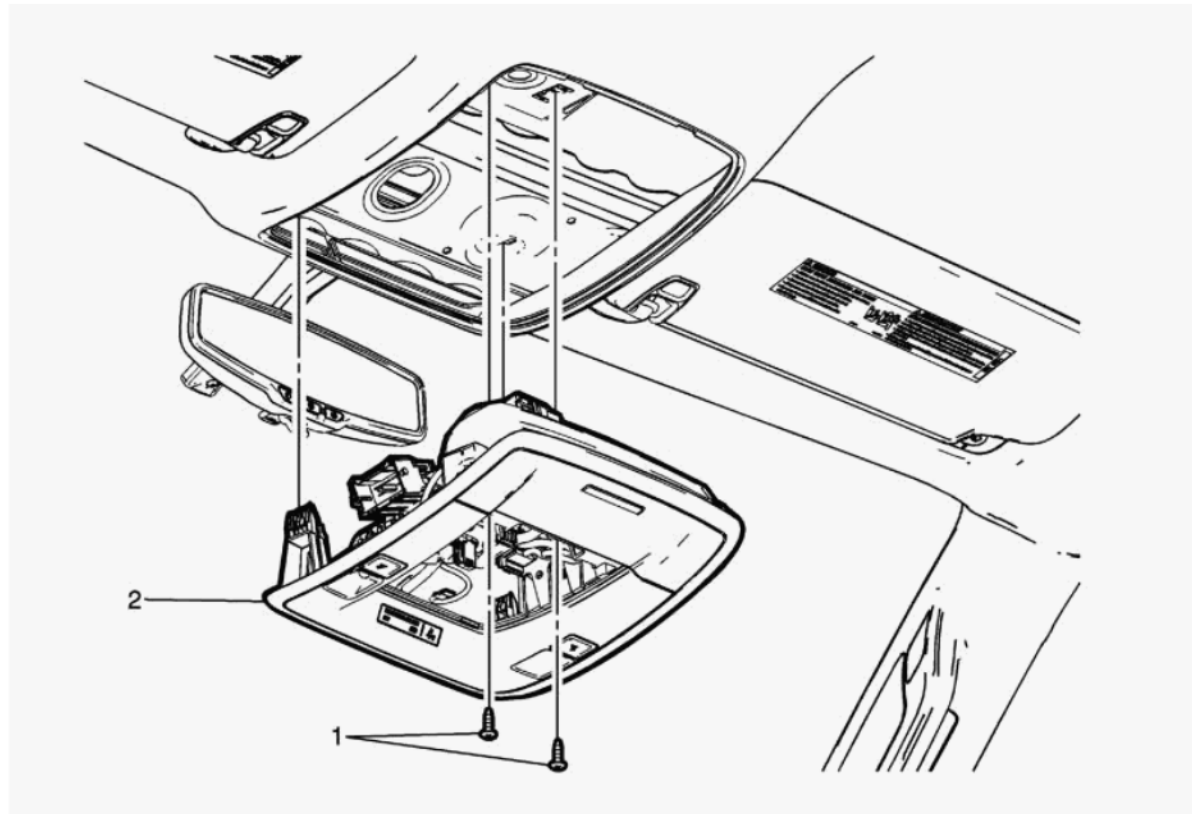
**Fig. 14: Roof Console Assembly**

10. Remove the roof console assembly (2). Refer to [Roof Console Replacement](#) .

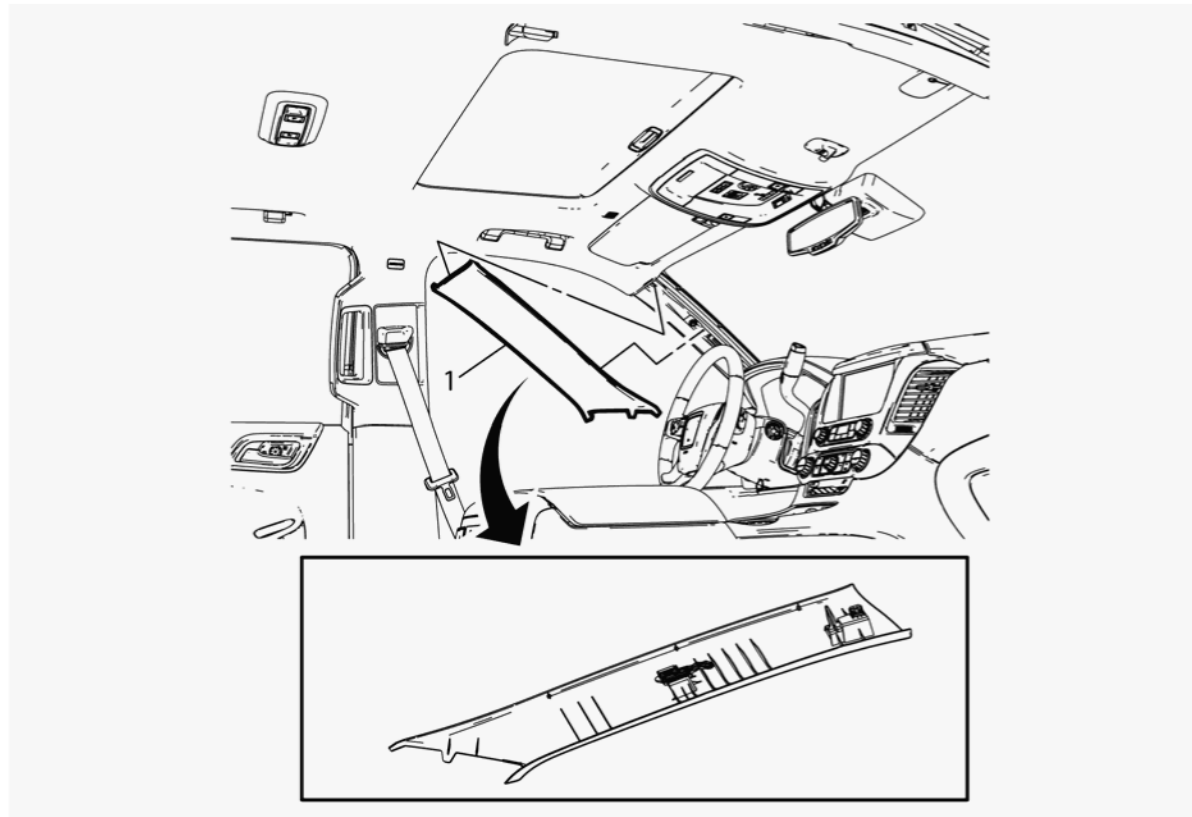
**Fig. 15: Windshield Garnish Molding Assembly Left Side**

11. Remove the windshield garnish molding assembly left side (1). Refer to [Windshield Garnish Molding Replacement \(Left Side\)](#) .

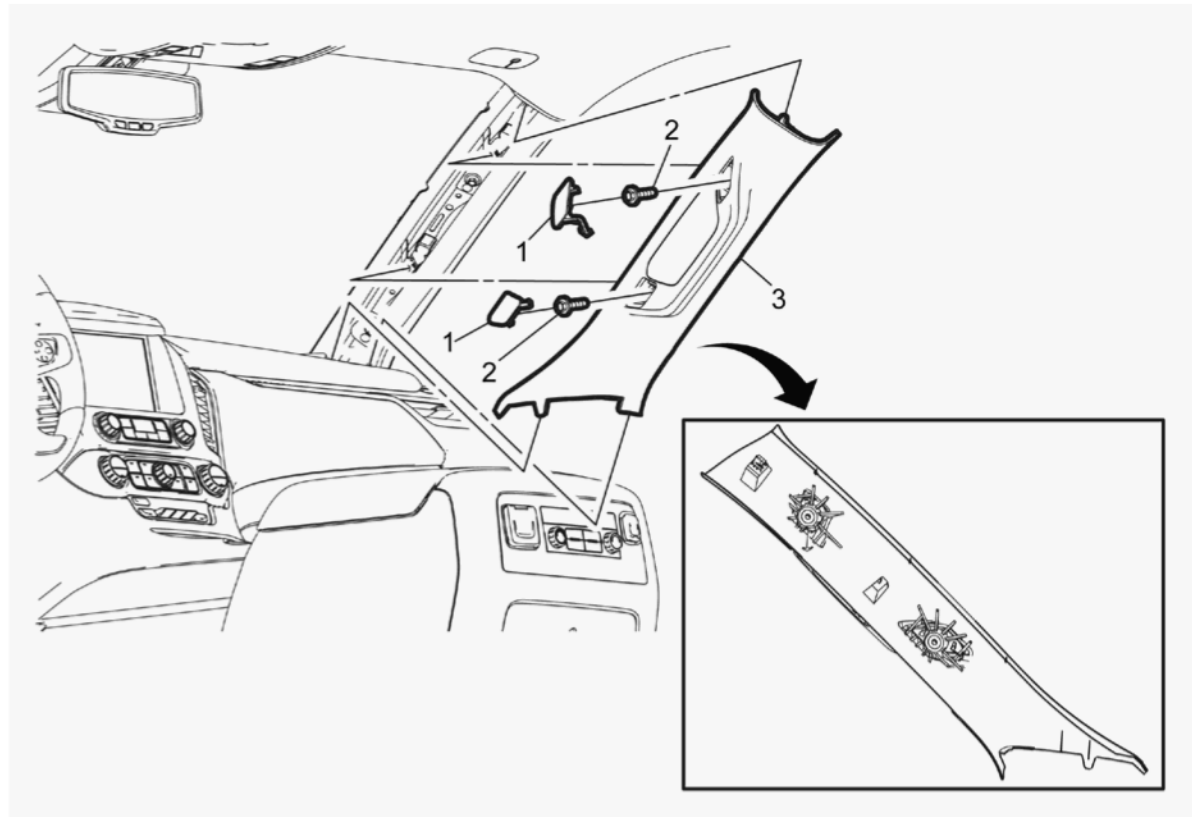
**Fig. 16: Windshield Garnish Molding Assembly Right Side**

12. Remove the windshield garnish molding assembly right side (3). Refer to [Windshield Garnish Molding Replacement \(Right Side\)](#) .

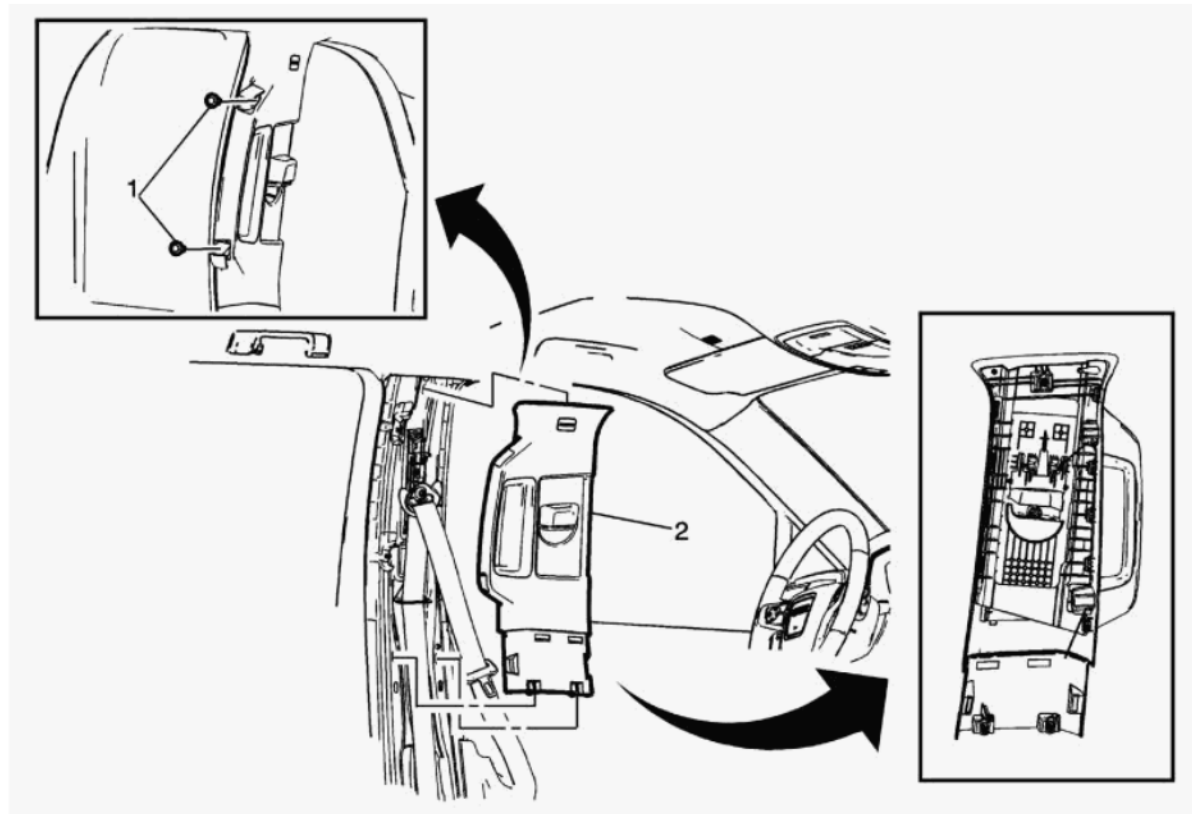
**Fig. 17: Center Pillar Upper Trim Panel Assembly**

13. Remove the center pillar upper trim panel assembly (2). Refer to [Center Pillar Upper Trim Panel Replacement](#).

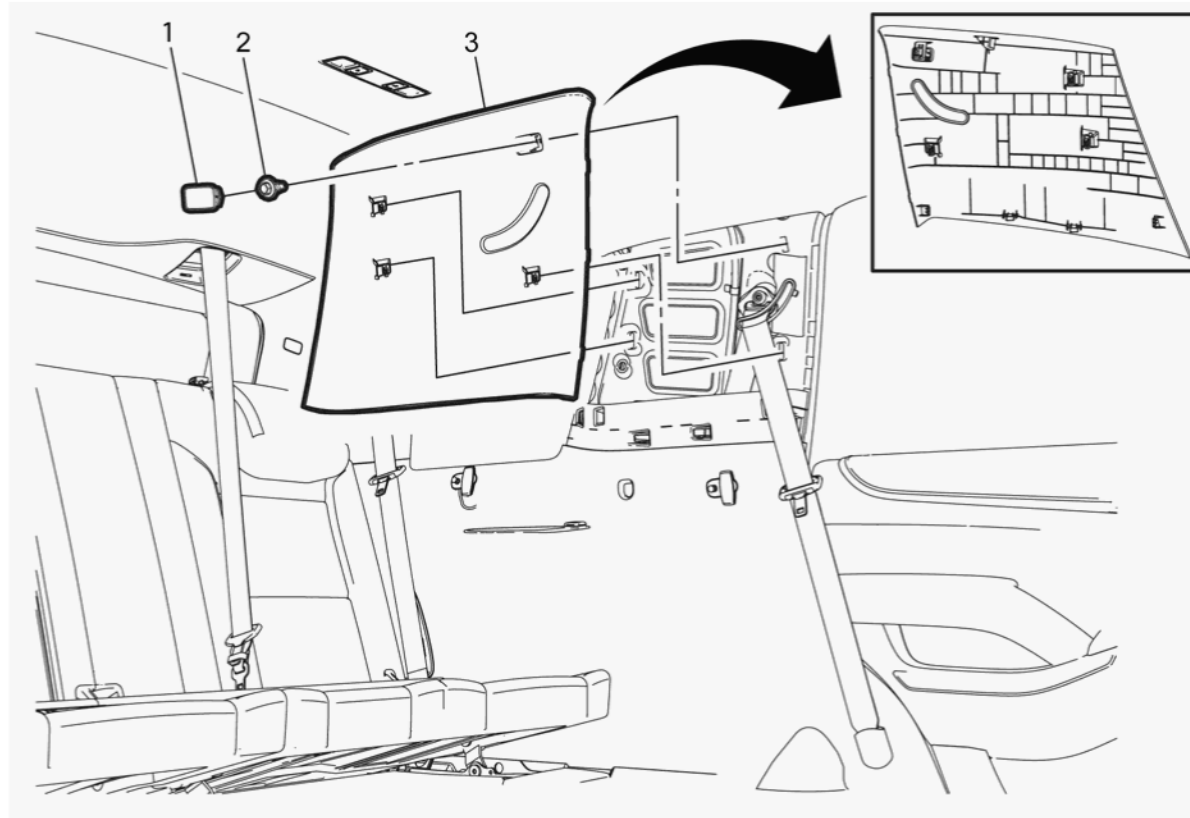
**Fig. 18: Body Lock Pillar Upper Trim Panel**

14. Remove the body lock pillar upper trim panel (3). Refer to [Body Lock Pillar Upper Trim Panel Replacement](#) .

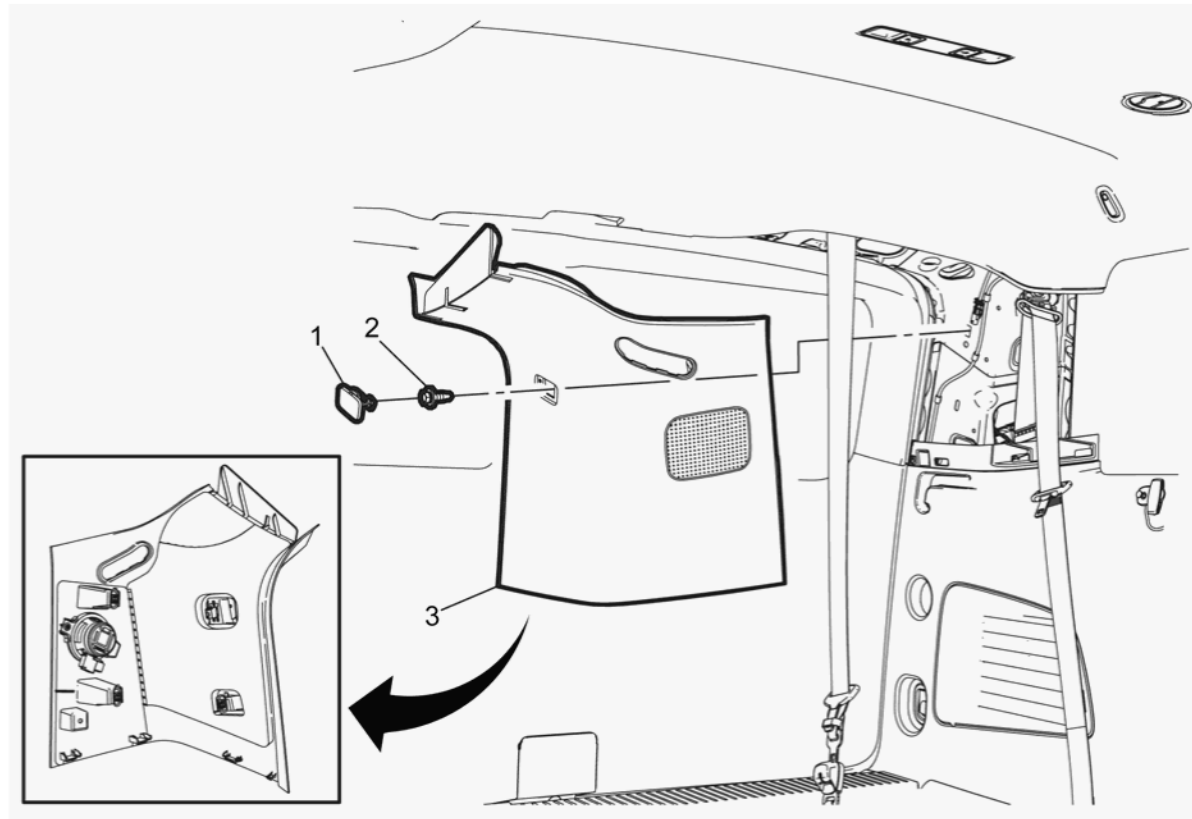
**Fig. 19: Body Rear Corner Upper Garnish Molding**

15. Remove the body rear corner upper garnish molding (3). Refer to [Body Rear Corner Upper Garnish Molding Replacement \(Standard Wheelbase\)](#) .

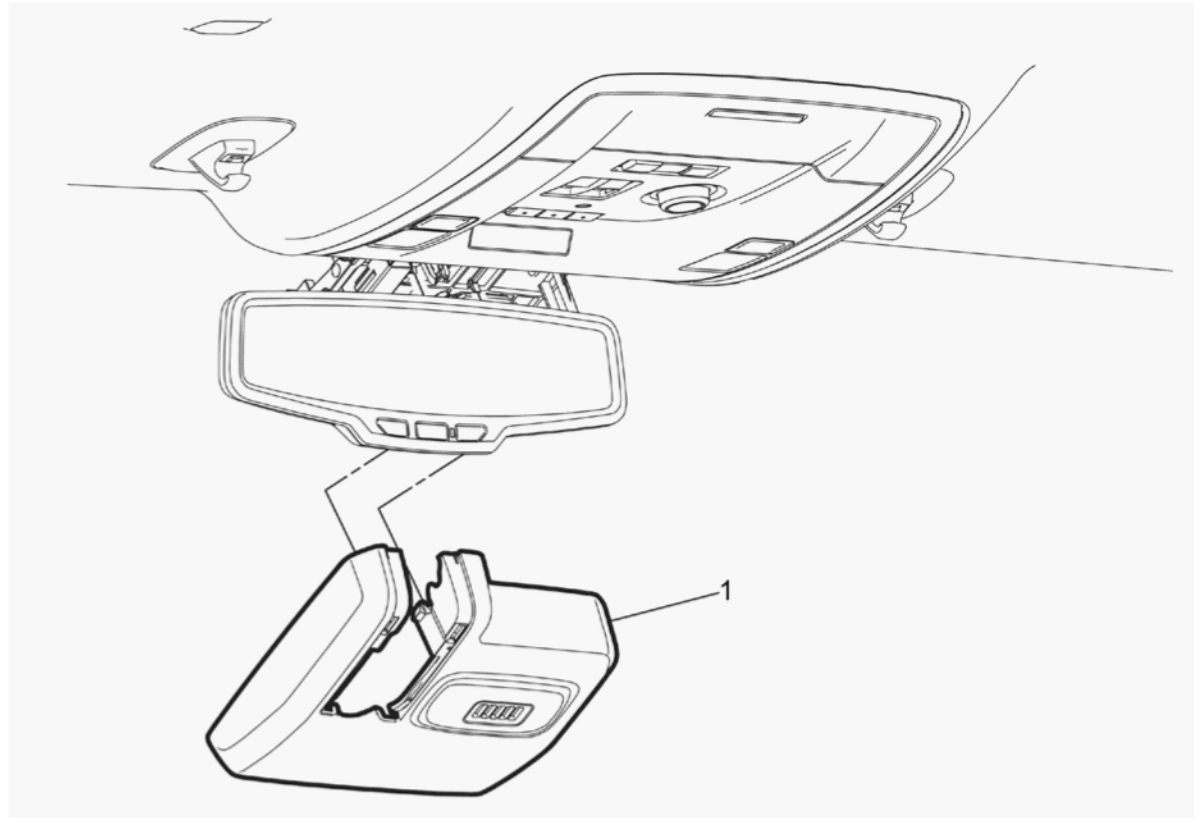
**Fig. 20: Windshield Multifunction Sensor Mount Bracket Cover**

16. Remove the windshield multifunction sensor mount bracket cover. Refer to [Windshield Multifunction Sensor Mount Bracket Cover Replacement](#) .
17. Disconnect the electrical connectors and release the headliner wiring harness from the windshield pillars.
18. Move the driver and passenger seats fully forward and recline.
19. Place the rear seats in the stowed position.
20. Lower the headlining trim panel down onto the interior and vehicle seats.

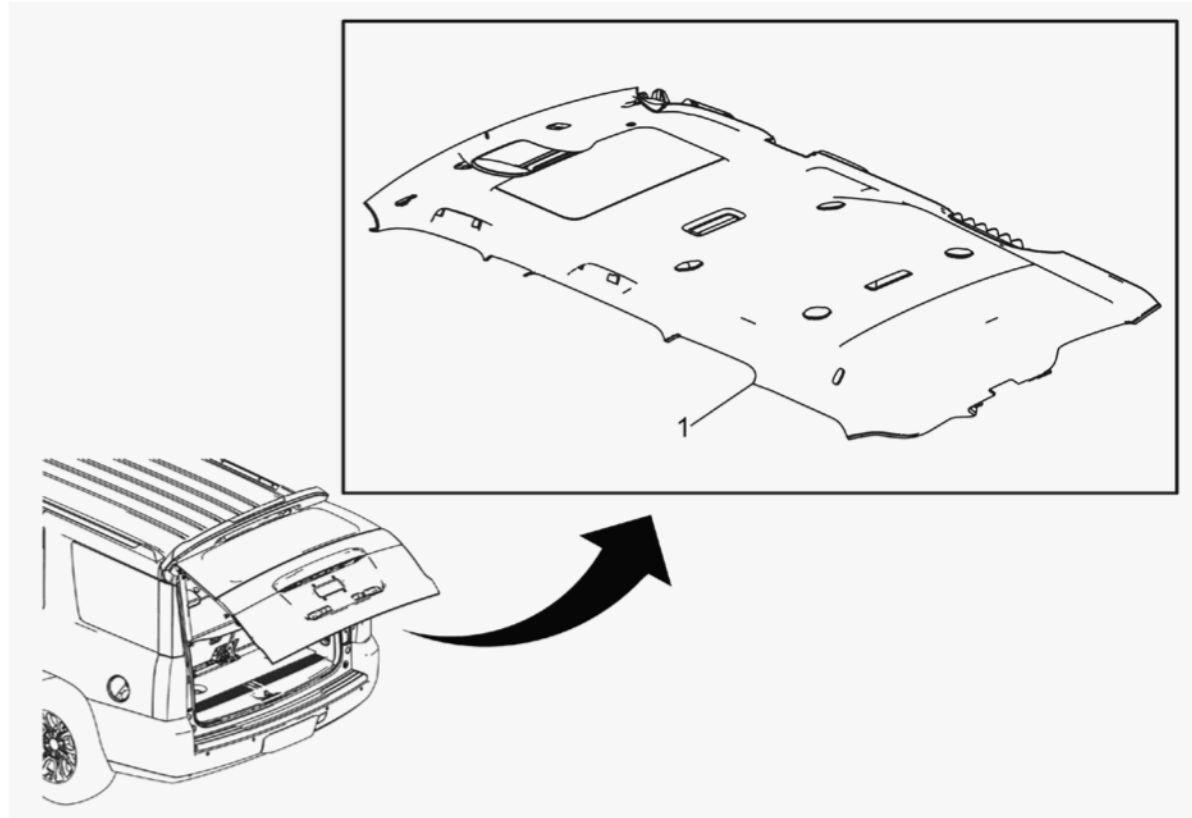
**Fig. 21: Headliner Trim Panel Assembly**

21. Disconnect the roof wiring harness connectors, route the harness as necessary for removal with the headliner trim panel. Refer to [Roof Wiring Harness Replacement \(Chevrolet, GMC\)](#) [Roof Wiring Harness Replacement \(Cadillac\)](#) .
22. With the aid of an assistant, remove the headliner trim panel assembly (1) from the vehicle through the liftgate opening.

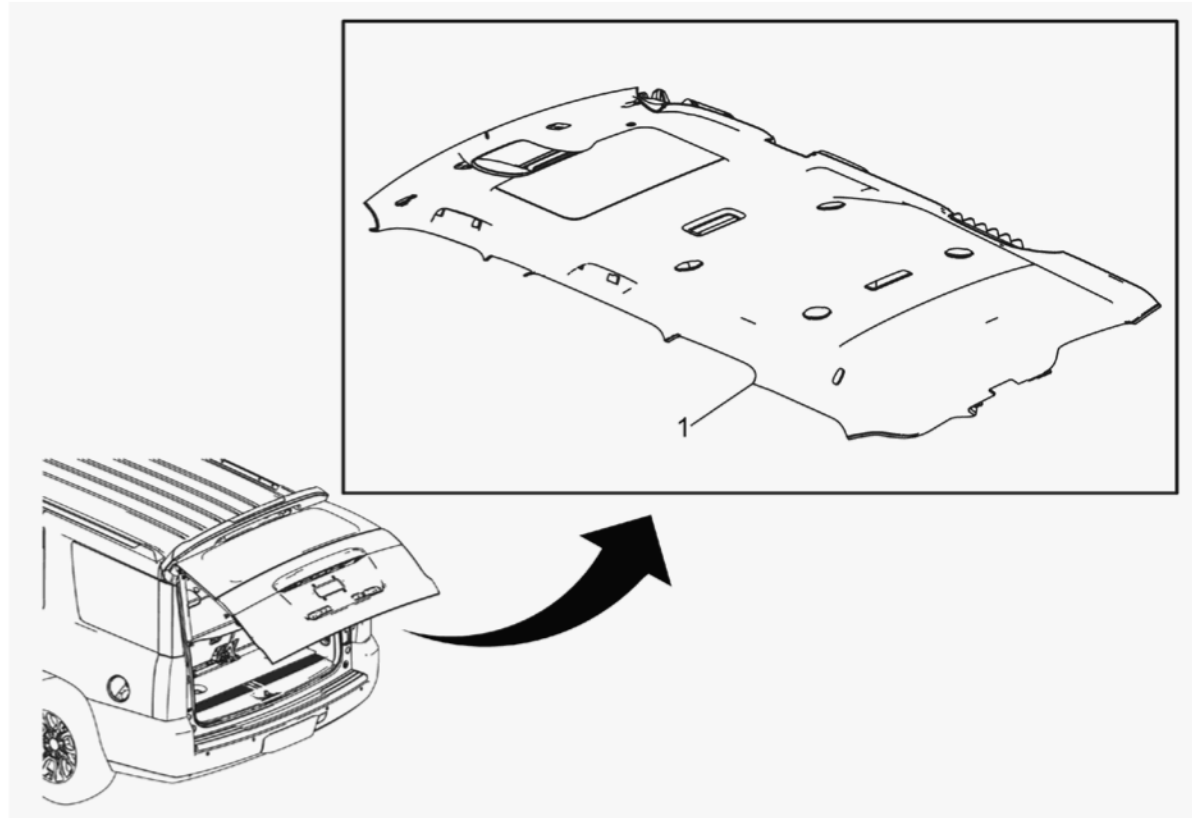
**Fig. 22: Headliner Trim Panel Assembly**

1. With the aid of an assistant, position the headliner trim panel assembly (1) into the vehicle through the liftgate opening.
2. Connect the electrical connectors and secure.
3. If replacing the headliner assembly, transfer all necessary components.
4. If transferring or replacing the wiring harness. Refer to [Headliner Harness Replacement](#).
5. Tape any unused connectors to the headliner with a high adhesive tape.

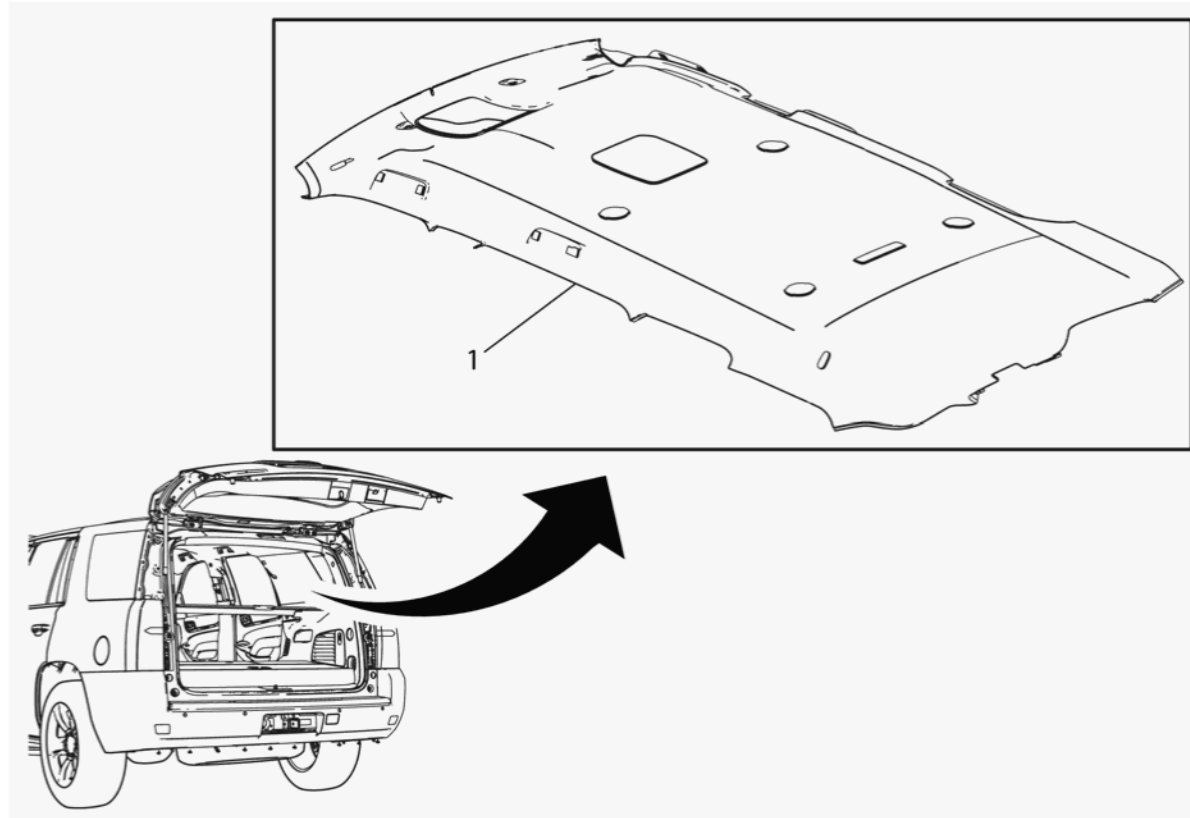
**Fig. 50: Headliner Trim Panel Assembly**

18. Lower the headlining trim panel down on the interior vehicle seats.
19. Disconnect the electrical connectors and un-route the harness as necessary for removal of the headlining trim panel (1). Refer to [Roof Wiring Harness Replacement \(Chevrolet, GMC\)](#) [Roof Wiring Harness Replacement \(Cadillac\)](#) .
20. With the aid of an assistant, remove the headliner trim panel assembly (1) from the vehicle through the liftgate opening.

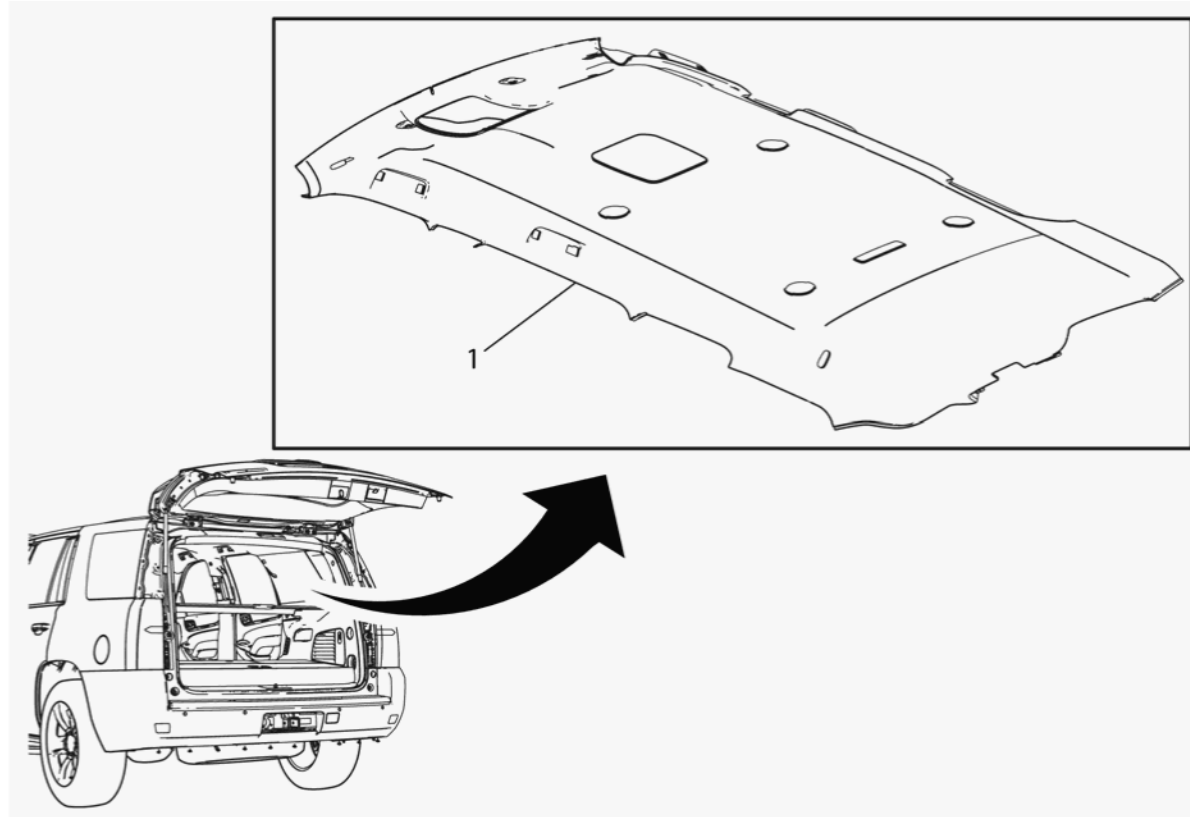
**Fig. 51: Headliner Trim Panel Assembly**

1. With the aid of an assistant, position the headliner trim panel assembly (1) into the vehicle through the liftgate opening.
2. Connect the electrical connectors and secure.
3. If replacing the headliner assembly, transfer all necessary components.
4. If transferring or replacing the wiring harness. Refer to [Headliner Harness Replacement](#).
5. Tape any unused connectors to the headliner with a high adhesive tape.

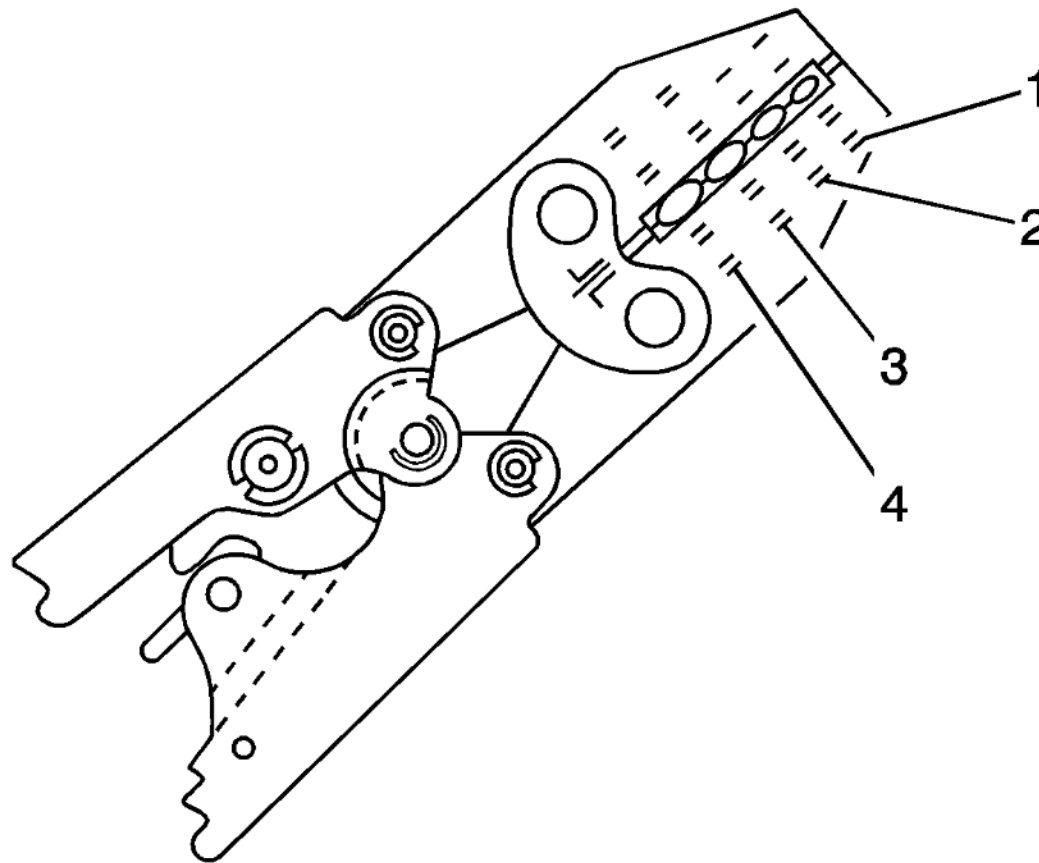
**Fig. 65: Splice Sleeve Crimping Tool With 4 Crimp Nests**

5. Select the proper DuraSeal splice sleeve according to the wire size. Refer to the above table at the beginning of the repair procedure for the color coding of the DuraSeal splice sleeves and the crimp tool nests.
