## ACCESSORIES & EQUIPMENT

### Floor Coverings and Headlinings - Escalade, Suburban, Tahoe, Yukon

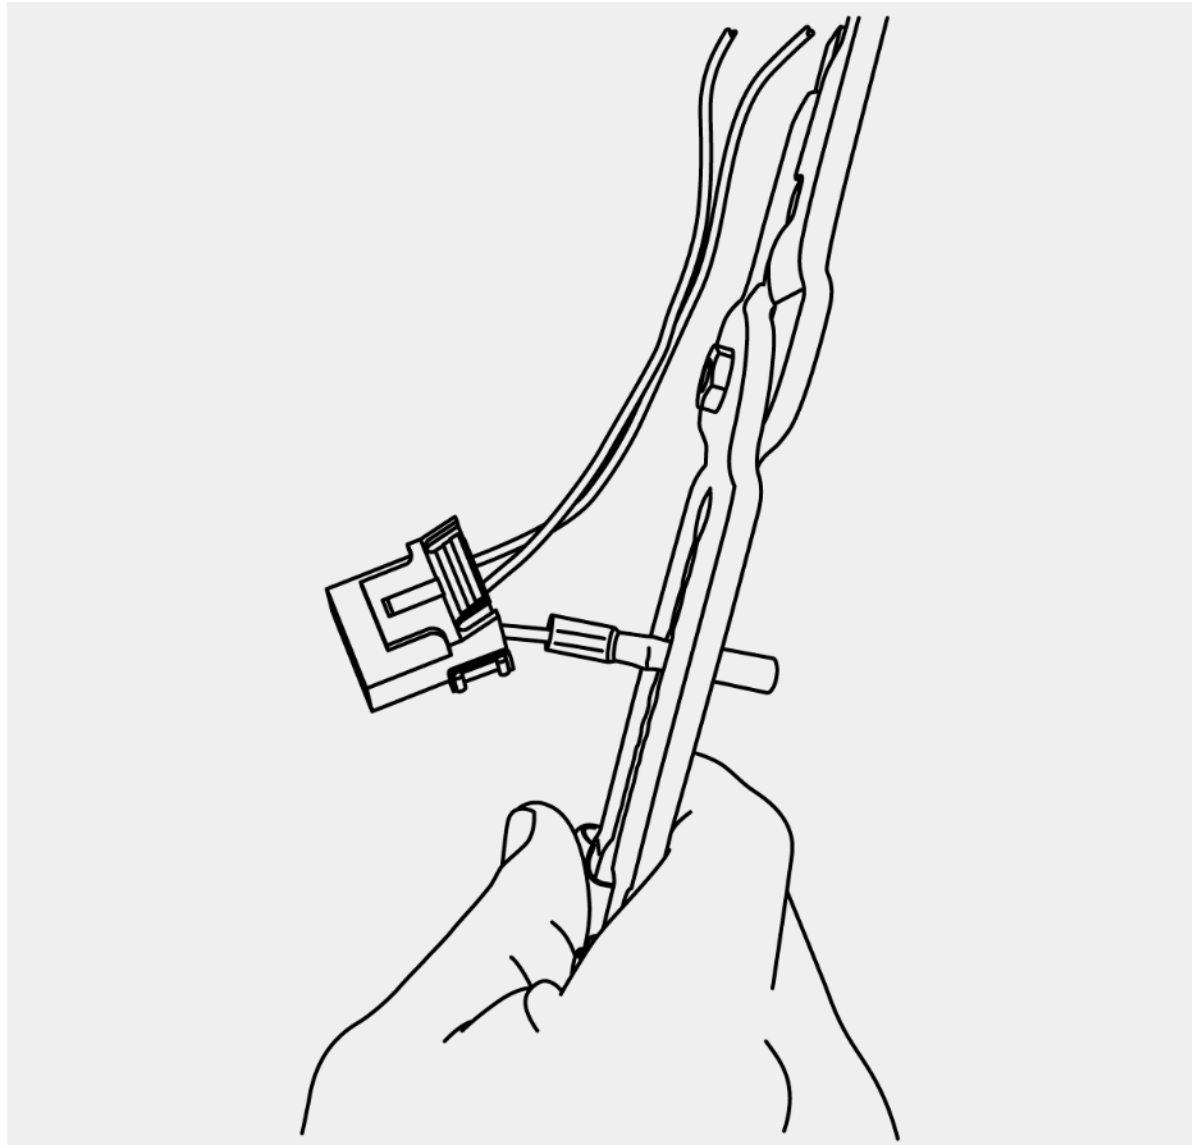
**Fig. 70: Tightly Close Handles Of Crimp Tool**  
Courtesy of GENERAL MOTORS COMPANY

1. Insert the wire into the splice sleeve barrel until the wire hits the barrel stop. Refer to [Folded-Over Wire Repair](#) for splicing wires of 0.35 mm or less (22, 24, 26 gauge sizes) and for splicing wires of different gauges.

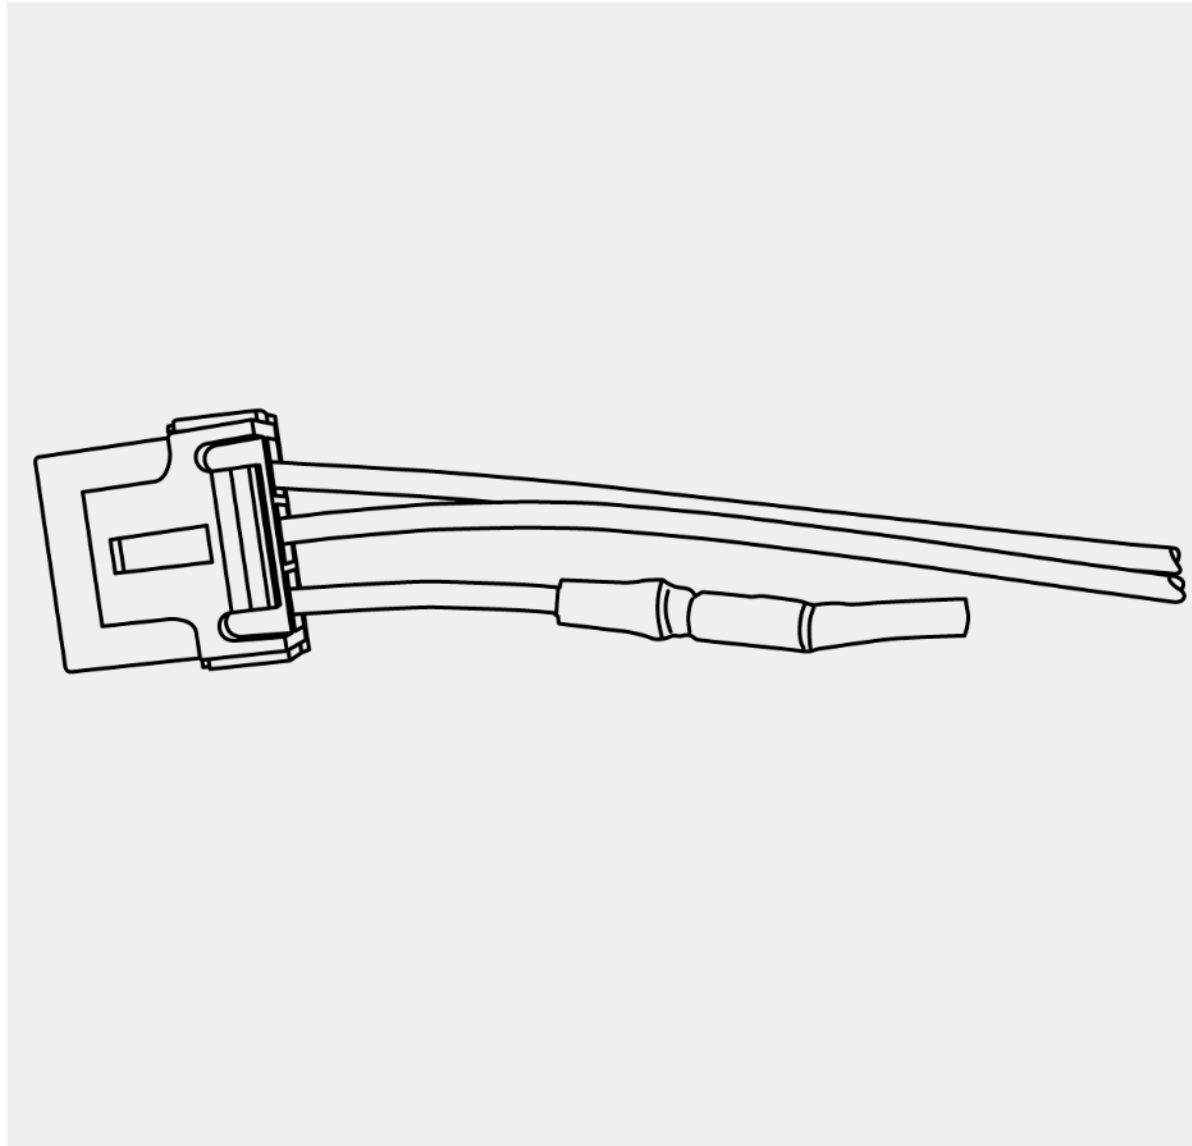
**Fig. 71: Applying Heat To Crimped Area Of Barrel**

3. Using the heat torch, apply heat to the crimped area of the barrel.
