# SERVICE BULLETIN

<br>O. Kai - E.V.P. & G.M.<br>After Sales Service Dept. |                                                            |        |          |          |         |                                                      |            |           |        |            |           |            |          |            |          |            |         |
| <b>1. Description:</b><br>In the ABS hydraulic unit inspection, time when the actuator is driven for the actuator test has been corrected. | | | | | | | | | | | | | | | | | | | |
| <b>2. Applicable Manuals:</b>

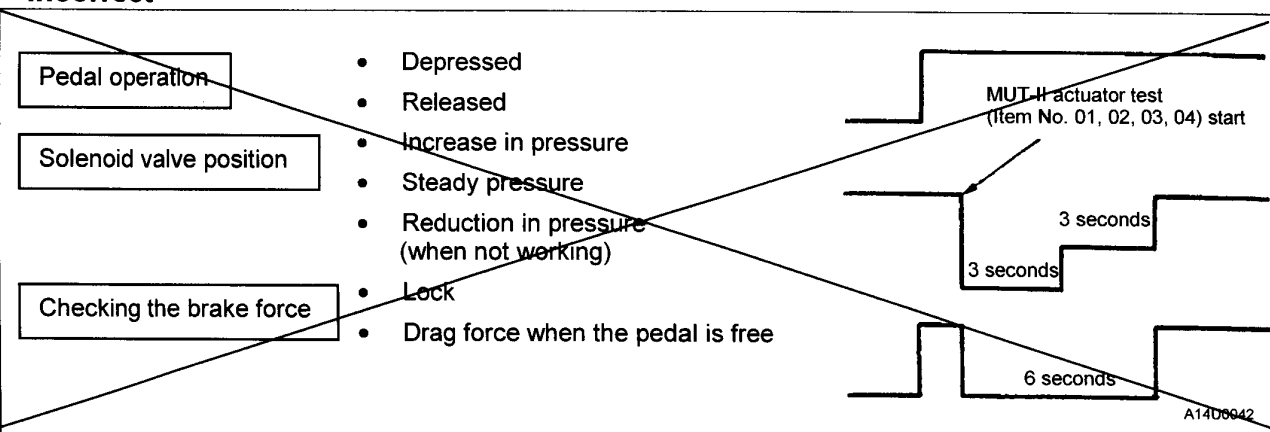
## &lt;Incorrect&gt;

7. If the result of inspection is abnormal, correct according to the Diagnosis Table below.
