## GROUP 27

# REAR AXLE

GENERAL INFORMATION

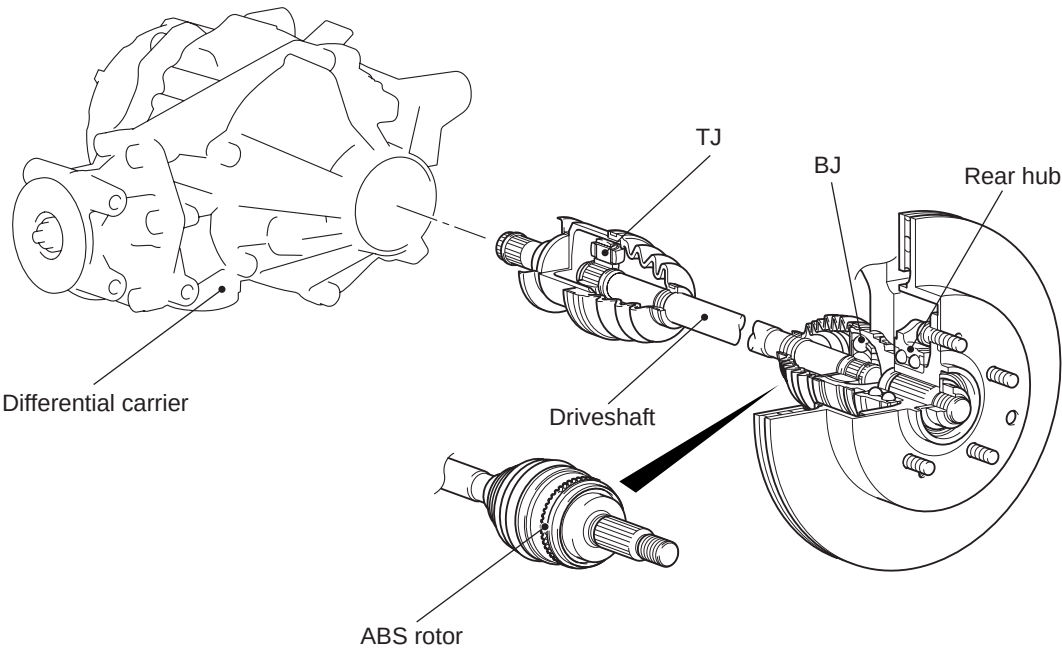
CONSTRUCTION DIAGRAM

The rear axle consists of rear wheel hub assembly, knuckles and driveshafts, and has the following features:

- The wheel bearing is a unit ball bearing (double-row angular contact ball bearing) for reduced friction.
- The driveshaft has EBJ-TJ constant velocity joints.
- ABS rotor for detecting the wheel speed is press-fitted to the EBJ.

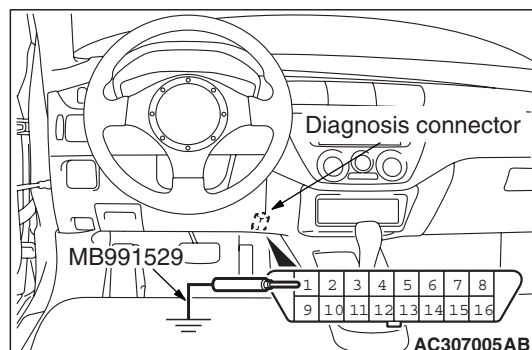
1. Turn the ignition switch to the "LOCK" (OFF) position.

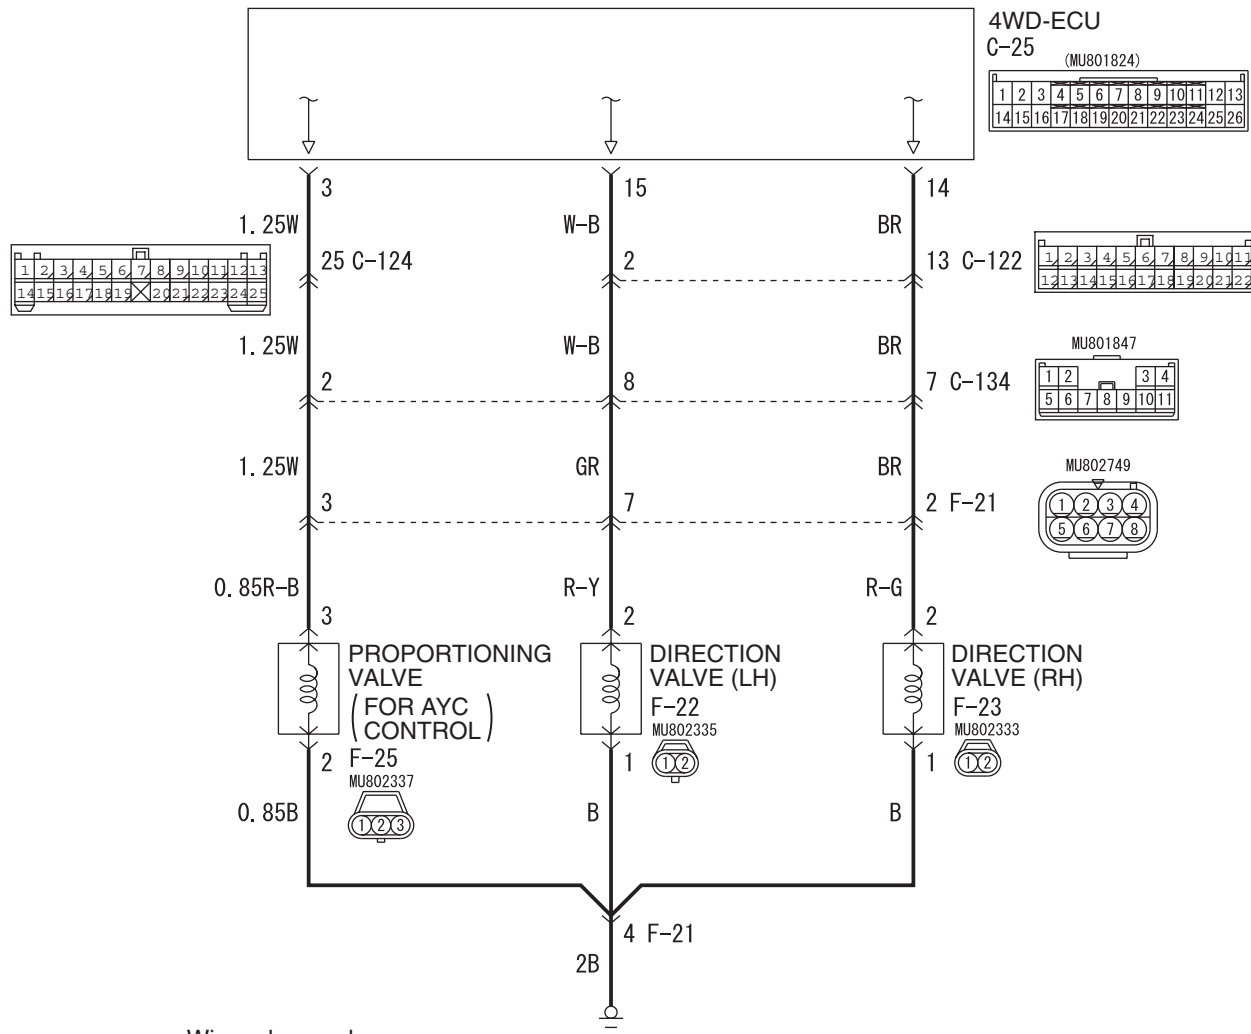
Proportioning valve system/direction valve system circuit

### Code No.71: Proportioning valve <AYC> system

Wire colour code

B : Black LG : Light green G : Green L : Blue W : White Y : Yellow SB : Sky blue  
BR : Brown O : Orange GR : Gray R : Red P : Pink V : Violet

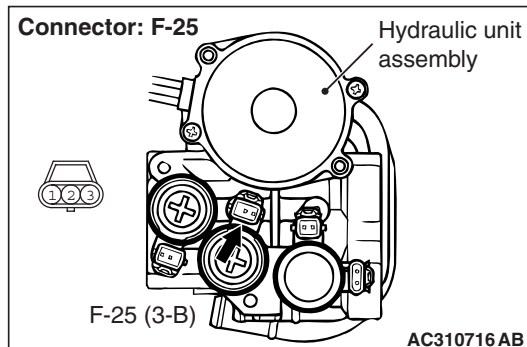
**STEP 2. Measure the resistance at proportioning valve connector F-25.**

Disconnect the connector, and measure the resistance between terminal 2 and 3 at the proportioning valve side.

**OK: 4.7  $\Omega$  or less**

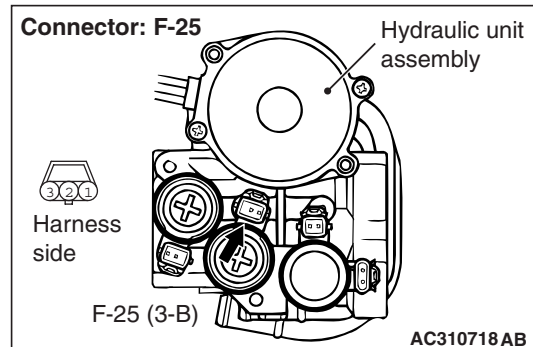
**STEP 3. Measure the resistance at proportioning valve connector F-25.**

Measure the resistance between terminal 2 and earth at the wiring harness side.

**OK: 2  $\Omega$  or less**

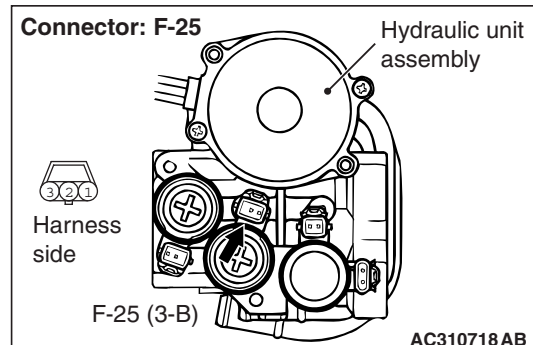
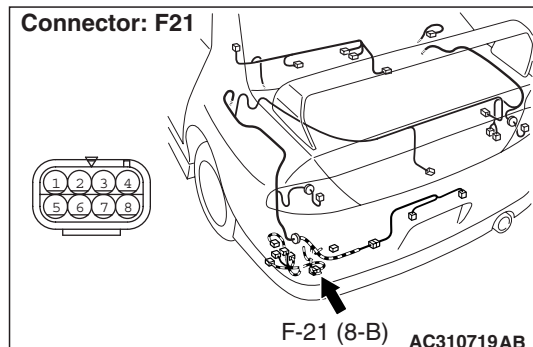
**STEP 4. Connectors check: F-25 proportioning valve connector, F-21 intermediate connector**

Check for the contact with terminals.

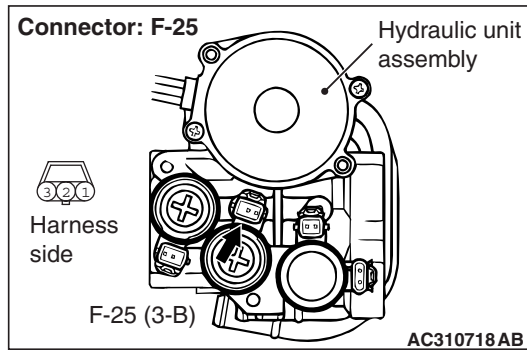
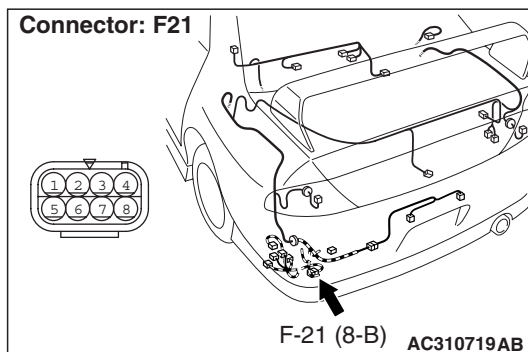
**STEP 5. Check the harness wires between proportioning valve connector F-25 terminal 2 and intermediate connector F-21 terminal 4 and earth.**

Check the earth line for open circuit.

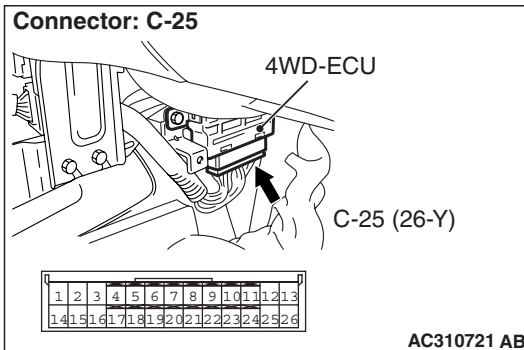
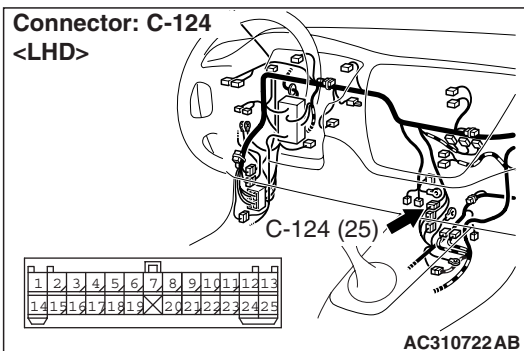
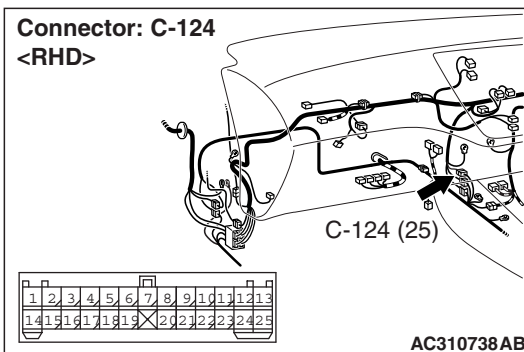
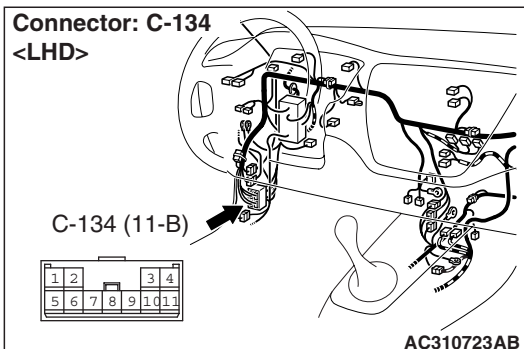
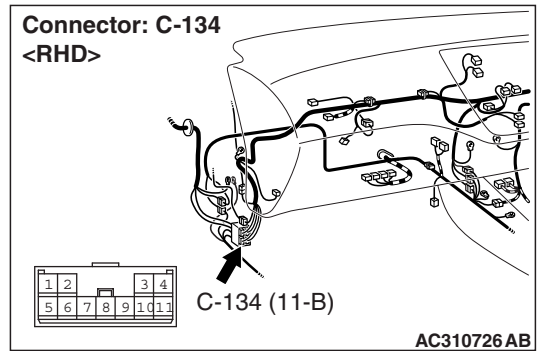
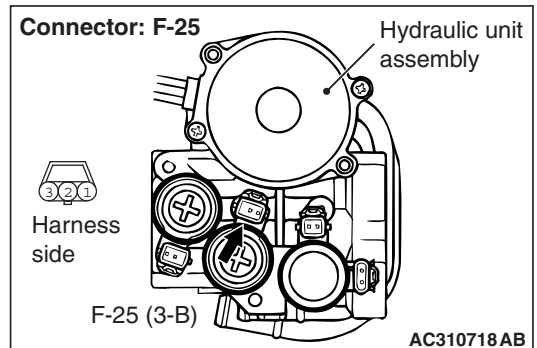
**STEP 6. Connectors check: C-25 4WD-ECU connector, C-124, C-134 and F-21 intermediate connectors, and F-25 proportioning valve connector**

Check for the contact with terminals.

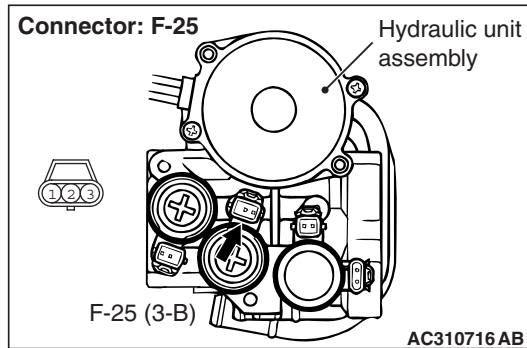
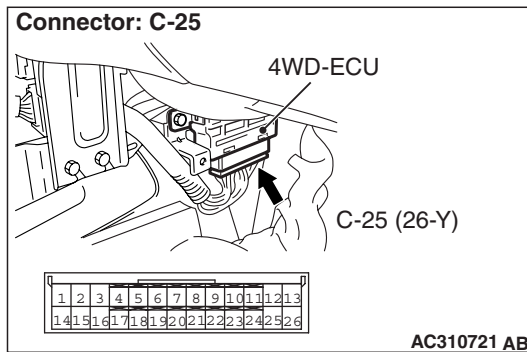
**STEP 7. Check the harness between proportioning valve connector F-25 terminal No.3 and 4WD-ECU connector C-25 terminal No.3.**

Check the output line for short-circuited or open circuit.

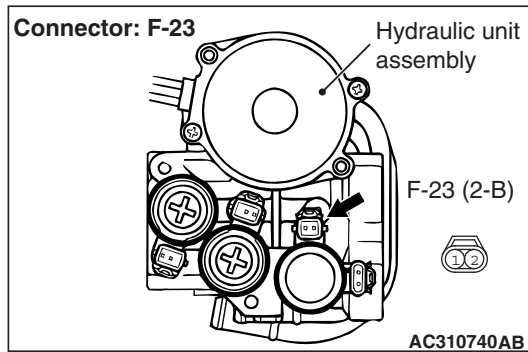
**STEP 2. Measure the resistance at direction valve (RH) connector F-23.**

Disconnect the connector, and measure the resistance between terminal 1 and 2 at the direction valve (RH) side.

**OK: 19 – 21  $\Omega$  or less**

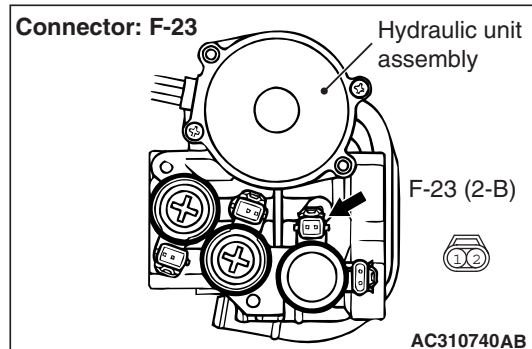
**STEP 3. Measure the resistance at direction valve (RH) connector F-23.**

Measure the resistance between terminal 1 and earth at the direction valve (RH) side

**OK: 2  $\Omega$  or less**

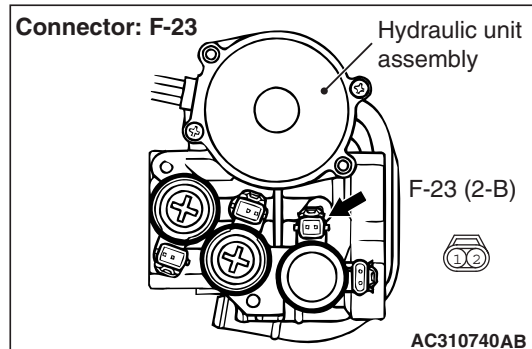
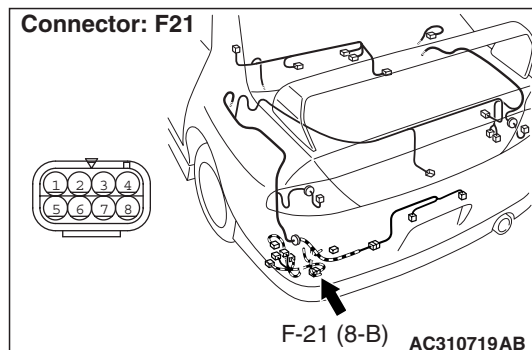
**STEP 4. Connectors check: F-23 direction valve (RH) connector, F-21 intermediate connector**

Check for the contact with terminals.

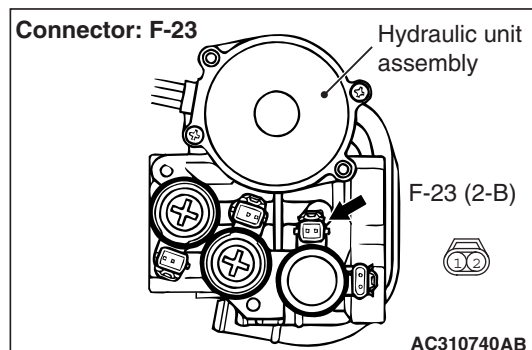
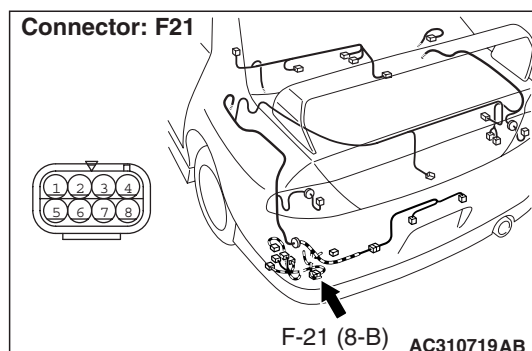
**STEP 5. Check the harness wires between direction valve (RH) connector F-23 terminal 1 and intermediate connector F-21 and earth.**

Check the earth line for open circuit.

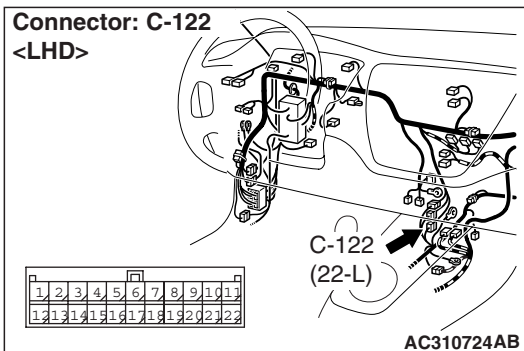
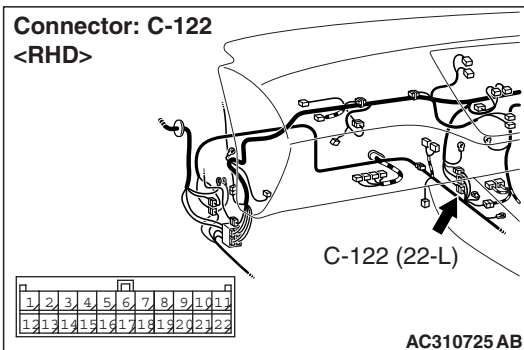
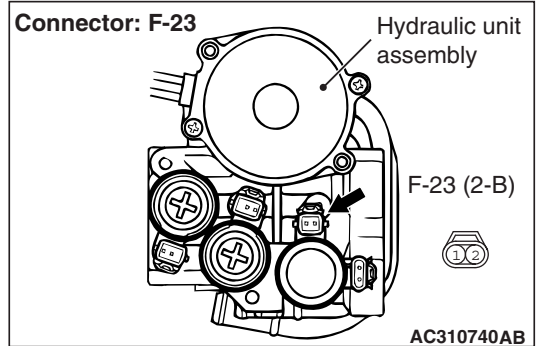
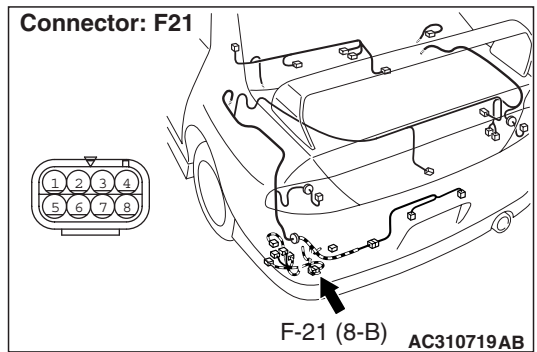
**STEP 6. Connectors check: C-25 4WD-ECU connector, C-122, C-134 and F-21 intermediate connectors, and F-23 direction valve (RH) connector**

Check for the contact with terminals.

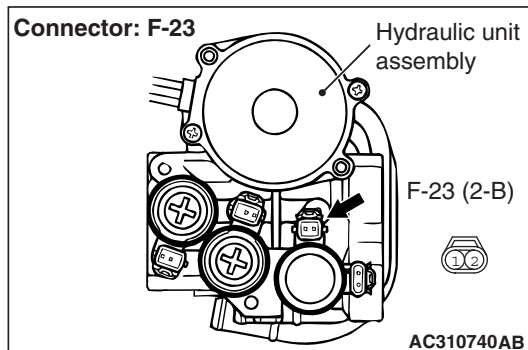
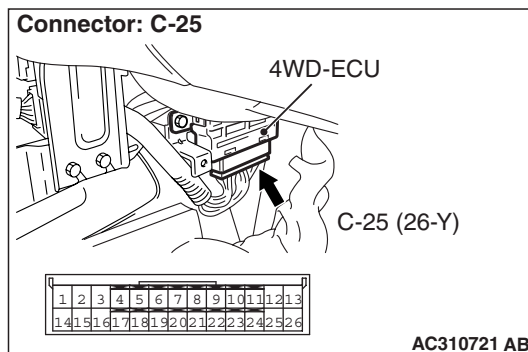
**STEP 7. Check the harness between direction valve (RH) connector F-23 terminal No.2 and 4WD-ECU connector C-25 terminal No.14.**

Check the output line for short-circuited or open circuit.

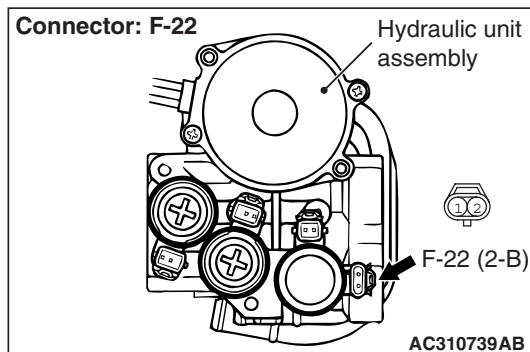
**STEP 2. Measure the resistance at direction valve (LH) connector F-22.**

Disconnect the connector, and measure the resistance between terminal 1 and 2 at the direction valve (LH) side.

**OK: 19 – 21  $\Omega$  or less**

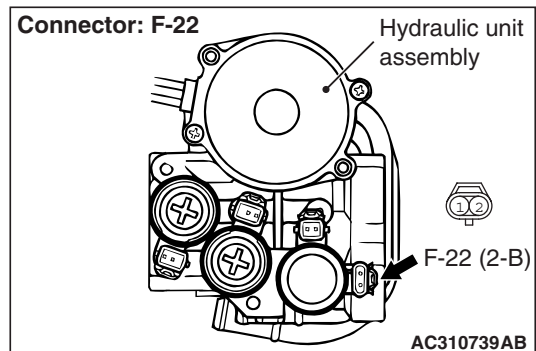
**STEP 3. Measure the resistance at direction valve (LH) connector F-22.**

Measure the resistance between terminal 1 and earth at the direction valve (LH) side

**OK: 2  $\Omega$  or less**

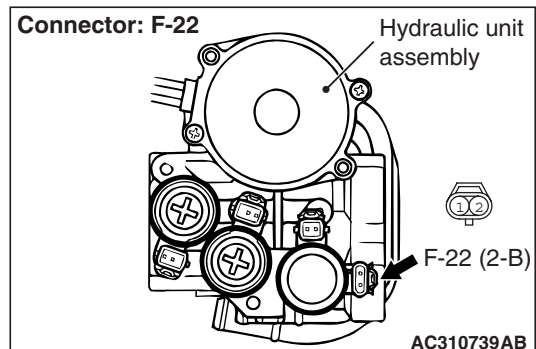
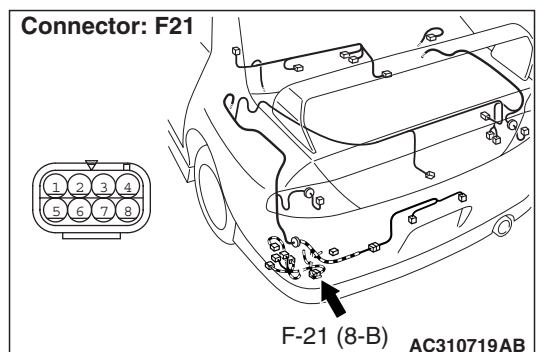
**STEP 4. Connectors check: F-22 direction valve (LH) connector, F-21 intermediate connector**

Check for the contact with terminals.

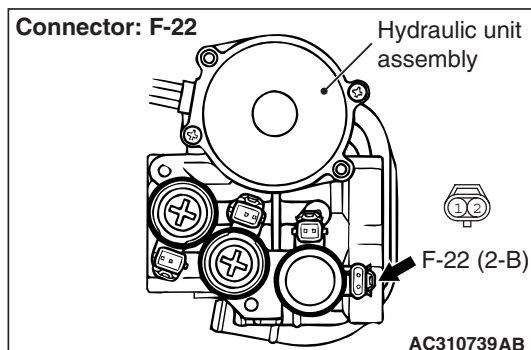
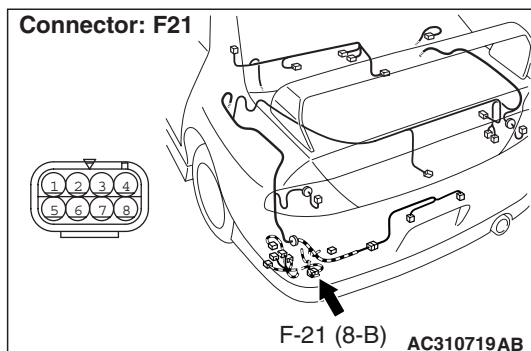
**STEP 5. Check the harness wires between direction valve (LH) connector F-22 terminal 1 and intermediate connector F-21 and body earth.**

Check the earth line for open circuit.

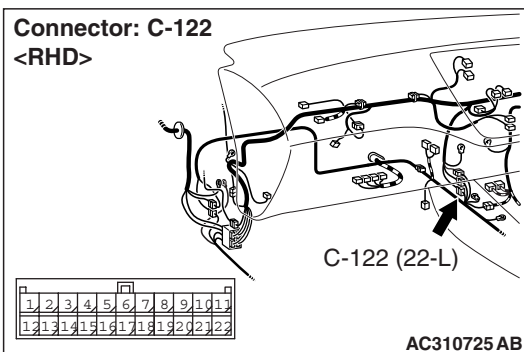
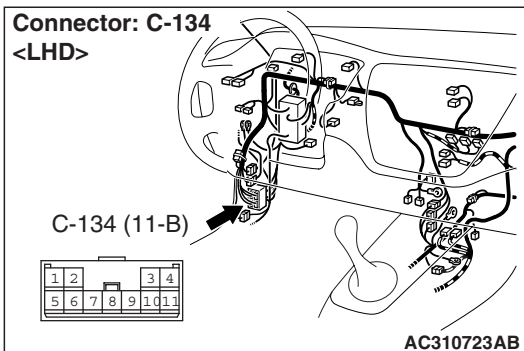
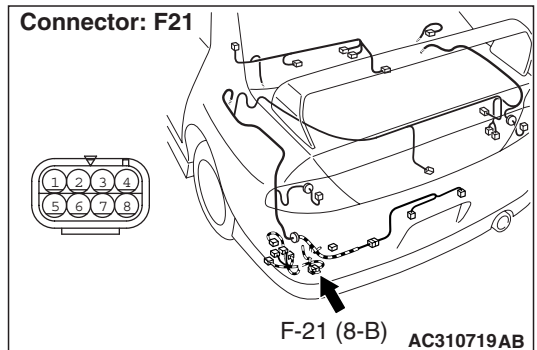
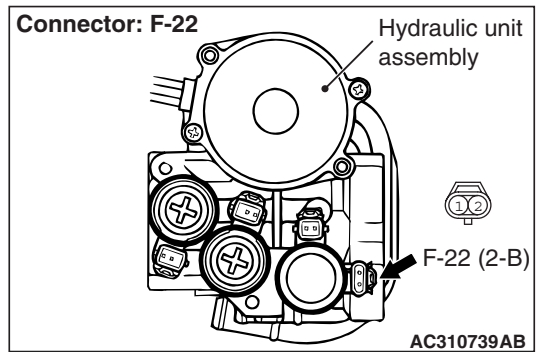
**STEP 6. Connectors check: C-25 4WD-ECU connector, C-122, C-134 and F-21 intermediate connectors, and F-22 direction valve (LH) connector**

Check for the contact with terminals.

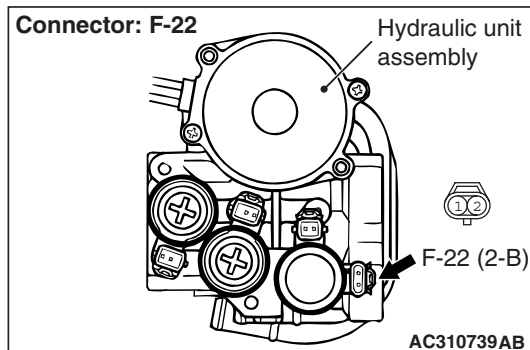
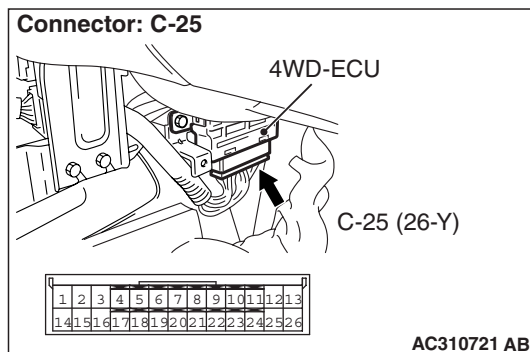
**STEP 7. Check the harness between direction valve (LH) connector F-22 terminal No.2 and 4WD-ECU connector C-25 terminal No.15.**

Check the output line for short-circuited or open circuit.

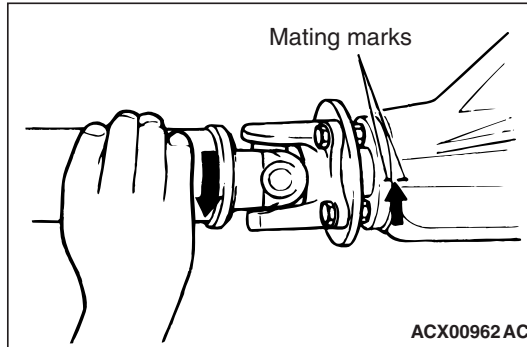
1. Park the vehicle on a flat, level surface.
2. Move the transmission gearshift lever to the neutral position. Apply the parking brake and jack up the vehicle.

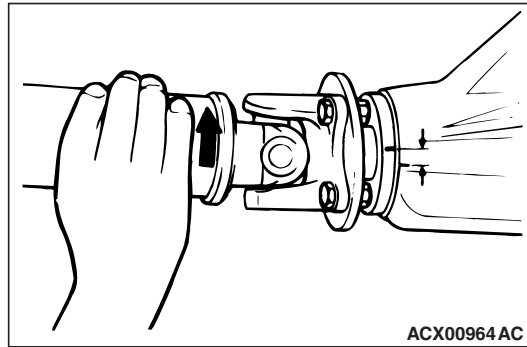
4. Turn the propeller shaft counterclockwise as far as it will go, and measure the amount of distance between the mating marks.

**Limit: 6 mm**

3. Turn the propeller shaft clockwise as far as it will go. Make the mating marks on the companion flange and on the differential carrier.

5. If the backlash exceeds the limit value, replace the differential carrier assembly.

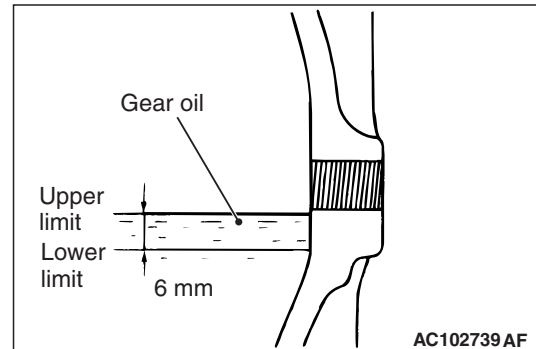
2. Check that the gear oil level is within the specified range from the bottom end of the filler plug hole.
3. If the gear oil level exceeds the standard value, add the specified gear oil up to the bottom end of the filler plug hole.

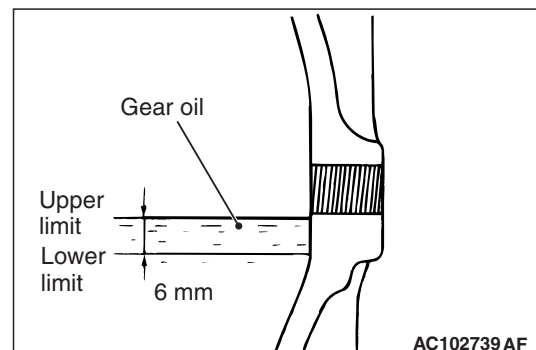
2. Check that the gear oil level is within the specified range from the bottom end of the filler plug hole.

- If the gear oil level exceeds the standard value, add the specified gear oil up to the bottom end of the filler plug hole.

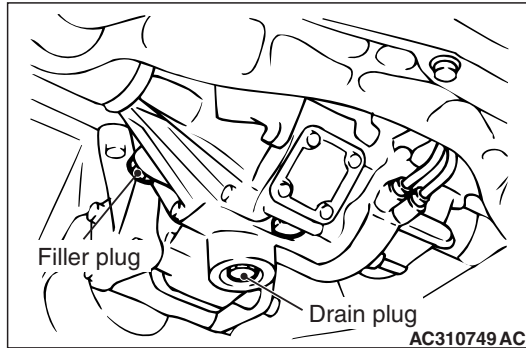
- Remove the drain plug to discharge the gear oil.
- Fit the drain plug and tighten it to the specified torque.

**Tightening torque:  $49 \pm 10$  N·m**

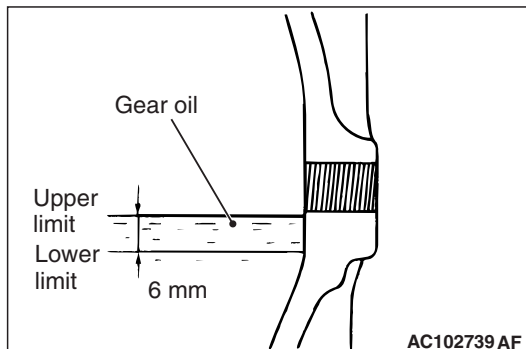
- Remove the filler plug and add the specified gear oil up to the bottom end of the filler plug hole.

**Specified gear oil: DIA QUEEN LSD gear oil**

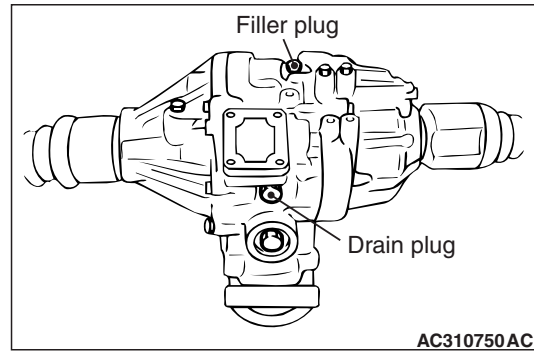
- Remove the drain plug to discharge the gear oil.
- Fit the drain plug and tighten it to the specified torque.

**Tightening torque:  $49 \pm 10$  N·m**

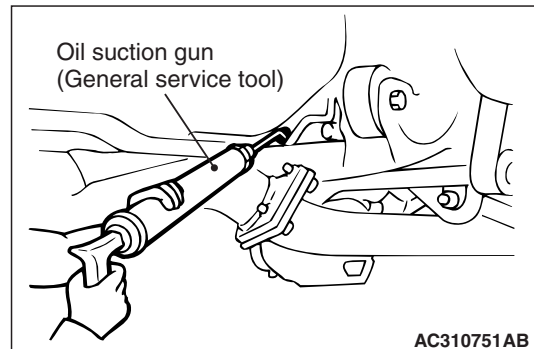
- Using the oil suction gun (general service tool), between the body and differential support arm, apply the specified gear oil up to the under of the filler plug hall.

**Amount to use: 0.55 – 0.6 L**

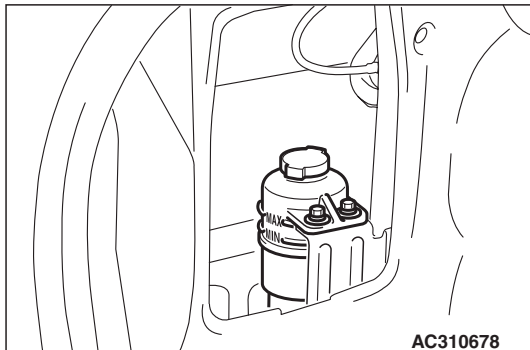
- Check that the fluid level in the oil reservoir is in the range between MAX and MIN.
- If the fluid level is lower than MIN, add the specified fluid.

**Specified fluid: DIA QUEEN ATF-SP III**

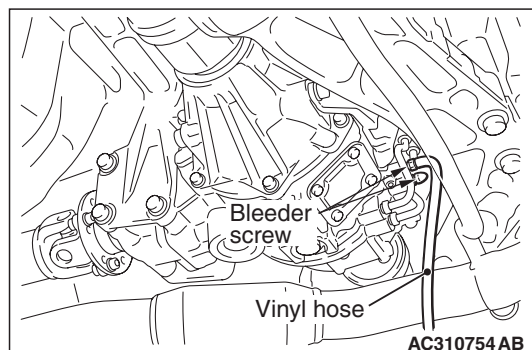
- Remove the cap of the left bleeder screw on the torque transfer differential and connect a vinyl hose.
- Gradually turn the steering wheel clockwise from the straight-ahead position. At this time, loosen the left bleeder screw and check that fluid is discharged with air.

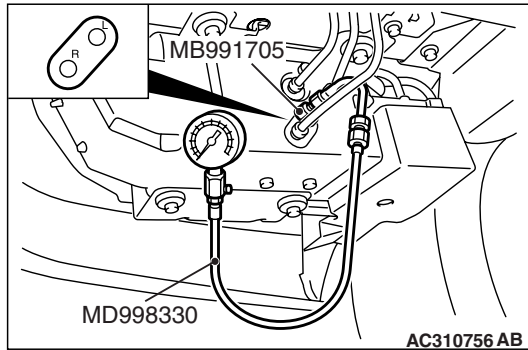
- Disconnect the hydraulic unit and the hydraulic unit hose assembly, connect the special tool to L port, put the lid to R port or connect the hydraulic unit hose assembly disconnected from L port to R port.
  - Hose adaptor (MB991705)
  - Oil pressure gauge (MD998330)
- Operating the M.U.T.-II/III, drive the hydraulic unit forcibly (actuator test item No.02).

**Standard value: 0.9 – 1.1 MPa**
- Check the oil pressure of the clutch right side following step 4 through 6. Connect the special tool to R port, put the lid to L port or hydraulic unit hose assembly disconnected from R port to L port, use the M.U.T.-II/III to drive actuator test item No.07 (operation check mode of clutch right side) forcibly.
- If the measured value exceeds the standard value, replace the hydraulic unit.
- Connect the hydraulic unit and the hydraulic unit hose assembly, and connect the torque transfer differential and hydraulic unit hose assembly, tighten the flare nut in specified torque.

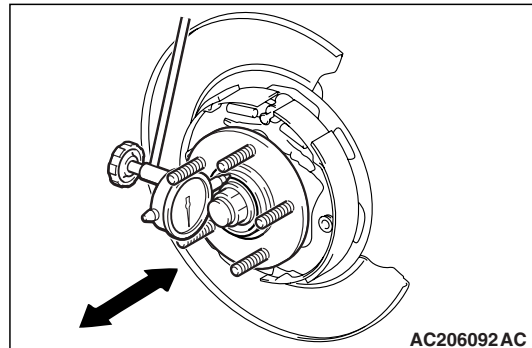
- Fit the dial gauge as shown in the diagram and move the hub in the axial direction to measure the play.

**Limit: 0.05 mm**

- Replace the rear hub assembly if adjustment cannot be made to within the limit.
- Install the brake disc and caliper assembly, and tighten the caliper assembly mounting bolts to the specified torque.

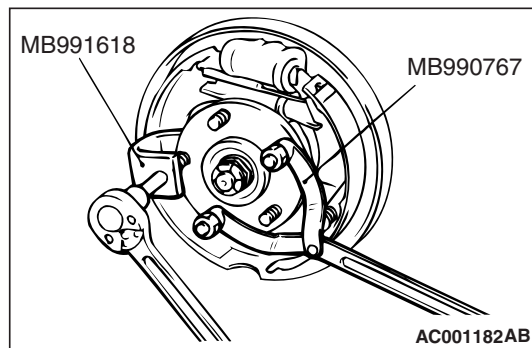
- Use the following special tools to remove the hub bolts.
  - Front hub and end yoke holder (MB990767)
  - Hub bolt remover (MB991618)

**NOTE:** To retain a space for removing the hub bolts, remove near the retainer spring mounting position.

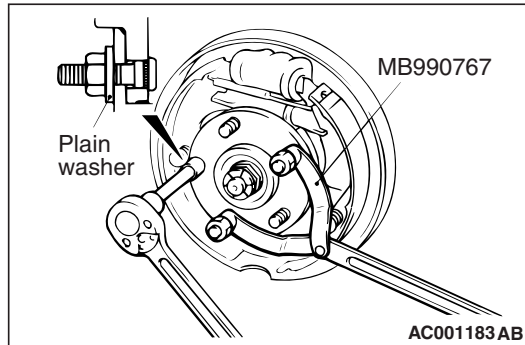
3. Install the plain washer to the new hub bolt, and install the bolt with a nut.

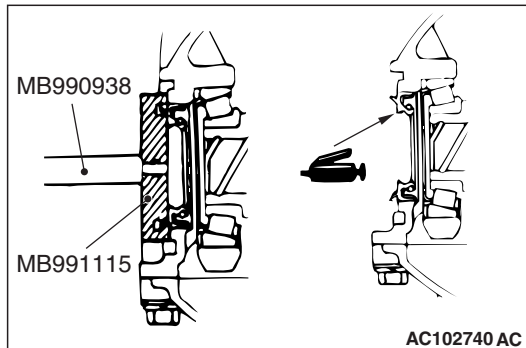
3. Use the following special tools to press-fit a new oil seal.
  - Installer bar (MB990938)
  - Oil seal installer (MB991115)
4. Apply multi-purpose grease to the oil seal lip and driveshaft oil seal seating area.
5. Replace the driveshaft circlip with a new one, and install the driveshaft to the differential carrier. (Refer to P.27-36).

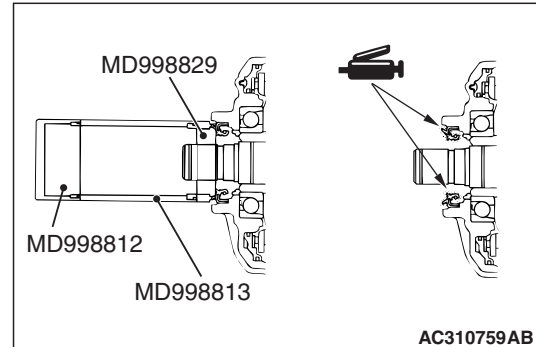
3. Use the following special tools to press-fit a new oil seal.
  - Installer cap (MD998812)
  - Installer 100 (MD998813)
  - Installer adaptor (MD998829)
4. Apply specified grease to the oil seal lip and driveshaft oil seal seating area.

**Specified grease: Vaseline**

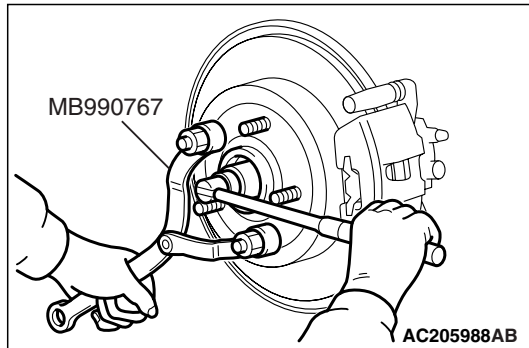
Use special tool front hub and end yoke holder (MB990767) to fix the hub and remove the driveshaft nut.

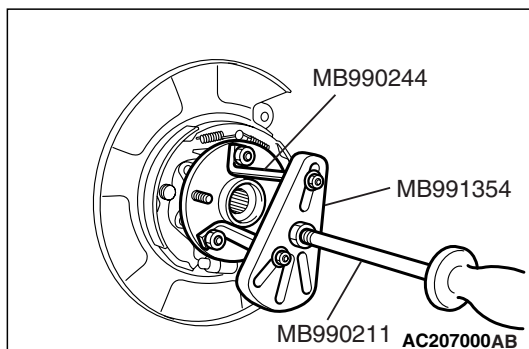
2. Use the following special tools to pull out the rear wheel hub from the knuckle.

- Puller bar (MB990244)
- Puller body (MB991354)
- Slide hammer (MB990211)

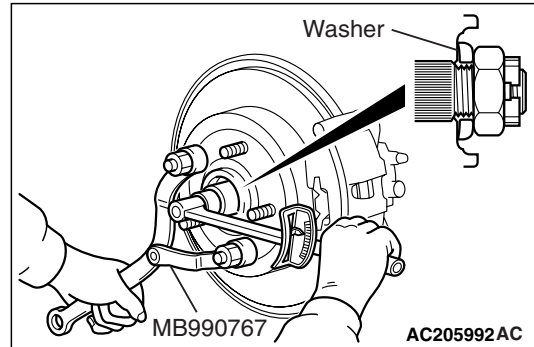
1. Be sure to install the driveshaft washer in the specified direction.
2. Using special tool front hub and end yoke holder (MB990767), tighten the driveshaft nut to the specified torque.

**Tightening torque:  $225 \pm 25$  N·m**

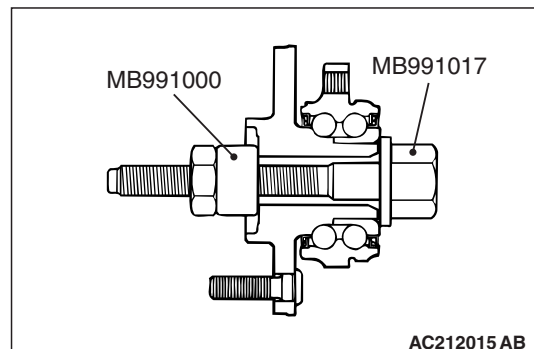
1. Tighten the following special tools to the specified torque.

- Front hub remover and installer (MB991017)
- Spacer (MB991000)

**Tightening torque:  $225 \pm 25$  N·m**

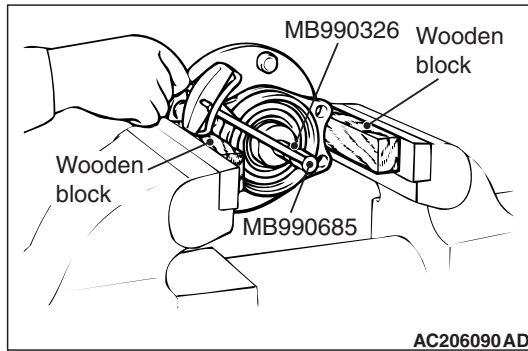
3. Hold the rear wheel hub assembly with wooden blocks.
4. Measure the wheel bearing rotation starting torque by using the following special tools.
  - Preload socket (MB990326)
  - Torque wrench (MB990685)

**Limit: 1.0 N·m**

5. If the rotation starting torque is not within the limit range while the nut is tightened to  $225 \pm 25$  N·m, replace the front wheel bearing assembly. If there are any signs of binding or tight spots when the wheel bearing turns, replace it.

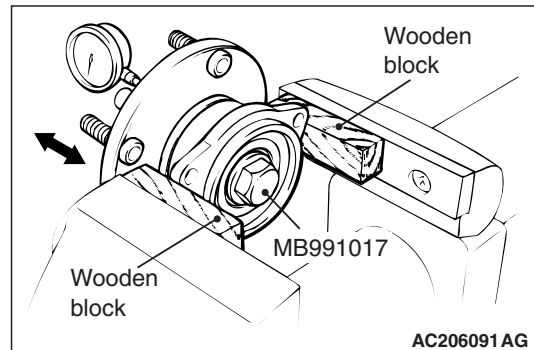
6. Measure to determine whether the wheel bearing axial play is within the specified limit or not.

**Limit: 0.05 mm**
7. If the play is not within the limit range while the nut is tightened to  $225 \pm 25$  N·m, replace the rear wheel hub assembly.

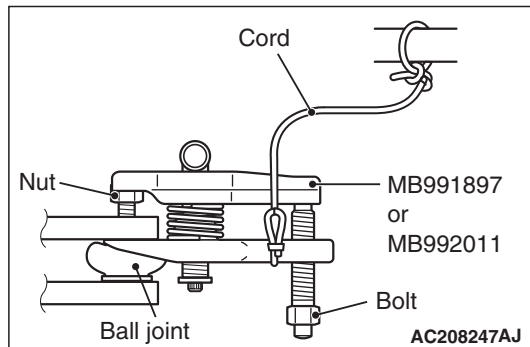
1. Install special tool ball joint remover (MB991897 or MB992011) as shown in the figure.

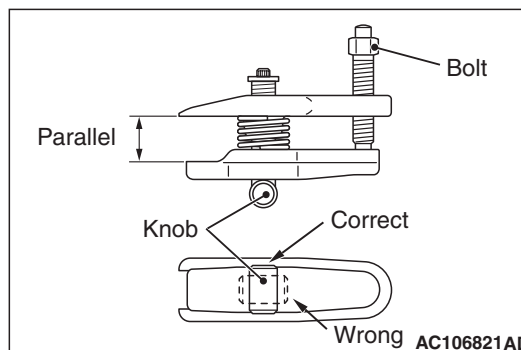
2. After turning the bolt and knob to adjust the arms of special tool in parallel, tighten the bolt by hand and confirm that the arms are parallel.

*NOTE: When adjusting the arms in parallel, turn the knob so that it is at right angles to the arms.*

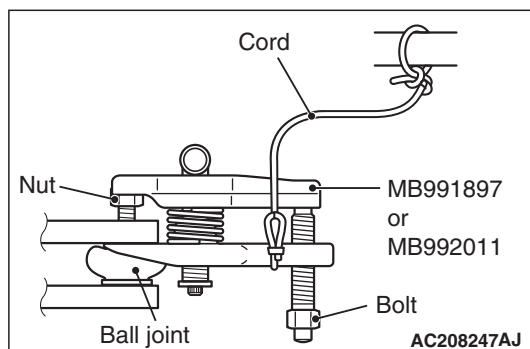
1. Install special tool ball joint remover (MB991897 or MB992011) as shown in the figure.

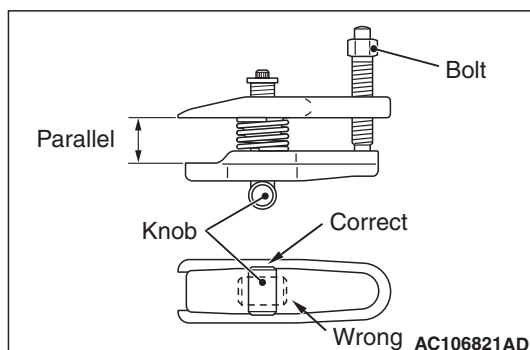
2. After turning the bolt and knob to adjust the arms of special tool in parallel, tighten the bolt by hand and confirm that the arms are parallel.

*NOTE: When adjusting the arms in parallel, turn the knob so that it is at right angles to the arms.*

3. Tighten the bolt with a wrench to disconnect the ball joint and remove the self-locking nut.

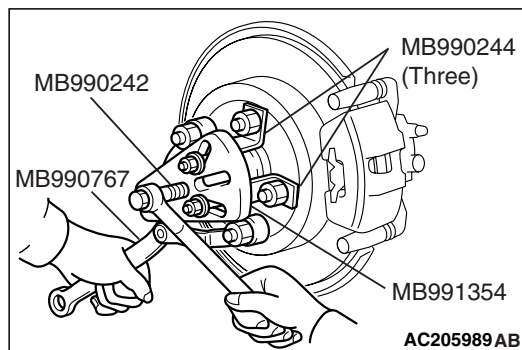
1. Use the following special tools to push out the driveshaft from the hub.
  - Puller shaft (MB990242)
  - Puller bar (MB990244)
  - Puller body (MB991354)
  - Front hub and end yoke holder (MB990767)

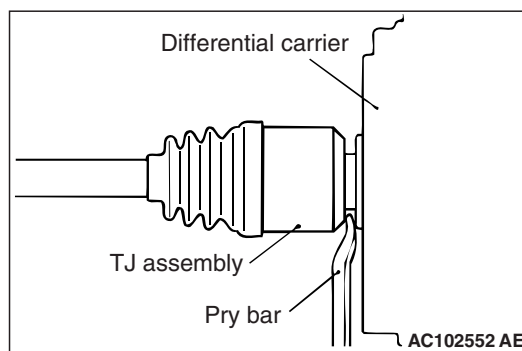
2. Remove the driveshaft from the differential carrier by using a pry bar.

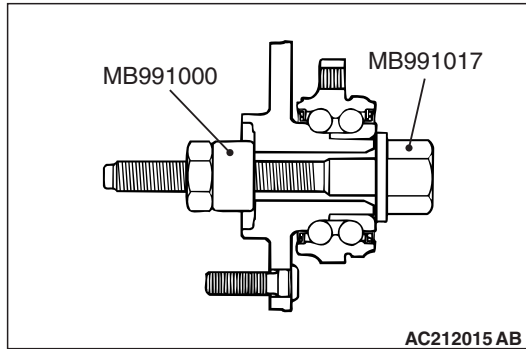
Do not apply pressure to the wheel bearing by the vehicle weight to avoid possible damage when the driveshaft is removed. If, however, vehicle weight must be applied to the bearing in moving the vehicle, temporarily secure the wheel bearing by using the following special tools.

- Front hub remover and installer (MB991017)
- Spacer (MB991000)

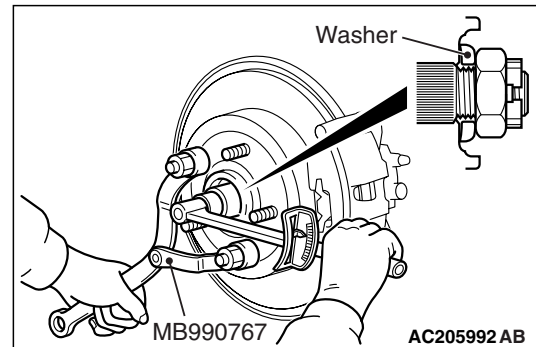
1. Assemble the driveshaft washer in the illustrated direction.
2. Tighten the driveshaft nut to the specified torque with special tool front hub and end yoke holder (MB990767).

**Tightening torque:  $225 \pm 25$  N·m**

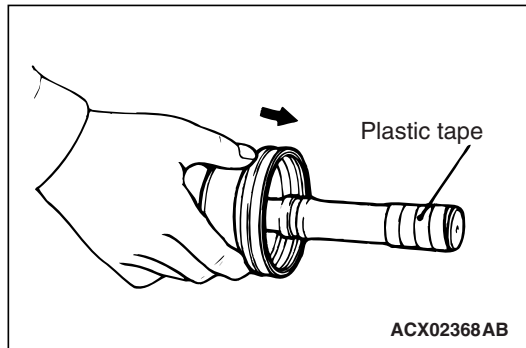
1. Wipe off grease from the shaft spline part.
2. Wrap plastic tape around the spline part on the TJ side of the driveshaft so that TJ and EBJ boots are not damaged when they are removed.

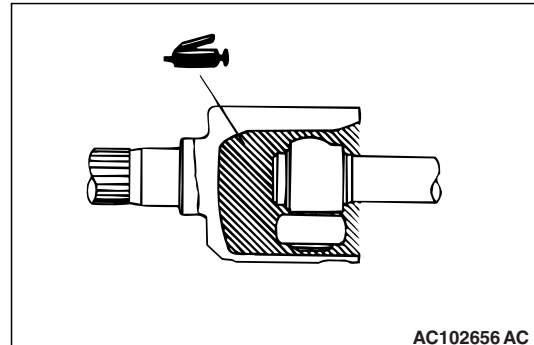
After applying the specified grease to the TJ case, insert the driveshaft and apply grease again.

**Specified grease: Repair kit grease**

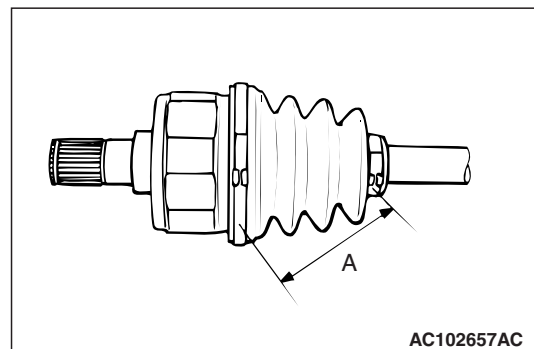
Set the TJ boot bands at the specified distance in order to adjust the amount of air inside the TJ boot, and then tighten the TJ boot band(large) and TJ boot band(small) securely.

**Standard value (A):  $90 \pm 3$  mm**

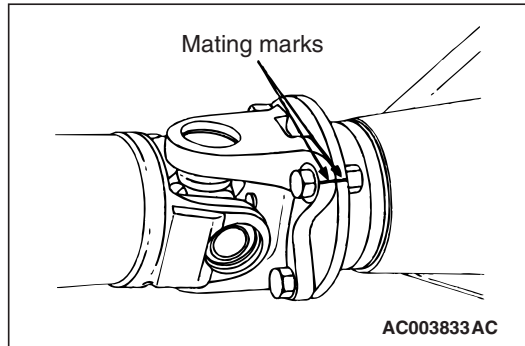
1. Make mating marks on the differential companion flange and the propeller shaft assembly.
2. Suspend the removed propeller shaft from the body with a wire to prevent bending.

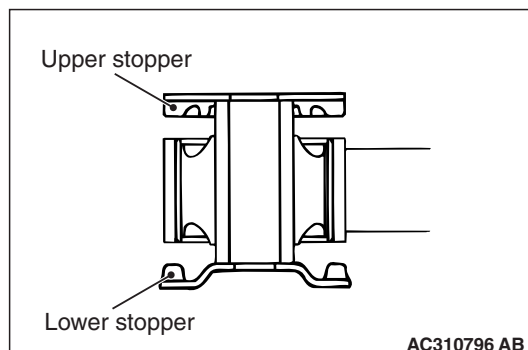
Install the lower and upper stopper as shown in the illustration.

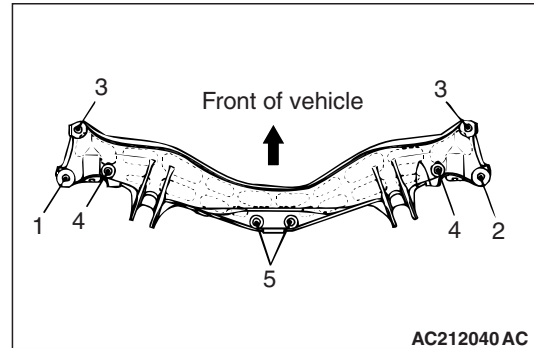
Tighten the rear crossmember mounting bolts in the numerical order shown.

*NOTE: To ensure both good installation accuracy and ease of installation, the rear crossmember mounting holes have different diameters between front and rear. This is the reason for specifying the tightening sequence of the mounting bolts.*

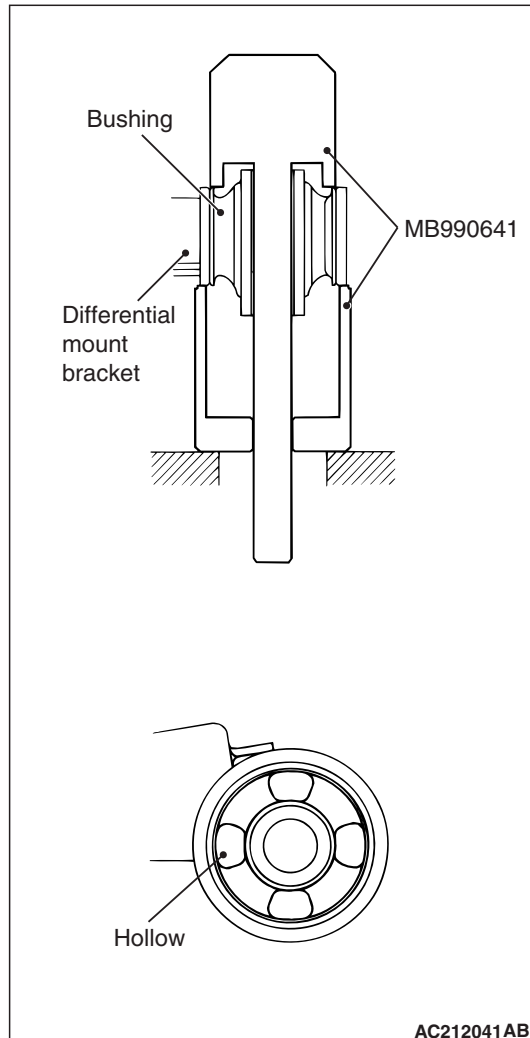
### <DIFFERENTIAL MOUNT BRACKET>

1. Use special tool lower arm bush (A) remover and installer (MB990641) to remove or install the bushing.
2. Press-fit the bushing with its hollow portion facing in the direction shown.
3. Press-fit the bushing until the bushing outer case end face is flush with the differential mount bracket.

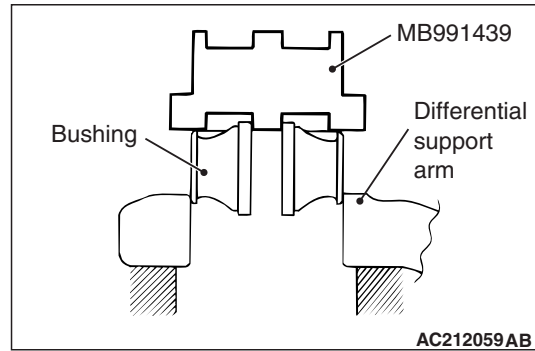
1. Use special tool bush remover and installer (MB991439) to remove the bushing.

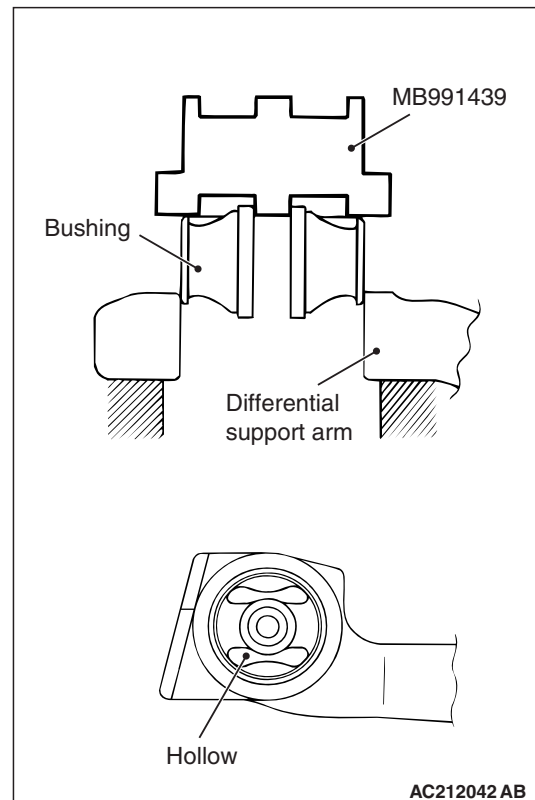
### <DIFFERENTIAL SUPPORT ARM>

2. Press-fit the bushing with its marks facing in the direction shown.
3. Press-fit the bushing until the bushing outer case end face is flush with the differential support arm.

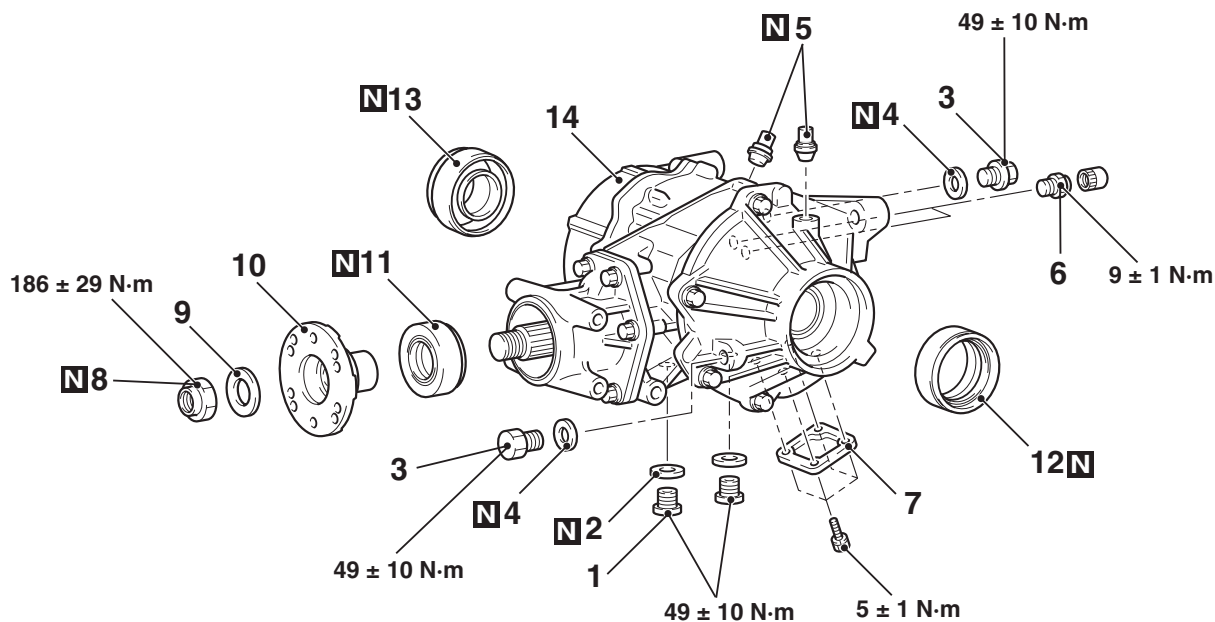
AC310833 AB

- <<A>> >>C<< 8. Self-locking nut
9. Washer
10. Companion flange
11. Oil seal
- >>B<< 12. Oil seal
- >>A<< 13. Oil seal
14. Differential carrier assembly

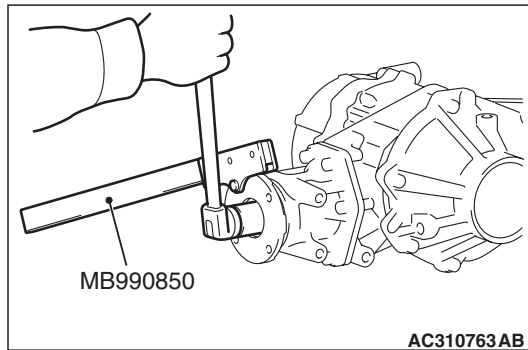
Use special tool end yoke holder (MB990850) to hold the companion flange, and then remove the companion flange self-locking nut.

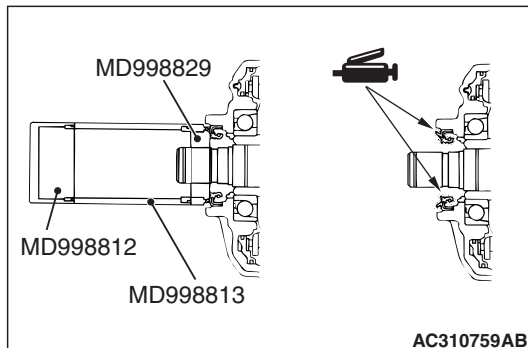
1. Use the following special tools to press-fit the oil seal.
  - Installer cap (MD998812)
  - Installer 100 (MD998813)
  - Installer adaptor (MD998829)
2. Apply specified grease to the oil seal lip and driveshaft oil seal seating area.

**Specified grease: Vaseline**

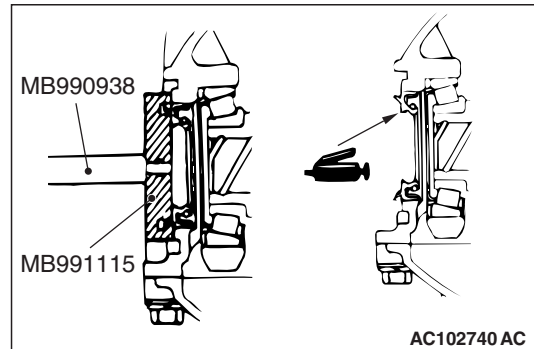
1. Use the following special tools to press-fit the oil seal.
  - Installer bar (MB990938)
  - Oil seal installer (MB991115)
2. Apply multi-purpose grease to the oil seal lip and driveshaft oil seal seating area.

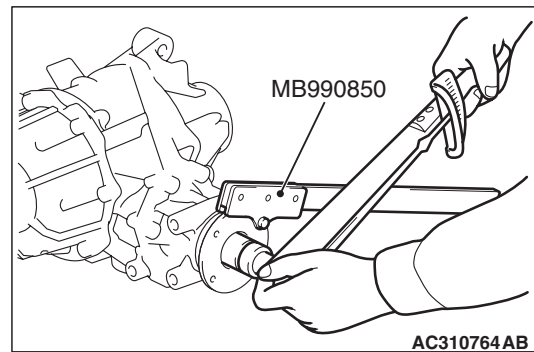
Tighten the companion flange self-locking nut to the specified torque while holding the companion flange with special tool end yoke holder (MB990850).

**Tightening torque:  $186 \pm 29$  N·m**

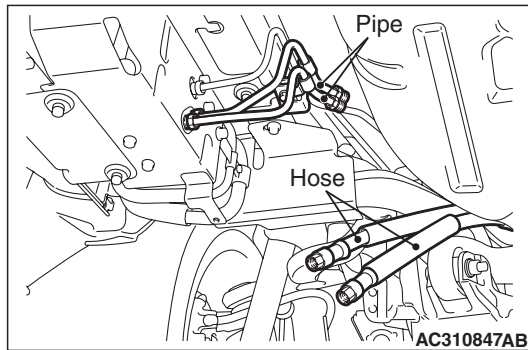
1. Disconnect the hydraulic unit side pipe and hose.

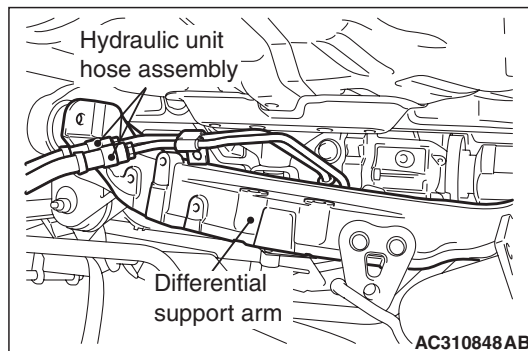
2. Pull down the differential support arm, remove the hydraulic unit hose assembly.
