## GROUP 27

# REAR AXLE

GENERAL INFORMATION

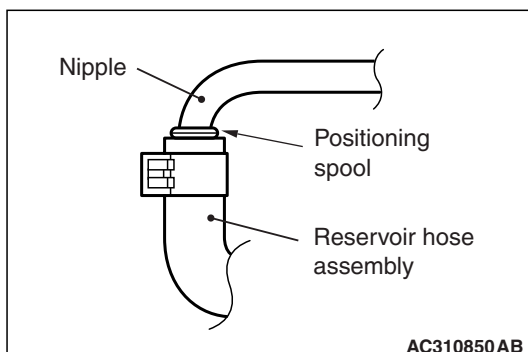
### >>A<< RESERVOIR HOSE ASSEMBLY INSTALLATION

Insert the reservoir hose assembly to the positioning spool.

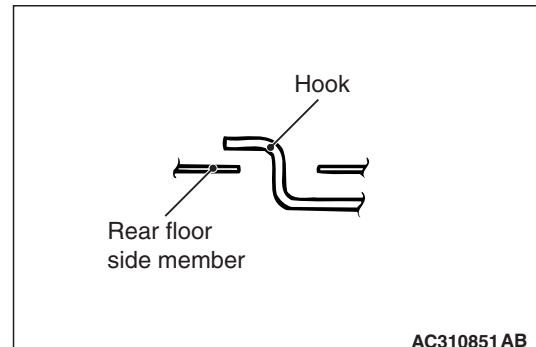
### >>B<< HYDRAULIC UNIT ASSEMBLY INSTALLATION

Hook the hydraulic unit assembly hook to the rear floor side member and tighten the hydraulic unit assembly mounting bolt.

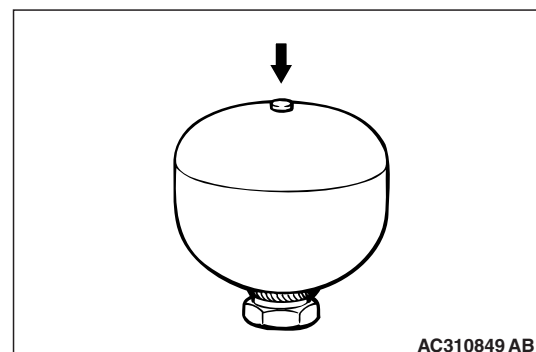
When discarding the hydraulic unit, drill a hole in the accumulator at the illustrated position beforehand in order to release the inside gas.
